Restoration of implant supported crowns

Uncommon problems and their solutions

Author_Dr Igor Cernavin, Australia

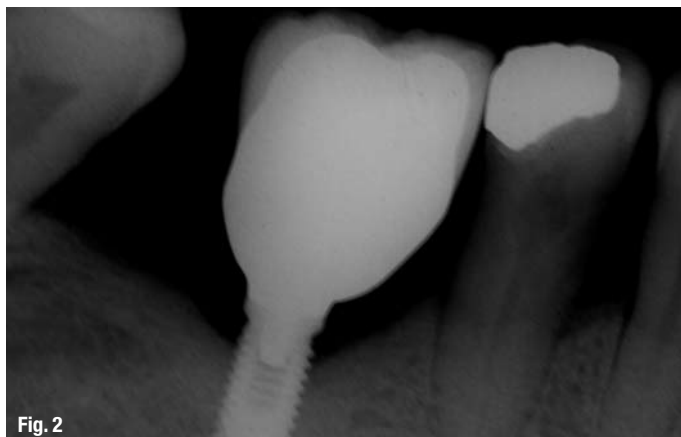
Fig. 2

Fig. 2_ Unfavourable crown root ratio for direct-to-fixture.

Figure 2 shows such a case in which the crown-root ratio is too large for a direct-to-fixture crown. This case has the added problem of a regular-diameter implant with a wide-diameter crown, which would tend to increase the possibility of the screw loosening further. A wide-diameter implant would probably have been better here.

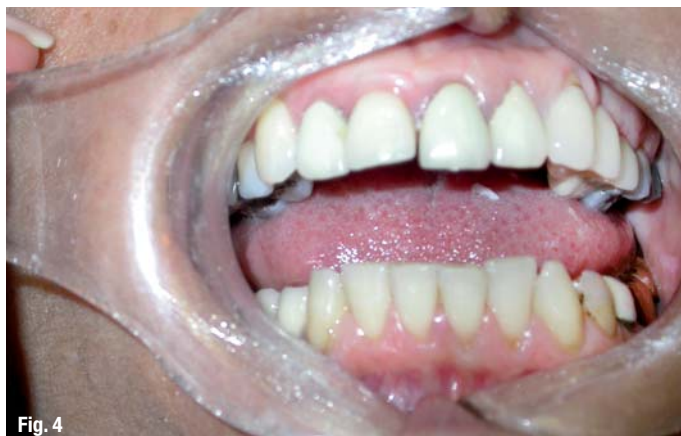
Fig. 4

Fig. 4_ Shifted implant retained crown.

patient was examined and it was found that indeed the crown was now angled at approximately 30° labial to its original position (Fig. 4). Clinical and radiographic examination revealed that the fixture was sound, not tender to percussion and there was no probing depth. As the crown was retained with a cross pin, it was removed and it was found that the abutmentscrew was not loose. The crown was replaced and the patient agreed that she would leave things as they were to await further developments. The crown remained in place, symptom free, for a further six months, at which time the fixture exhibited clear clinical signs and symptoms of failure of integration, and was removed.

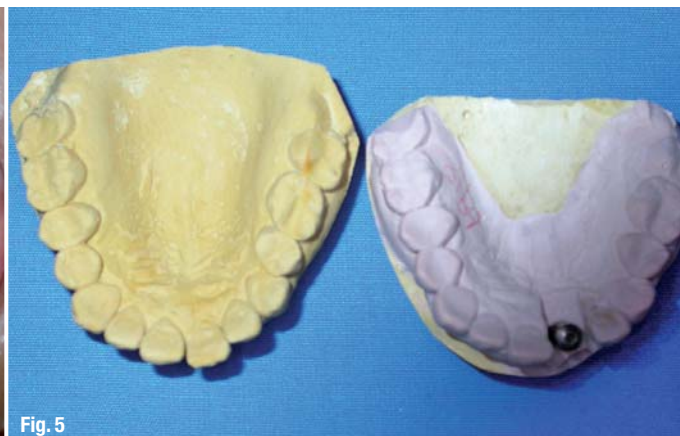
Fig. 5

Fig. 5_ Models comparing the original position of the fixture and the position of the implant retained crown after it had "shifted".
