Restoration of **implant supported crowns**

Uncommon problems and their solutions

Author_Dr Igor Cernavin, Australia

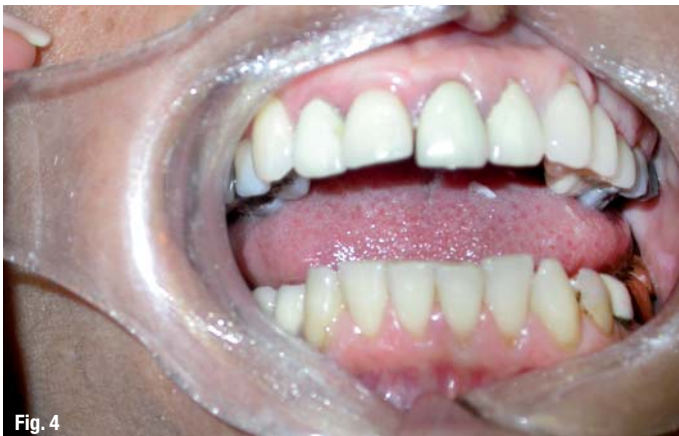
patient was examined and it was found that indeed the crown was now angled at approximately 30° labial to its original position (Fig. 4). Clinical and radiographic examination revealed that the fixture was sound, not tender to percussion and there was no probing depth. As the crown was retained with a cross pin, it was removed and it was found that the abutments screw was not loose. The crown was replaced and the patient agreed that she would leave things as they were to await further developments. The crown remained in place, symptom free, for a further six months, at which time the fixture exhibited clear clinical signs and symptoms of failure of integration, and was removed.

Fig. 4 Shifted implant retained crown.

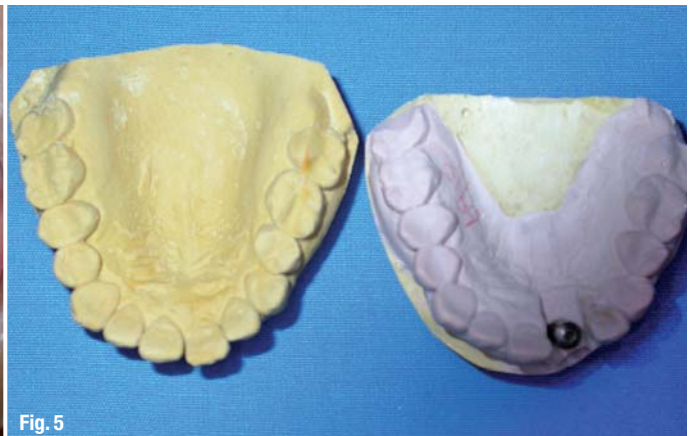
Fig. 5 Models comparing the original position of the fixture and the position of the implant retained crown after it had "shifted".
