# Restoration of **implant supported crowns**

## Uncommon problems and their solutions

Author\_Dr Igor Cernavin, Australia

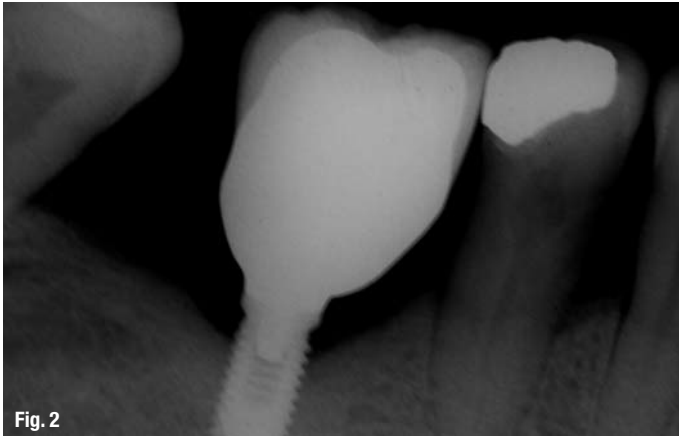
Fig. 2

Figure 2 shows such a case in which the crown-root ratio is too large for a direct-to-fixture crown. This case has the added problem of a regular-diameter implant with a wide-diameter crown, which would tend to increase the possibility of the screw loosening further. A wide-diameter implant would probably have been better here.

**Fig. 2** Unfavourable crown root ratio for direct-to-fixture.

Direct-to-fixture crowns are a good way of restoring implants if the fixture is in an ideal position. However, in cases, especially in the molar region and for single units, in which the crown – fixture ratio is too great, the forces acting on the crown can lead to screw loosening. In such cases, it would be more prudent to use an

abutment and then attach the crown to the abutment with a cross pin or in some other removable fashion. The abutment will alter the crown-root ratio significantly, thereby decreasing the forces on the abutment screw and decreasing the likelihood of the abutment screw loosening. Retrievability, using a cross pin or other method, will facilitate access to the abutment screw should it loosen.

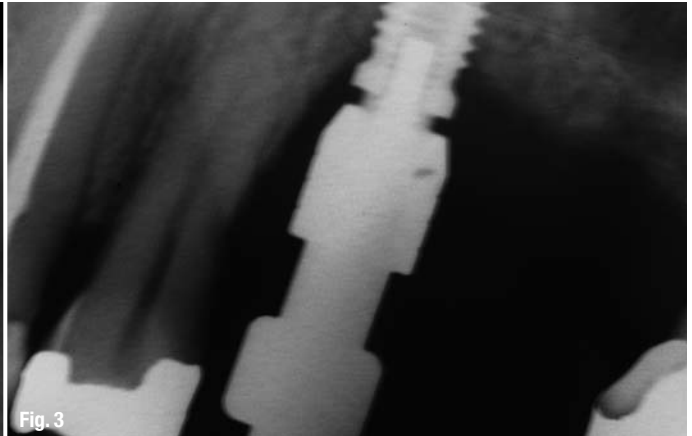
Fig. 3

The case presented in Figure 3 is very unusual. A radiograph was taken to verify seating of the impression coping and it was observed that the coping was seated halfway down the external hex and could be placed no farther (Fig. 3). It was clear from the radiograph that there was no bone or soft-tissue interference. Different impression copings were tried but the result was the same. The conclusion that the author finally reached

was that there must have been a mismatch between the diameter of the external hex on the fixture and the diameter of the impression coping. Once this concept was accepted, a laboratory impression coping was fabricated to allow for this and the coping seated correctly, with treatment proceeding uneventfully. The crowns have been in place for many years with no problems.

**Fig. 3** Mismatch in diameter between external hex of the fixture and the impression coping.

A mismatch in diameter between the external hex of the fixture and the diameter of the impression coping appears to be the only explanation for these cases. However, the author would be interested in other explanations.

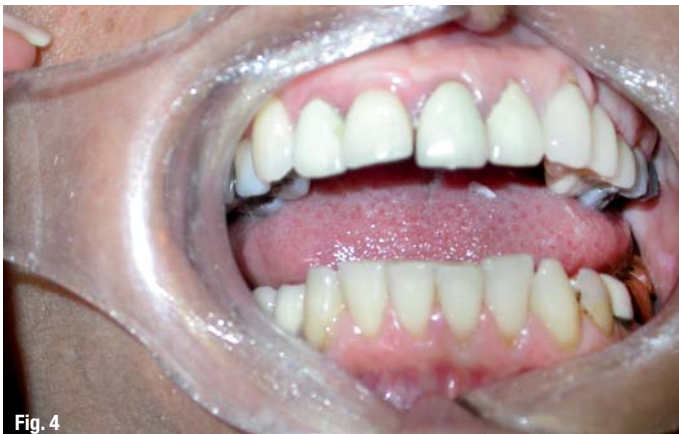
Fig. 4

patient was examined and it was found that indeed the crown was now angled at approximately 30° labial to its original position (Fig. 4). Clinical and radiographic examination revealed that the fixture was sound, not tender to percussion and there was no probing depth. As the crown was retained with a cross pin, it was removed and it was found that the abutments screw was not loose. The crown was replaced and the patient agreed that she would leave things as they were to await further developments. The crown remained in place, symptom free, for a further six months, at which time the fixture exhibited clear clinical signs and symptoms of failure of integration, and was removed.

**Fig. 4** Shifted implant retained crown.
