# Restoration of implant supported crowns

## Uncommon problems and their solutions

Author\_Dr Igor Cernavin, Australia

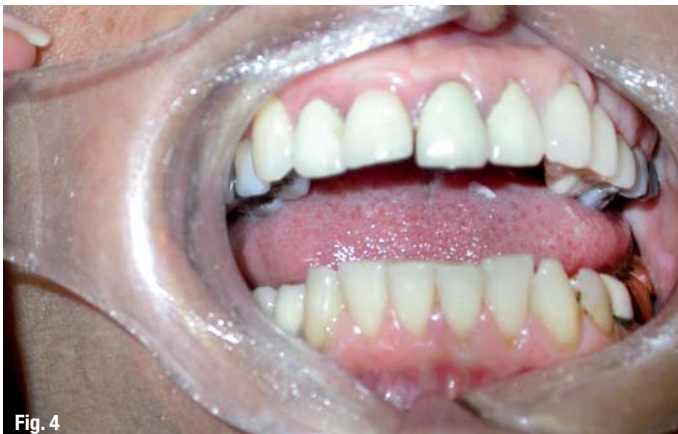
Fig. 4

patient was examined and it was found that indeed the crown was now angled at approximately 30° labial to its original position (Fig. 4). Clinical and radiographic examination revealed that the fixture was sound, not tender to percussion and there was no probing depth. As the crown was retained with a cross pin, it was removed and it was found that the abutments screw was not loose. The crown was replaced and the patient agreed that she would leave things as they were to await further developments. The crown remained in place, symptom free, for a further six months, at which time the fixture exhibited clear clinical signs and symptoms of failure of integration, and was removed.

**Fig. 4** Shifted implant retained crown.
