# Restoration of implant supported crowns

## Uncommon problems and their solutions

Author\_Dr Igor Cernavin, Australia

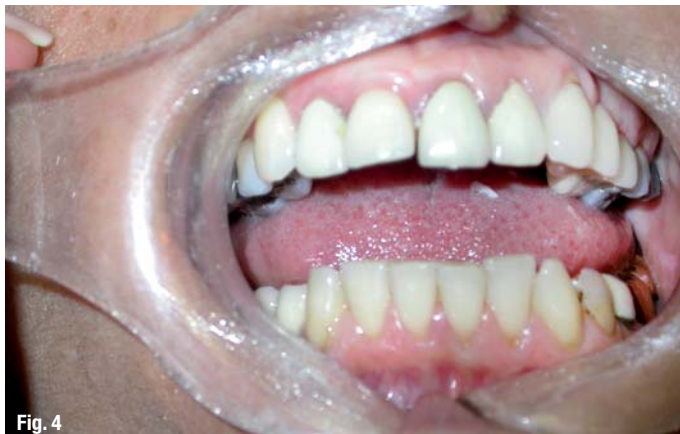
Fig. 4

patient was examined and it was found that indeed the crown was now angled at approximately 30° labial to its original position (Fig. 4). Clinical and radiographic examination revealed that the fixture was sound, not tender to percussion and there was no probing depth. As the crown was retained with a cross pin, it was removed and it was found that the abutmentscrew was not loose. The crown was replaced and the patient agreed that she would leave things as they were to await further developments. The crown remained in place, symptom free, for a further six months, at which time the fixture exhibited clear clinical signs and symptoms of failure of integration, and was removed.

**Fig. 4\_** Shifted implant retained crown.

In the past, it was understood that there was a problem with the use of bisphosphonates and alveolar bone. A patient taking Fosamax was referred for implant replacement of the missing tooth #11. The fixture was placed by a periodontist, and after a suitable waiting period was restored by the author. All procedures were routine and uneventful, and the patient was pleased with the result. About one year after the crown had been placed, the patient rang, saying that the "implant had moved". This generally indicates that either the fixture has failed or the abutment or crown has loosened. The

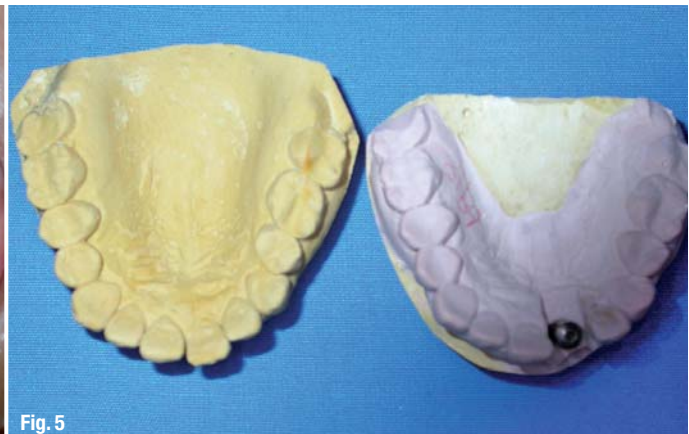
Fig. 5

**Fig. 5\_** Models comparing the original position of the fixture and the position of the implant retained crown after it had "shifted".
