# Replacement of a single anterior tooth

## Surgical procedure and three-year results

Author\_Dr Peter Randelzhofer, Germany

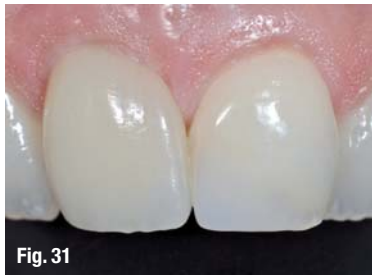
**Fig. 31**

**Fig. 31**\_Stable soft tissue showing no resorption at the implant-crown interface or gingival sulcus.

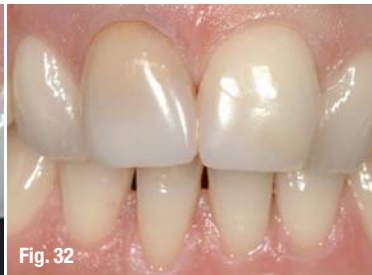
**Fig. 32**

**Fig. 32**\_Initial situation before extraction.

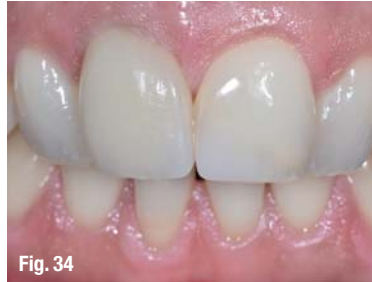
**Fig. 34**

**Fig. 34**\_Clinical situation three years after implantation.
