Iatrogenic errors before and after non-surgical root-canal treatment

Author_ Dr Rafaël Michiels, Belgium

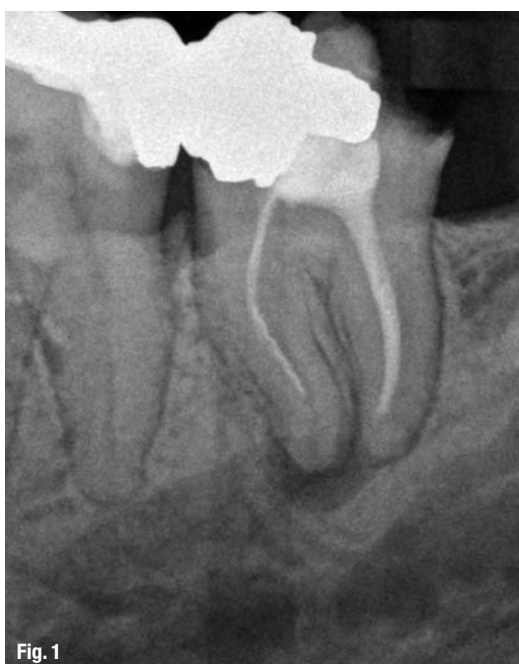
Fig. 1_Diagnostic radiograph, showing the separated instrument in the mesiobuccal canal.

The tooth was diagnosed as having symptomatic apical periodontitis and was previously treated inadequately, including a separated instrument in one of the mesial canals (Fig. 1).

In the first visit, I removed the gutta-percha from the mesiolingual canal, and cleaned and shaped it completely. The separated instrument was located in the mesiobuccal canal, but I could not remove it completely. I left the distal canal untouched. Calcium hydroxide was used as an inter-appointment dressing, and the tooth was restored with a cotton pellet and glass ionomer cement. An initial error was made by not removing the old restoration and caries completely.

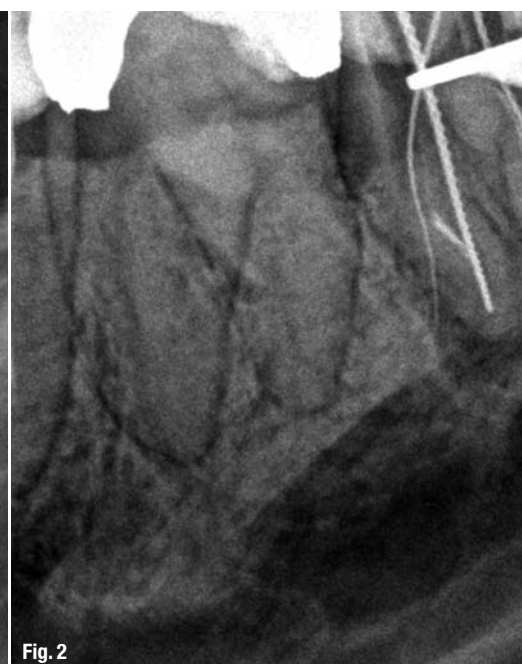
Fig. 2_Size 15 Flexile file passing through the perforation.

One month later the patient returned in agony. When I re-opened the tooth, a great deal of pus and blood came out of the tooth. I then tried to bypass the remainder of the fragment in the mesiobuccal canal, but perforated the root with a 15.04 ProFile (DENTSPLY Maillefer; Fig. 2). I also retreated the distal canal in this session and fractured a small piece of a 25.06 ProFile in the apical part, but could bypass it. I then filled the canals again with calcium hydroxide and sealed the tooth with a glass ionomer filling.

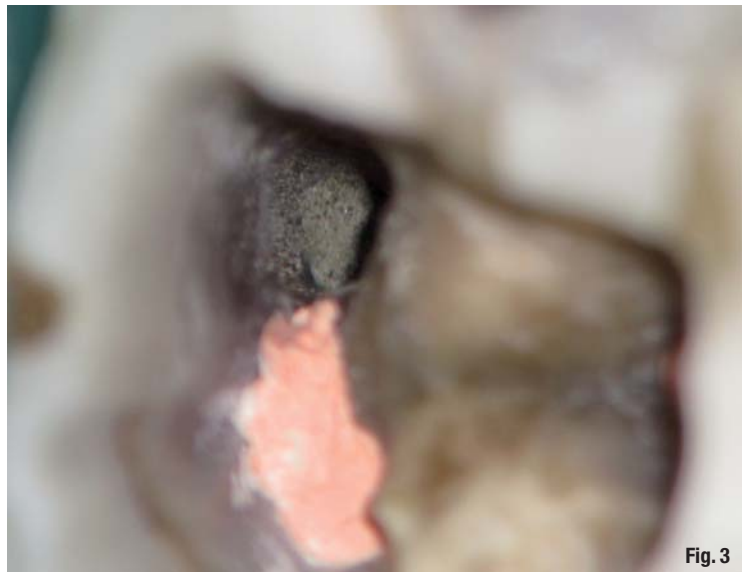
Fig. 3 Perforation repair with grey MTA-Angelus.

One month later, I saw the patient again for the completion of the treatment. He no longer had any symptoms. I restored the perforation with grey MTA-Angelus (Fig. 3). I obturated the canals with gutta-percha and Topseal (DENTSPLY Maillefer) using warm vertical condensation. I sealed the cavity with Fuji IX A1 (GC) immediately on top of the gutta-percha (Fig. 4). I then referred the patient back to the dentist for a permanent restoration, with the explicit advice to have the distal restoration replaced too.

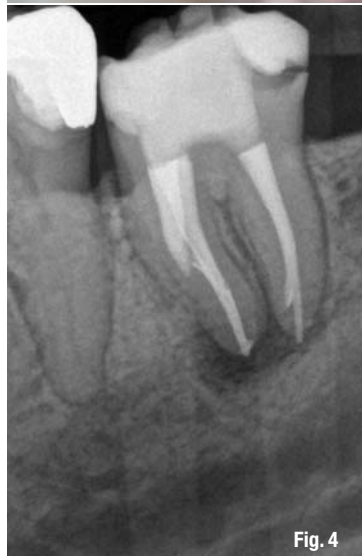
Fig. 4 Post-op radiograph.

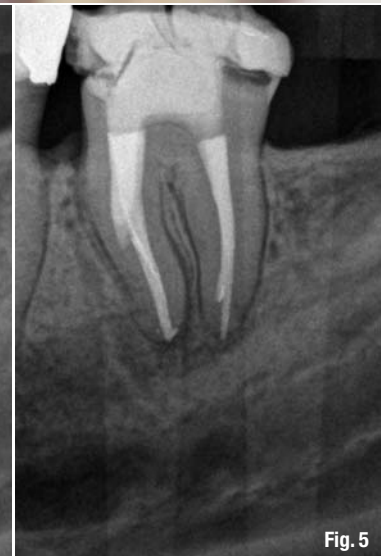
Fig. 5 Follow-up radiograph after nine months, showing coronal restoration that was less than ideal.

Nine months later the patient returned to my office for another tooth. I decided to take a follow-up radiograph of the left mandibular second molar to see if healing was favourable. The patient had not experienced any complaints since I completed the treatment and the radiograph showed a favourable apical outcome. However, the permanent restoration was less than ideal (Fig. 5). I had to refer the patient back to the dentist for a new restoration.

Looking back upon this case, I can conclude that I should have removed the old restoration and the caries at the start of the treatment. Positively, it was good that the glass ionomer filling was placed immediately above the canal orifices, preventing contamination via a leaky restoration. Ideally, I should have finished the restoration myself.

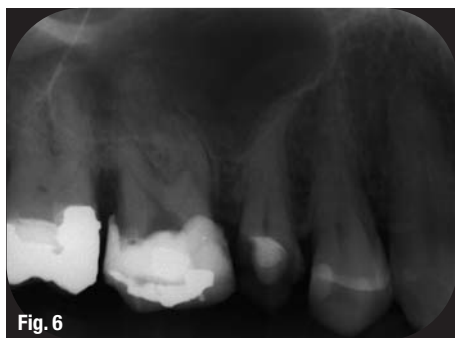
Fig. 6 Diagnostic radiograph of another referred tooth (tooth #16).

It required a change in my behaviour and some perseverance to begin to perform cases in accordance with the afore-mentioned approaches, as can be seen in Figures 6, 7 and 8.

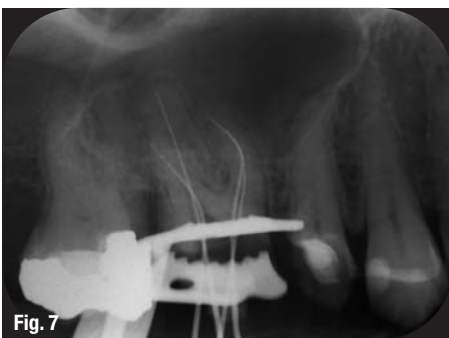
Fig. 7 Working length, together with complete removal of the old restoration.

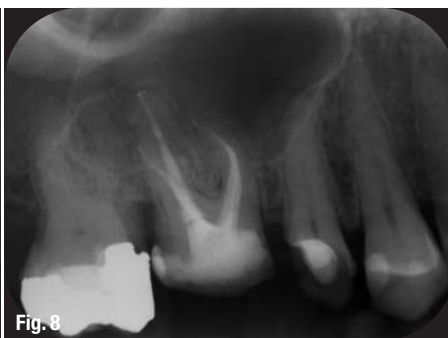
Fig. 8 Post-op radiograph, with temporary glass ionomer restoration.
