Iatrogenic errors before and after non-surgical root-canal treatment

Author_ Dr Rafaël Michiels, Belgium

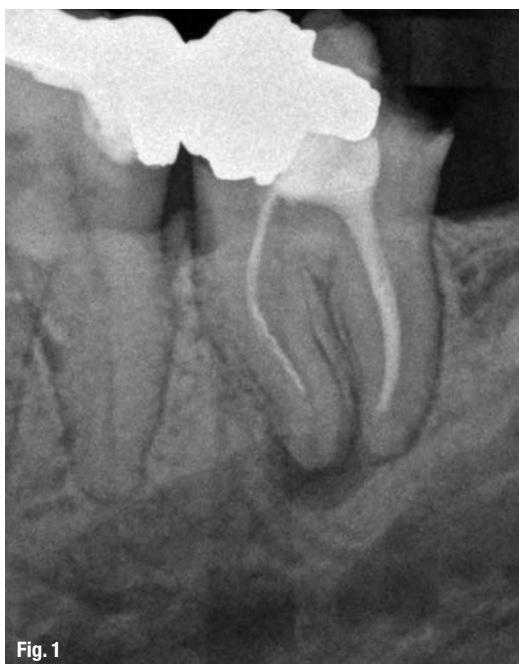
Fig. 1_Diagnostic radiograph, showing the separated instrument in the mesiobuccal canal.

The tooth was diagnosed as having symptomatic apical periodontitis and was previously treated inadequately, including a separated instrument in one of the mesial canals (Fig. 1).

In the first visit, I removed the gutta-percha from the mesiolingual canal, and cleaned and shaped it completely. The separated instrument was located in the mesiobuccal canal, but I could not remove it completely. I left the distal canal untouched. Calcium hydroxide was used as an inter-appointment dressing, and the tooth was restored with a cotton pellet and glass ionomer cement. An initial error was made by not removing the old restoration and caries completely.

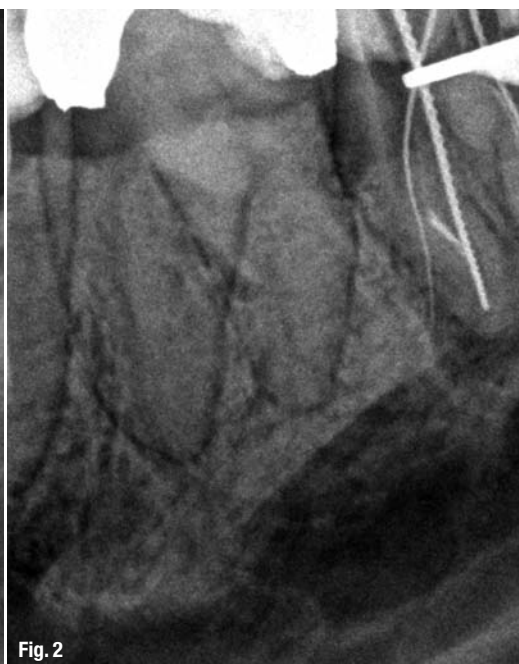
Fig. 2_Size 15 Flexile file passing through the perforation.

One month later the patient returned in agony. When I re-opened the tooth, a great deal of pus and blood came out of the tooth. I then tried to bypass the remainder of the fragment in the mesiobuccal canal, but perforated the root with a 15.04 ProFile (DENTSPLY Maillefer; Fig. 2). I also retreated the distal canal in this session and fractured a small piece of a 25.06 ProFile in the apical part, but could bypass it. I then filled the canals again with calcium hydroxide and sealed the tooth with a glass ionomer filling.
