# Precautions for using zirconia implant abutments

**authors** Moustafa N Aboushelib\*, Egypt, and Rien van Paridon\*\*, Netherlands

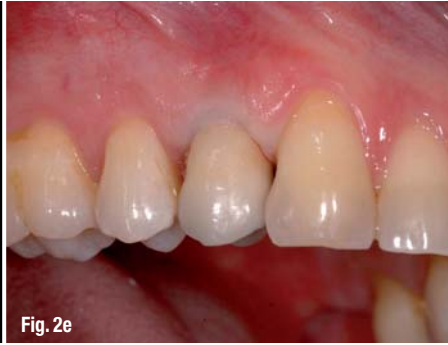
Fig. 2e

**Fig. 2e\_** A new zirconia veneered crown was inserted over a titanium abutment. Observe the grayish color at the cervical margin.

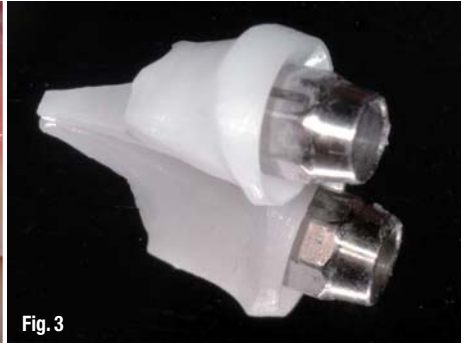
Fig. 3

A broken zirconia implant abutment was examined. SEM analysis revealed that it was an angled abutment which corrected the tilt of an implant replacing a maxillary lateral incisor. The entire buccal wall was fractured beneath the temporarily cemented zirconia veneered crown.

**Fig. 3\_** Digital image demonstrating a fractured zirconia abutment due to over reduction of the buccal wall.

Zirconia is a brittle ceramic material that must be used in adequate thickness to gain full potential of its high strength. A minimal wall thickness (0.5-0.7mm) is required in the entire structure of the zirconia implant abutment. This thickness must be increased in areas of high stresses to avoid unexpected fracture. Tilt correction—resulted in over reduction of the buccal wall (0.3 mm thickness) which resulted in fracture of the weakened segment. To reduce possibility of fracture, it is recommend to use a metallic abutment for correction of angle of insertion.

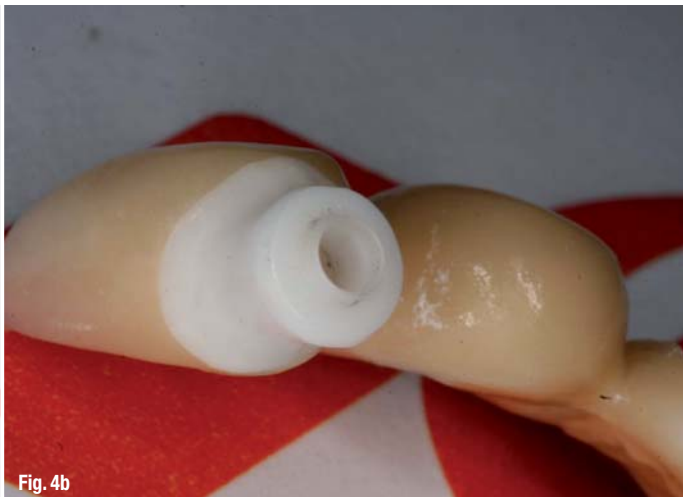
Fig. 4b

This single component zirconia structure does not utilize an internal metallic nut for achieving contact with the implant body. On the contrary, this single component super structure utilizes directly the fixation screw to obtain direct fixation to the implant body.

**Fig. 4b\_** Digital image demonstrating the contact surface with the implant body. Antirotation is not required for this fixed partial denture as the whole framework and the implant abutment are joined into a single superstructure.

Using single component superstructures has several advantages as it simplify the handling procedure, does not require anti-rotation feature, and reduces the num-
