Peri-implantitis prophylaxis by sealing implant gaps and hollow spaces

Author_Prof. Dr Dr Claus Udo Fritzemeier, Germany

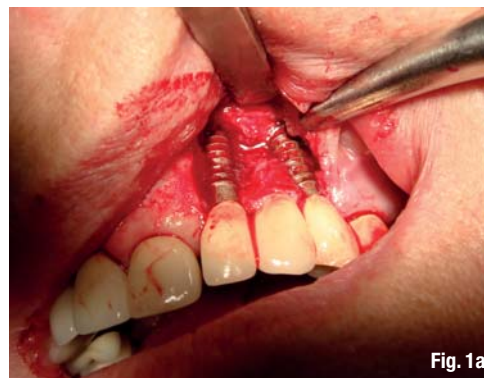
Fig. 1a Peri-implantitis, clinically.
Fig. 1b X-ray of peri-implantitis.

Against this background, implantology with all its prosthetic treatment varieties is considered an established method. One of the most common and most feared complications occurring in implantology is peri-implantitis (Figs. 1a & b), which usually leads to implant loss when it remains untreated.
