Jawbone cavitation and its implication in implant dentistry

Author_Prof. Dr Mauro Marincola, Italy

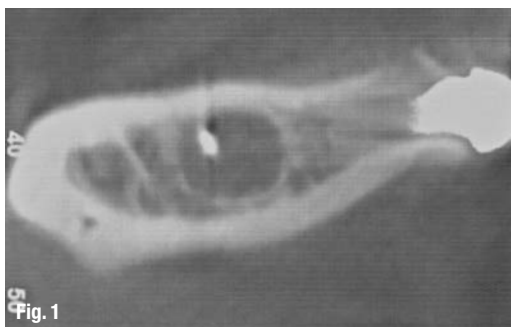
Fig. 1 Only a cavitation that has formed with additional calcification around a well-defined border will be visualized on X-ray. Observe the encapsulated extraneous body.

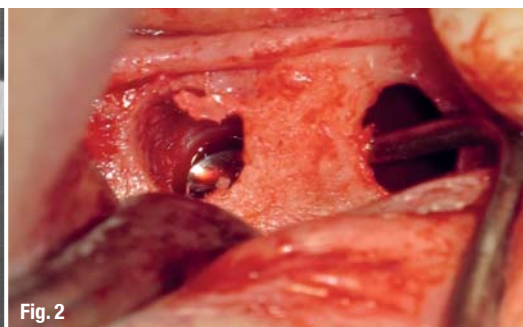
Fig. 2 An explored channel might be counted as only one cavitation when it actually developed from more than one unhealed extraction site. Larger cavitations can extend below the mandibular nerve.

Since the periodontal ligament does not extend to the upper edge of the extraction site, new bone growth activity will not be inhibited at the top of the socket, and a characteristic thin cap of bone will eventually extend over the extraction hole. Larger cavitations often have only a cap of gingival tissue over them. Even the thin overlying cap of bone does not form in these cases. In routine dental extraction, portions of the periodontal ligament will sometimes be more strongly attached to the tooth than the bone and be removed along with the tooth. When partially removed in this fashion, the haphazard absence of the ligament will permit equally haphazard growth of bone, resulting in the wide variety of cavitation shapes and sizes (Fig. 2).

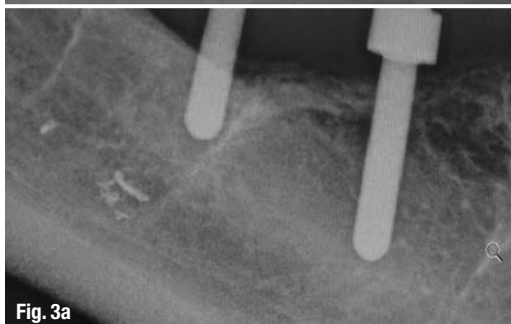
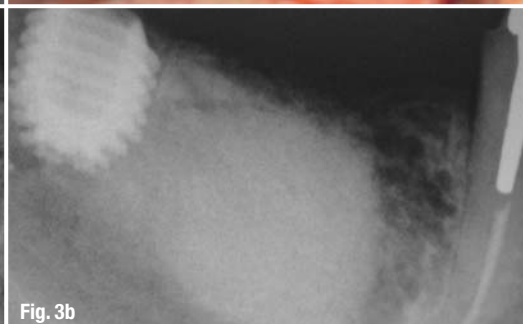
Figs. 3a & b 15 mm mesio-distal and 10 mm vertical bone cavitation filled with β -TCP graft. The distal hole was a third of dimension and a Short Implant (Bicon) could be placed immediately.

The next treatment step is a bone grafting procedure to fill the cleaned and disinfected cavity. If the cavitation is limited to 5–6 mm in diameter, a plateau press fitted root form implant can be placed into the grafting material immediately. Otherwise, the implant will be placed in a larger grafted area after three months of healing (Figs. 3a & b).

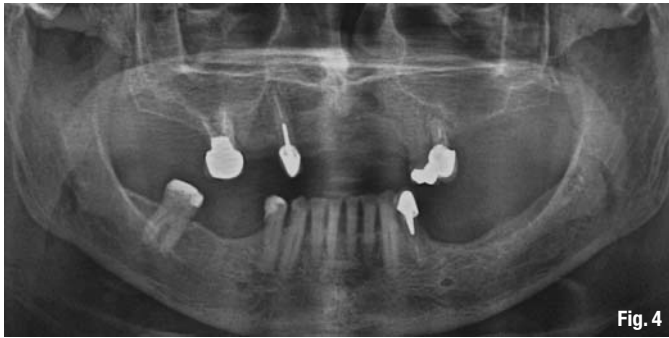
Fig. 4 A trained eye is needed to recognise the circular bone cavitation mesial to the lower right molar. Observe the capsulation, the thin crestal cortical and the lack of trabecular geometry.

The treatment plan was to insert four short implants to replace the second premolars and first molars of the mandible. The dental panoramic tomogram showed a circular formation of 5–6 mm in diameter mesial to the second molar root on the right side of the mandible

(Fig. 4). My experience with bone cavitations suggested a surgical approach that would entail performing an osteotomy and afterwards cleaning, disinfecting and filling the cavitation before placing the implant. Bone cavitations are not visible at crest level (Fig. 5) because the bony defect is located inside the bone marrow.

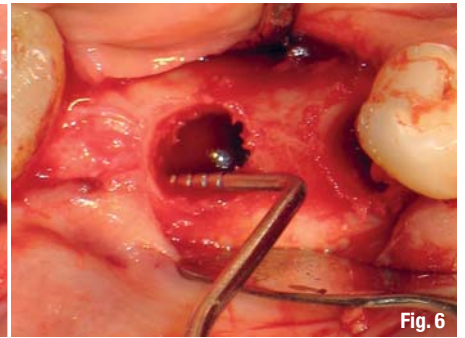
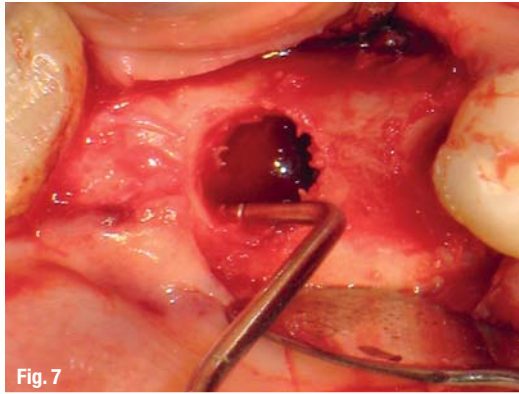
Fig. 6

Figs. 6 & 7 Depth gauge demonstrating the absence of trabecular bone. The distal extension of the hole is approx. 10 mm.

Once the diameter of the planned implant size (5 mm) had been achieved, the walls and floor of the osteotomy were controlled with a depth gauge. All walls except the lingual plate were missing and no floor limited the 8 mm length of the osteotomy. The depth gauge established a distal hole of 10 mm. The mesial and buccal defects extended for only a few millimetres (Figs. 6 & 7).

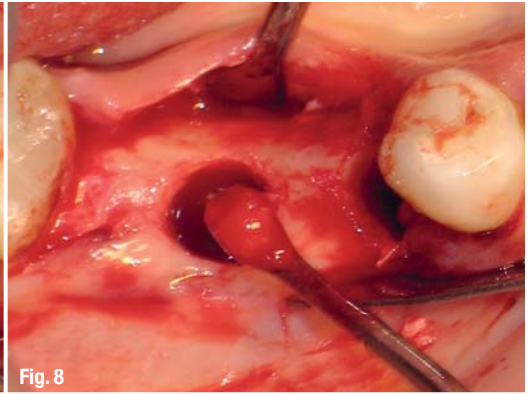
Fig. 8

Fig. 8_Solid, healthy bone must be reached to allow the normal regeneration of bone. When infection or necrosis remain throughout the socket and adjacent bone, with or without condensing osteitis, healing will rarely ever be completed.

The fibrous tissue was removed from the cavity with a Lucas curette (Fig. 8). Multiple applications of a diode laser combined with local antibiotics were performed before proceeding to fill the cavity.

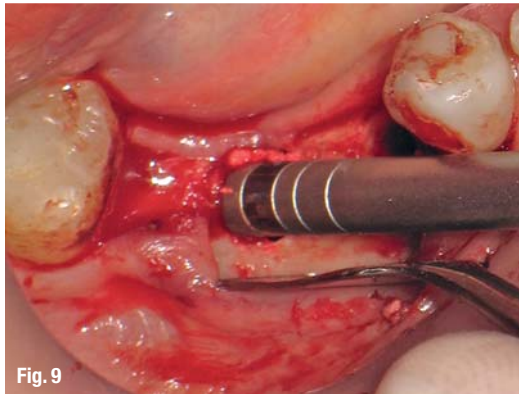
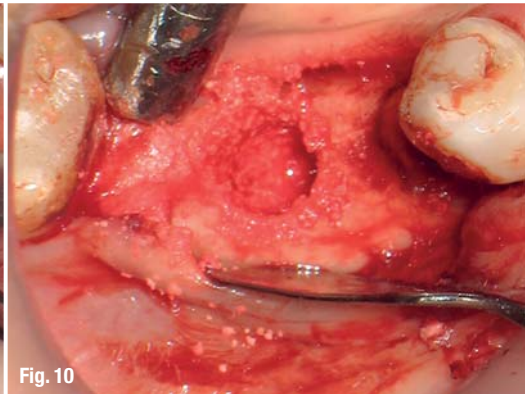
Fig. 9

Figs. 9 & 10_The hole is filled with a synthetic graft material (Synthograft) after elimination of fibrous marrow and disinfection of the cavity.

The graft material should be 100 per cent synthetic in order to avoid cross infection, as may be the case with xenografts. The beta-tricalcium phosphate (β -TCP; SynthoGraft, Bicon) was mixed with the patient's blood and injected into the cavity (Figs. 9 & 10). Once the cavity had almost been filled, two Short Implants (\varnothing 5 mm, length 6 mm) were placed into the graft (Fig. 11). Finally, the implants were completely buried under the crestal bone (Fig. 12), in accordance with the characteristics of the implant design (plateau press fitted root form implant).

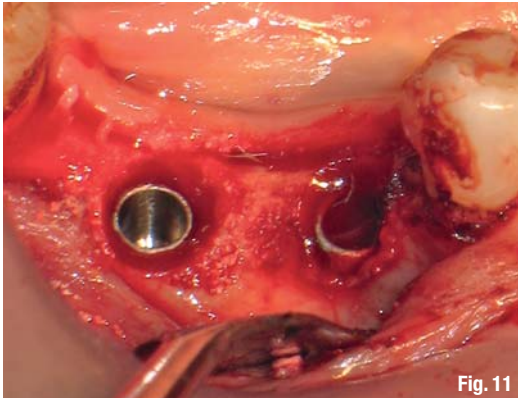
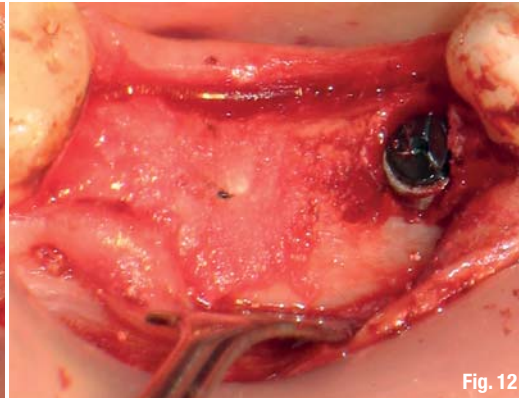
Fig. 11

Figs. 11 & 12 Two 5 x 6 mm Short Implants (Bicon) are directly placed into the graft and buried under the crestal bone.

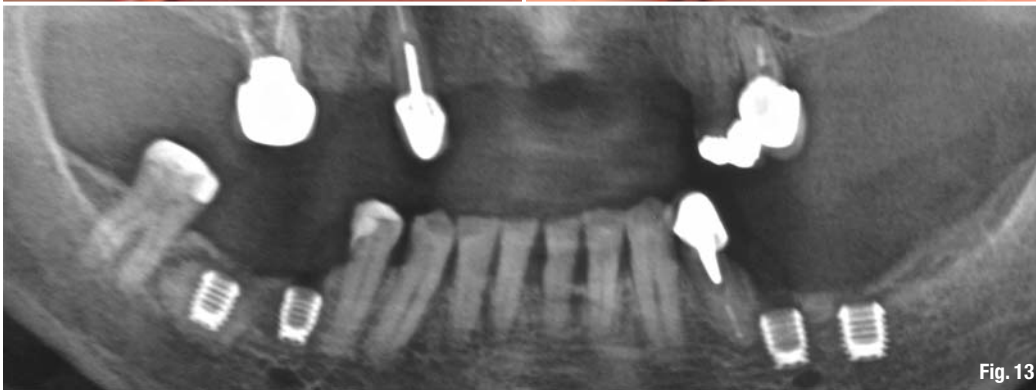
Fig. 13 Evidence of the grafted bone cavitation and implant placement. Mandatory is the use of Short Implants in order to avoid proximity to the mental nerve and the alveolar nerve.

Short implants were necessary in this case because of the reduced vertical jaw dimension and the proximity to the mental nerve and the inferior alveolar nerve (Fig. 13).
