Laser Supported Treatment of Periimplantitis on a Strategically Important Individual Tooth Implant in the Superior Maxilla

author_Georg Bach, Germany

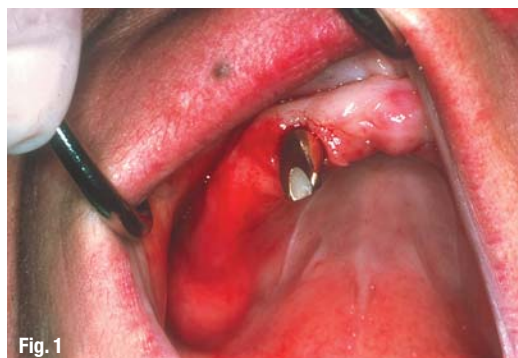
Fig. 1 Regio 13, an ITI implant has been incorporated onto which a primary crown was mounted. A mucositis manifested itself that could already be clinically diagnosed.

In 1991, the 43-year-old female patient had an ITI implant incorporated alio loco regio 13 (Fig. 1). Except for the remaining tooth 23, the superior maxilla is edentulous. After the healing-in process of the implant, a telescopic crown was placed onto the implant and the remaining tooth 23, onto which a telescopic prosthesis is fastened (Figs. 3, 4). After completion of the prosthetic phase, no recall took place because the patient moved away. Upon the recommendation of an acquaintance, the patient came back to our office in

1994 when she detected that brushing implant abutment 13 resulted in profuse bleeding. The clinical findings verified this observation. Probing with a pressure-calibrated plastic PA probe, BOP could be found and also there was a circular probing depth of 6 mm.
