# Laser Supported Treatment of Periimplantitis on a Strategically Important Individual Tooth Implant in the Superior Maxilla

author\_Georg Bach, Germany

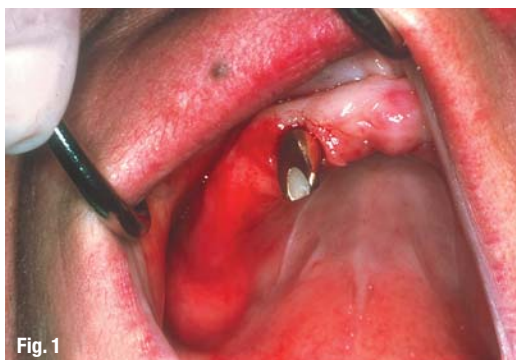
Fig. 1

Fig. 1\_Regio 13, an ITI implant has been incorporated onto which a primary crown was mounted. A mucositis manifested itself that could already be clinically diagnosed.

In 1991, the 43-year-old female patient had an ITI implant incorporated alio loco regio 13 (Fig. 1). Except for the remaining tooth 23, the superior maxilla is edentulous. After the healing-in process of the implant, a telescopic crown was placed onto the implant and the remaining tooth 23, onto which a telescopic prosthesis is fastened (Figs. 3, 4). After completion of the prosthetic phase, no recall took place because the patient moved away. Upon the recommendation of an acquaintance, the patient came back to our office in

1994 when she detected that brushing implant abutment 13 resulted in profuse bleeding. The clinical findings verified this observation. Probing with a pressure-calibrated plastic PA probe, BOP could be found and also there was a circular probing depth of 6 mm.

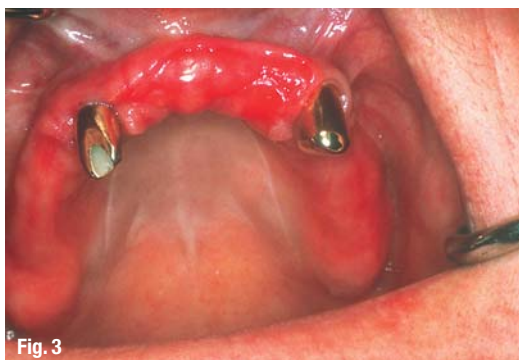
**Fig. 3** Six-months postoperative check; please note the irritation-free wound condition.

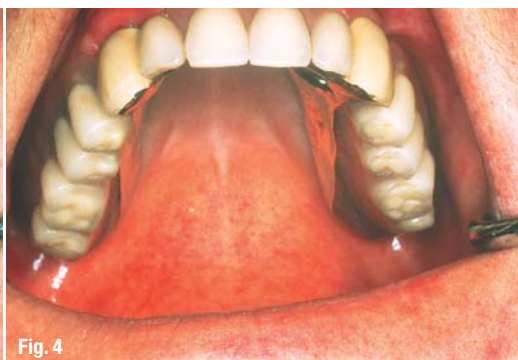
**Fig. 4** Thanks to the laser supported periimplantitis treatment, the baseless designed superior maxilla prosthesis could be left in situ.

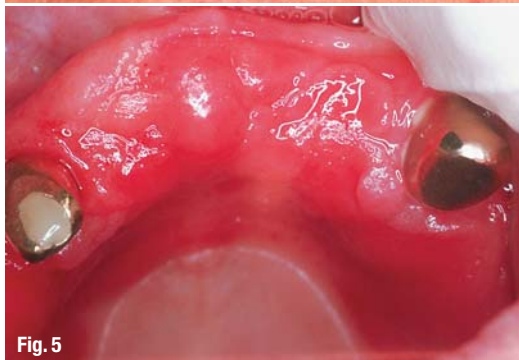
**Fig. 5** More than ten years after the completion of the surgical resective phase, both abutments are still in the superior maxilla.

each other in a flushing manner to ensure healing per primam intentionem. The suture material was removed after one week. Further recall sittings took place after 6 weeks and 3 months. At the final inspection of the surgical resective phase after 6 months, the former surgical area was without irritation (Fig. 5). No probing depth could be measured. The telescopic superior maxilla prosthesis is in situ without irritation (Fig. 6).

Now, more than ten years after the surgical treatment of the periimplantary lesion, the prosthetic situation in the superior maxilla is unchanged. The telescopic bridge is still in place on 13 (supported by the implant) and 23 (natural tooth) (Fig. 5). The ITI implant regio 13 is located in a healthy environment without irritation, and, even after removal of the secondary crown, healthy periimplantary conditions are found (Fig. 7).

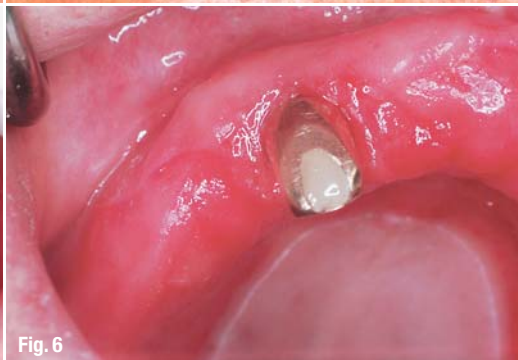
**Fig. 6** The individual implant regio 13 is in an irritation-free environment.

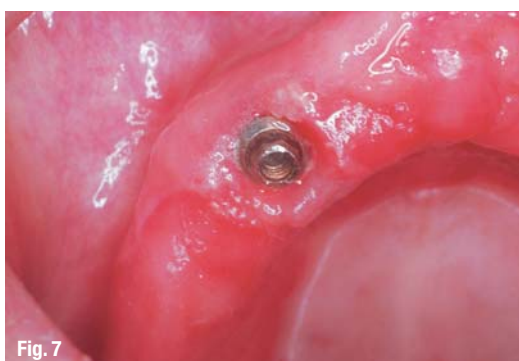
**Fig. 7** Even after removal of the secondary crown, healthy periimplantary conditions are found.
