## S-shaped root risks of a master challenge in endodontology

Author\_ Dr Friedrich Müller, Germany

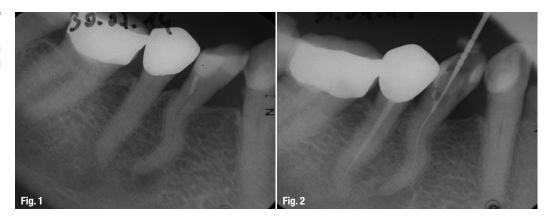
Fig. 1\_Diagnostic radiograph of tooth 45 an tooth 44. Fig. 2\_Radiograph with masterpoint in tooth 45 and hedstrom file in tooth 44.

The sensitivity testing showed a prolonged positive result in tooth 45 and no result in tooth 44. The percussion testing showed contrary results; no result in tooth 45 and a slight positive result in tooth 44. A radiograph showed an apical lesion of endodontic origin in tooth 44 and no diagnostic findings in tooth 45.

mension, the cause of her acute pain was tooth 45. Furthermore, the radiograph showed an s-shaped root morphology in tooth 44 that made endodontic treatment not just difficult, but a real master challenge.

After irrigation with 3% natriumhypochloride solution, the apex locator showed 21 mm working length in tooth 45. The cleaning and shaping of the root canal of tooth 45 was completed in the first appointment. A combination of tetracycline and cortisone was brought into the root canal reaching its depth. In tooth 44, probing was performed with a Hedström file (ISO 08/.02) to drain the pus. The second stage of treating tooth 44 also included probing and irrigation, as well as the exploration of the working length with an apex locator 21 mm in length.

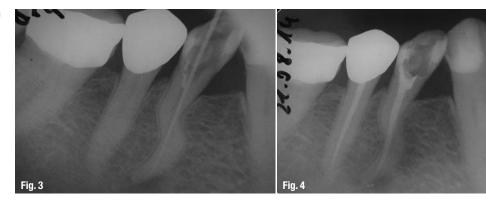
Fig. 3\_Radiograph with masterpoint in tooth 44. Fig. 4\_Radiograph of canal obturation in tooth 45 and tooth 44.

After manual cleaning and shaping with Hedström files, subsequent irrigation followed by reciprocating preparation, a radiograph was taken to confirm the length of the root canal. In the third endodontic approach, the working length was reconfirmed and both root canals were obturated with gutta percha in a combination of cold and warm obturation. As it can be seen, one major risk in s-shaped roots is the straightening of the curvature wherefore the preparation of the root canal should not exceed ISO 25 to prevent accidental weakening or strip perforation of the inner bend.
