Restoration of endodontic teeth: An engineering perspective

Author_Dr Gregori M. Kurtzman, USA

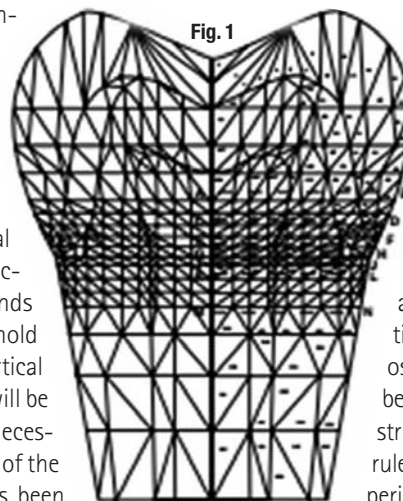
Fig. 1 Strain analysis of a posterior tooth demonstrating concentration of strain on loading at the cervical. (Image/Dr Gene McCoy)

When rebuilding an endodontically treated tooth, it is best to maintain all dentin that is available, even thin slivers. These thin slivers of dentin provide a strong connecting link between the core and tooth's root and between the crown and root.⁶ It is important to attempt to retain as much tooth structure as possible, and this aids in achieving ferrule as well as maintaining cervical strength of the tooth where loading concentrates. Under masticatory loading, strain concentrates at the cervical portion of teeth, thus it is important to avoid over-preparation of this portion of the tooth during endodontic treatment and preserve this area during restoration of the tooth (Fig. 1).

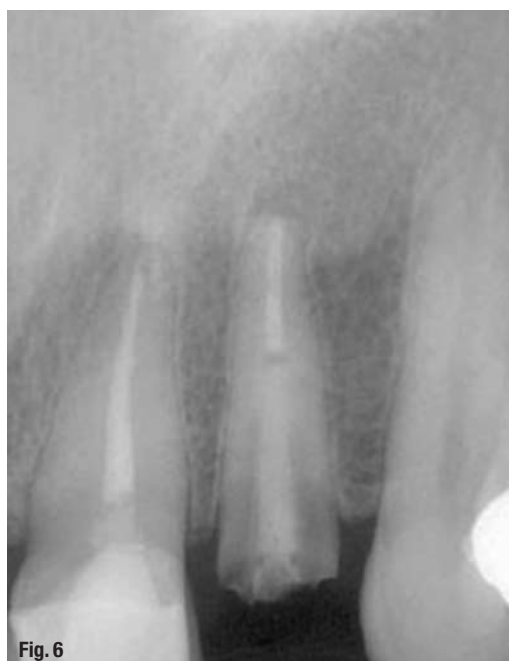
Fig. 6

Fig. 6_ Tooth restored with a fiber post demonstrating coronal horizontal fracture supracrestally typically seen with teeth restored with fiber posts when overloaded.

When a tooth restored with a fiber post does fail due to overload, the mode of failure is coronal, protecting remaining root and tooth structure.¹² This mode of failure with fiber-post-restored teeth typically allows the tooth to be restored, as vertical root fracture is a rare occurrence. Bitter reported, "Compared to metal posts, FRC posts revealed reduced fracture resistance in vitro, along with a usually restorable failure mode"¹³ (Fig. 6). Whereas, with metal posts either prefabricated or cast, failure was at a higher value for cast post and core 91 per cent of the specimens had fractured roots, none of the specimens with a fiber post demonstrated root fracture; the post and core usually fractured at the tooth composite core interface.¹⁴ As stress concentrates at the apical tip of the metal post due to its higher modulus of elas-

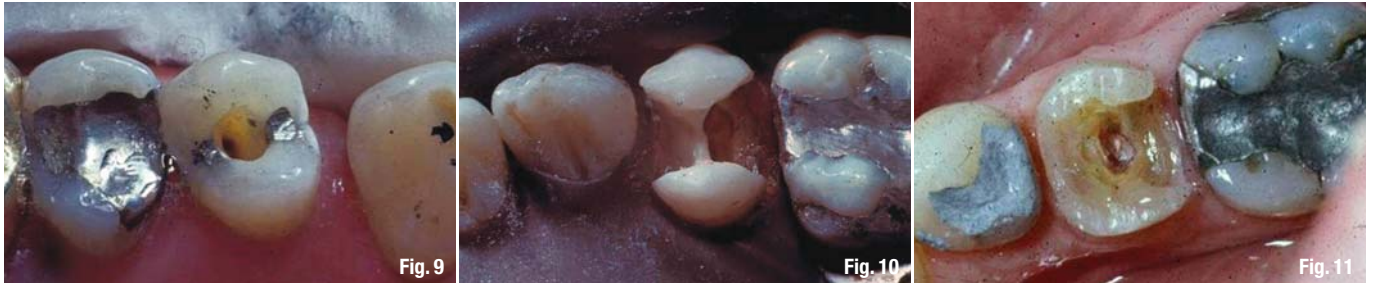
Fig. 9 Minimal tooth missing or previously restored following endodontic treatment.

Fig. 10 Moderate tooth missing or previously restored following endodontic treatment.

Fig. 11 Significant tooth missing or previously restored following endodontic treatment.

Posterior teeth gain strength when the marginal ridge area and proximal surface is natural tooth structure and has not been restored. Teeth that have undergone endodontic treatment when either occlusal decay was present in the pits and fissures leading to pulpal involvement or a small- to moderate-sized previously placed amalgam or composite restoration is present require conservative restoration (Fig. 9). These teeth can be restored with removal of the existing restorative material and cleaning the pulp chamber of obturation material including 2 to 3 mm of the canal. Placement of a conventional composite bonded within the tooth provides a good long-term restorative solution to these teeth, and a crown is not needed typically. The access or existing restoration should leave most of the cuspal width present. When the preparation following removal of decay and existing restorative materials invades the width of the cusp leaving half of this tooth structure missing, more extensive restoration is indicated.

When the tooth to be restored is missing one or both marginal ridges and these areas have been previously restored or will be restored, placement of a bonded composite will not suffice as the final restoration (Fig. 10). The marginal ridges provide resistance to cuspal flexure of the tooth, improving its strength. When these are missing, functional loading of the tooth will allow greater cuspal flexure and consequently a higher chance of fracture under masticatory function. Restoration of these teeth will require a core buildup with optional pins or other retentive elements for the core followed by a full coverage crown. Posts are often not needed, as the remaining tooth structure at the cusps after crown preparation is sufficient to retain the core and a ferrule can be achieved. A post may be considered in those patients who are bruxers or clenchers or whose occlusion may place higher forces on the restored tooth due to the tooth's position relative to the occlusal plane. When a ferrule cannot be achieved, the practitioner should consider osseous crown lengthening or forced eruption to improve the ferrule. Inlay restorations should be avoided in endodontically treated teeth because the access created to perform the endodontic treatment weakens the tooth from a cuspal flexure standpoint and the inlay even when bonded may act as a wedge forcing the cusps apart and leading to fracture of the tooth. An onlay restoration may be utilized, and its design should include shoeing of the cusps to limit cuspal flexure.

These teeth are a challenge to restore, as they are after removal of the old restorative material and decay has left significant portions of the tooth needing replacement (Fig. 11). These teeth will require placement of posts to retain the core of the remaining tooth structure. As the purpose of posts is to retain the core, it is recommended that in multi-canal teeth a post be placed into each canal to cross-pin the core to the remaining tooth structure (Fig. 12). Projection of the posts in posterior teeth due to the angulation

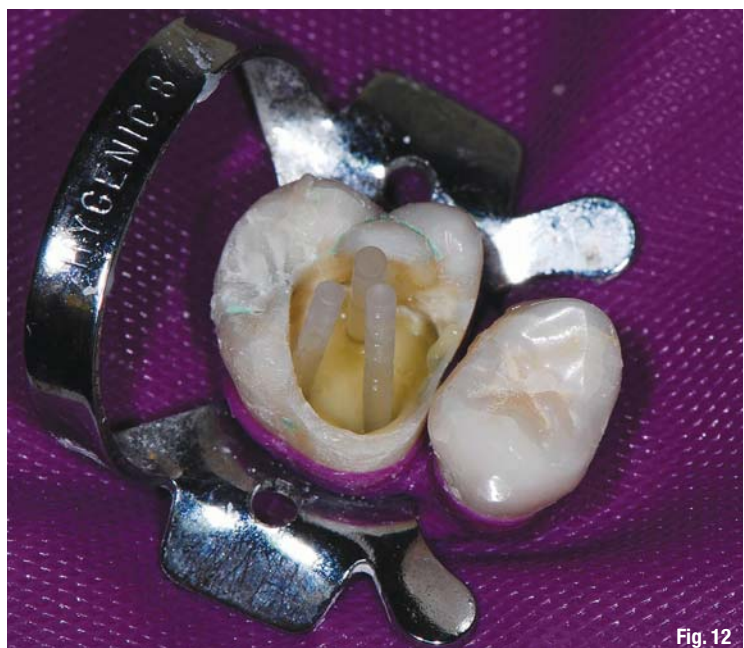
Fig. 12 Multiple fiber posts placed into a molar to lock the core to the remaining tooth structure.

of the canals leads to convergence of the posts in the coronal portion of the tooth. This locks the core in place and assists in preventing fracture of the post or dislodgement under function that is observed when only a single post is placed. Use of pins may also be considered to assist in retaining the core portion when cusps are missing and as an augment to posts being placed. These teeth require a full coverage crown to limit cuspal flexure under load. As with teeth with moderate missing tooth structure, use of inlays should be avoided as they do not restrict cuspal flexure. An onlay may be used if desired in some cases but should include shoeing the cusps as part of the preparation design to limit cuspal flexure. Again, when ferrule is not achievable, consider osseous crown lengthening or forced eruption to improve the ferrule.
