# Restoration of endodontic teeth: An engineering perspective

**Author\_** Dr Gregori M. Kurtzman, USA

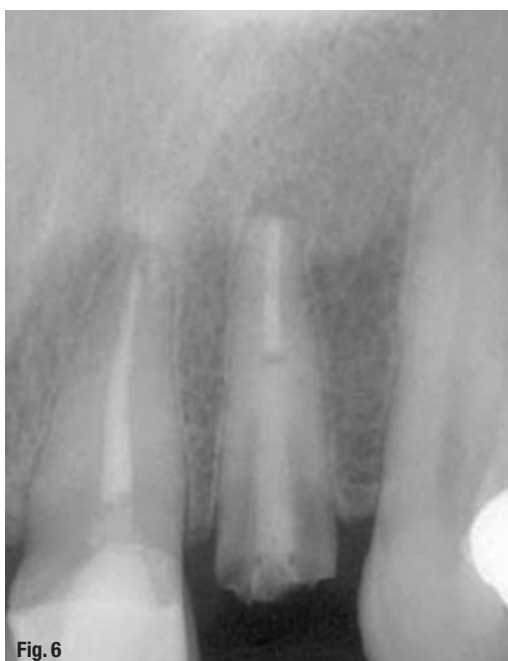
**Fig. 6**

**Fig. 6\_** Tooth restored with a fiber post demonstrating coronal horizontal fracture supracrestally typically seen with teeth restored with fiber posts when overloaded.

When a tooth restored with a fiber post does fail due to overload, the mode of failure is coronal, protecting remaining root and tooth structure.<sup>12</sup> This mode of failure with fiber-post-restored teeth typically allows the tooth to be restored, as vertical root fracture is a rare occurrence. Bitter reported, "Compared to metal posts, FRC posts revealed reduced fracture resistance in vitro, along with a usually restorable failure mode"<sup>13</sup> (Fig. 6). Whereas, with metal posts either prefabricated or cast, failure was at a higher value for cast post and core 91 per cent of the specimens had fractured roots, none of the specimens with a fiber post demonstrated root fracture; the post and core usually fractured at the tooth composite core interface.<sup>14</sup> As stress concentrates at the apical tip of the metal post due to its higher modulus of elas-

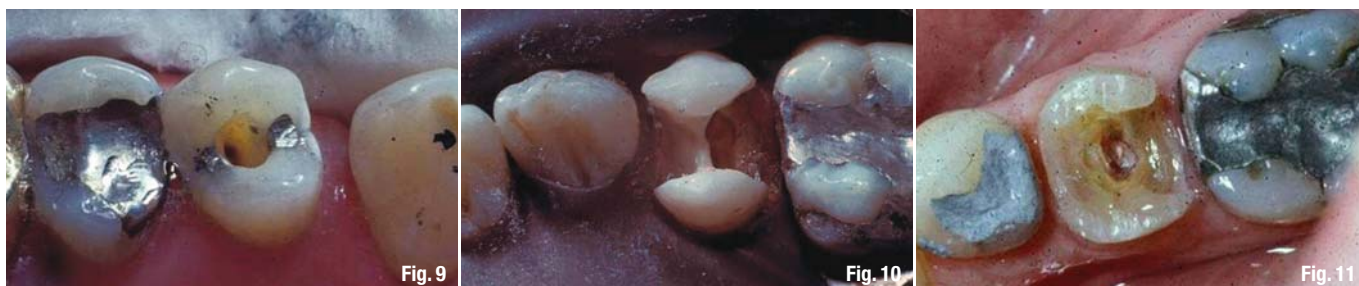
**Fig. 9** Minimal tooth missing or previously restored following endodontic treatment.

**Fig. 10** Moderate tooth missing or previously restored following endodontic treatment.

**Fig. 11** Significant tooth missing or previously restored following endodontic treatment.

Posterior teeth gain strength when the marginal ridge area and proximal surface is natural tooth structure and has not been restored. Teeth that have undergone endodontic treatment when either occlusal decay was present in the pits and fissures leading to pulpal involvement or a small- to moderate-sized previously placed amalgam or composite restoration is present require conservative restoration (Fig. 9). These teeth can be restored with removal of the existing restorative material and cleaning the pulp chamber of obturation material including 2 to 3 mm of the canal. Placement of a conventional composite bonded within the tooth provides a good long-term restorative solution to these teeth, and a crown is not needed typically. The access or existing restoration should leave most of the cuspal width present. When the preparation following removal of decay and existing restorative materials invades the width of the cusp leaving half of this tooth structure missing, more extensive restoration is indicated.

When the tooth to be restored is missing one or both marginal ridges and these areas have been previously restored or will be restored, placement of a bonded composite will not suffice as the final restoration (Fig. 10). The marginal ridges provide resistance to cuspal flexure of the tooth, improving its strength. When these are missing, functional loading of the tooth will allow greater cuspal flexure and consequently a higher chance of fracture under masticatory function. Restoration of these teeth will require a core buildup with optional pins or other retentive elements for the core followed by a full coverage crown. Posts are often not needed, as the remaining tooth structure at the cusps after crown preparation is sufficient to retain the core and a ferrule can be achieved. A post may be considered in those patients who are bruxers or clenchers or whose occlusion may place higher forces on the restored tooth due to the tooth's position relative to the occlusal plane. When a ferrule cannot be achieved, the practitioner should consider osseous crown lengthening or forced eruption to improve the ferrule. Inlay restorations should be avoided in endodontically treated teeth because the access created to perform the endodontic treatment weakens the tooth from a cuspal flexure standpoint and the inlay even when bonded may act as a wedge forcing the cusps apart and leading to fracture of the tooth. An onlay restoration may be utilized, and its design should include shoeing of the cusps to limit cuspal flexure.

These teeth are a challenge to restore, as they are after removal of the old restorative material and decay has left significant portions of the tooth needing replacement (Fig. 11). These teeth will require placement of posts to retain the core of the remaining tooth structure. As the purpose of posts is to retain the core, it is recommended that in multi-canal teeth a post be placed into each canal to cross-pin the core to the remaining tooth structure (Fig. 12). Projection of the posts in posterior teeth due to the angulation

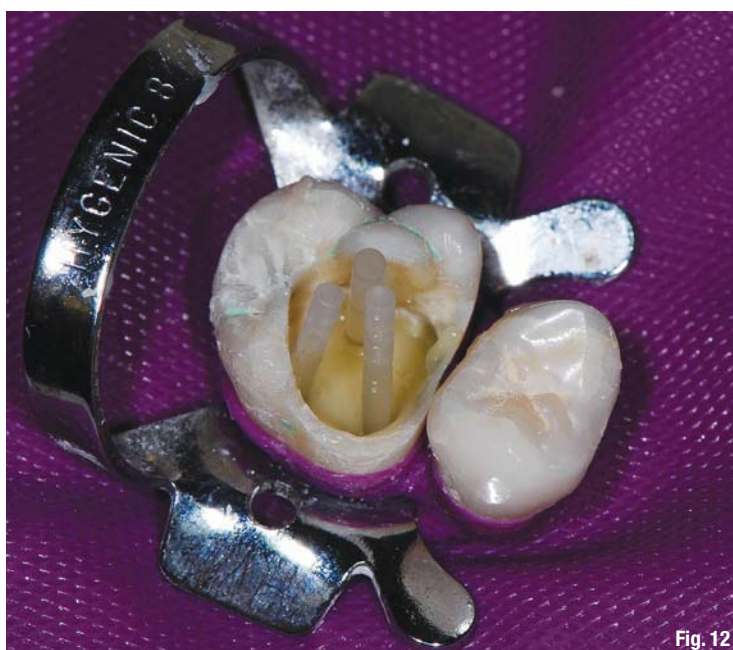
**Fig. 12** Multiple fiber posts placed into a molar to lock the core to the remaining tooth structure.

of the canals leads to convergence of the posts in the coronal portion of the tooth. This locks the core in place and assists in preventing fracture of the post or dislodgement under function that is observed when only a single post is placed. Use of pins may also be considered to assist in retaining the core portion when cusps are missing and as an augment to posts being placed. These teeth require a full coverage crown to limit cuspal flexure under load. As with teeth with moderate missing tooth structure, use of inlays should be avoided as they do not restrict cuspal flexure. An onlay may be used if desired in some cases but should include shoeing the cusps as part of the preparation design to limit cuspal flexure. Again, when ferrule is not achievable, consider osseous crown lengthening or forced eruption to improve the ferrule.
