Restoration of endodontic teeth: An engineering perspective

Author_Dr Gregori M. Kurtzman, USA

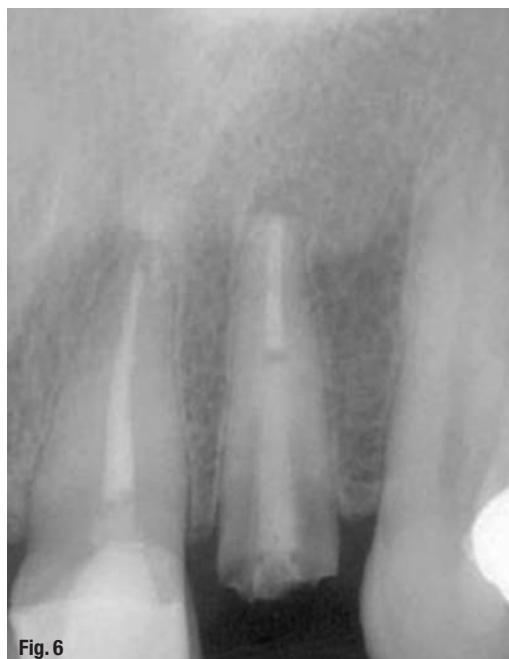
Fig. 6

Fig. 6_ Tooth restored with a fiber post demonstrating coronal horizontal fracture supracrestally typically seen with teeth restored with fiber posts when overloaded.

When a tooth restored with a fiber post does fail due to overload, the mode of failure is coronal, protecting remaining root and tooth structure.¹² This mode of failure with fiber-post-restored teeth typically allows the tooth to be restored, as vertical root fracture is a rare occurrence. Bitter reported, "Compared to metal posts, FRC posts revealed reduced fracture resistance in vitro, along with a usually restorable failure mode"¹³ (Fig. 6). Whereas, with metal posts either prefabricated or cast, failure was at a higher value for cast post and core 91 per cent of the specimens had fractured roots, none of the specimens with a fiber post demonstrated root fracture; the post and core usually fractured at the tooth composite core interface.¹⁴ As stress concentrates at the apical tip of the metal post due to its higher modulus of elas-
