Restoration of endodontic teeth: An engineering perspective

Author_ Dr Gregori M. Kurtzman, USA

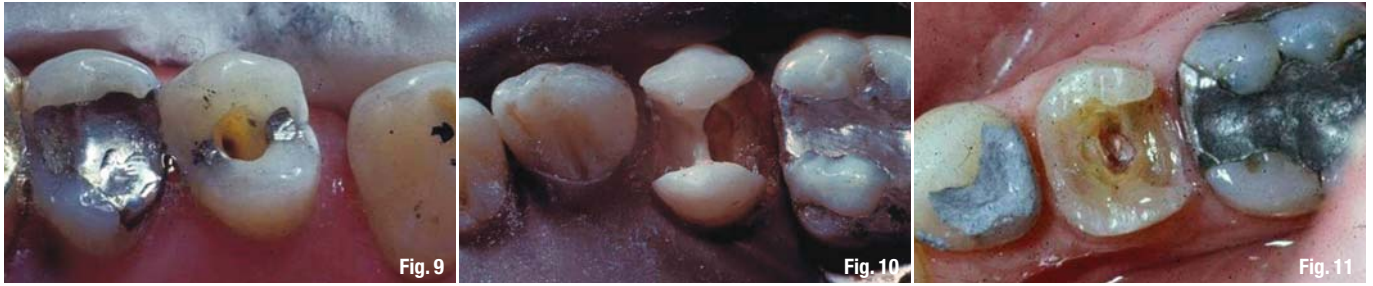
Fig. 9 Minimal tooth missing or previously restored following endodontic treatment.

Fig. 10 Moderate tooth missing or previously restored following endodontic treatment.

Fig. 11 Significant tooth missing or previously restored following endodontic treatment.

Posterior teeth gain strength when the marginal ridge area and proximal surface is natural tooth structure and has not been restored. Teeth that have undergone endodontic treatment when either occlusal decay was present in the pits and fissures leading to pulpal involvement or a small- to moderate-sized previously placed amalgam or composite restoration is present require conservative restoration (Fig. 9). These teeth can be restored with removal of the existing restorative material and cleaning the pulp chamber of obturation material including 2 to 3 mm of the canal. Placement of a conventional composite bonded within the tooth provides a good long-term restorative solution to these teeth, and a crown is not needed typically. The access or existing restoration should leave most of the cuspal width present. When the preparation following removal of decay and existing restorative materials invades the width of the cusplaving half of this tooth structure missing, more extensive restoration is indicated.

When the tooth to be restored is missing one or both marginal ridges and these areas have been previously restored or will be restored, placement of a bonded composite will not suffice as the final restoration (Fig. 10). The marginal ridges provide resistance to cuspal flexure of the tooth, improving its strength. When these are missing, functional loading of the tooth will allow greater cuspal flexure and consequently a higher chance of fracture under masticatory function. Restoration of these teeth will require a core buildup with optional pins or other retentive elements for the core followed by a full coverage crown. Posts are often not needed, as the remaining tooth structure at the cusps after crown preparation is sufficient to retain the core and a ferrule can be achieved. A post may be considered in those patients who are bruxers or clenchers or whose occlusion may place higher forces on the restored tooth due to the tooth's position relative to the occlusal plane. When a ferrule cannot be achieved, the practitioner should consider osseous crown lengthening or forced eruption to improve the ferrule. Inlay restorations should be avoided in endodontically treated teeth because the access created to perform the endodontic treatment weakens the tooth from a cuspal flexure standpoint and the inlay even when bonded may act as a wedge forcing the cusps apart and leading to fracture of the tooth. An onlay restoration may be utilized, and its design should include shoeing of the cusps to limit cuspal flexure.

These teeth are a challenge to restore, as they are after removal of the old restorative material and decay has left significant portions of the tooth needing replacement (Fig. 11). These teeth will require placement of posts to retain the core of the remaining tooth structure. As the purpose of posts is to retain the core, it is recommended that in multi-canal teeth a post be placed into each canal to cross-pin the core to the remaining tooth structure (Fig. 12). Projection of the posts in posterior teeth due to the angulation
