# Abutment fracture in a bridge supported by natural teeth and implants

**Authors** Dr Gregory-George Zafiropoulos, Dr Giorgio Deli & Dr Rainer Valentin, Germany/Italy

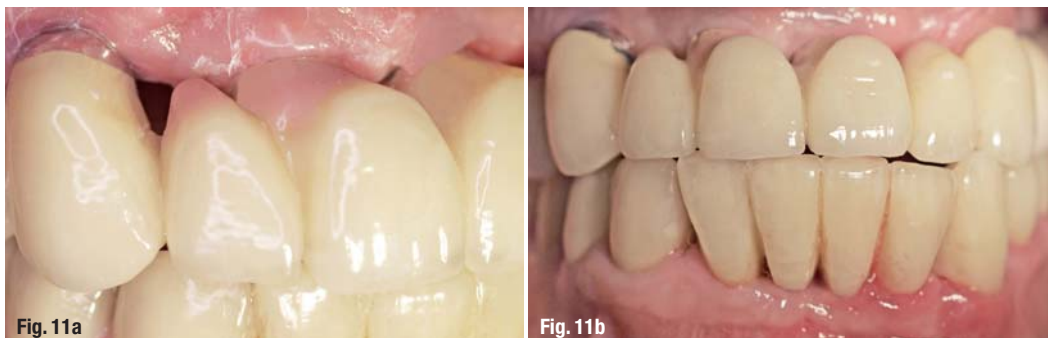
**Figs. 11a & b** Denture in place; a) close-up; b) anterior view.

provisional cement (TempBond, Kerr Co., Orange, USA; Fig. 4b). In addition, a surgical stent fitting onto the abutments was milled from clear PMMA (Zenotec; Wieland, Pforzheim, Germany, Fig. 5a). The planned axis of implant #13 was determined using a dental parallelometer (Fig. 5b), and a drill sleeve was placed into the surgical stent (Fig. 5c). An implant (4.5 x 10 mm, SB line; Dentegris, Duisburg, Germany) was inserted with a torque of 35 Ncm using a two-phase protocol (Fig. 6). Three months after implant placement, an impression post was positioned on the implant and the surgical stent was placed in the patient's mouth after the drill sleeve had been removed. The impression post was attached to the surgical stent using modeling resin (pattern resin, GC, Alsip, USA; Fig. 7). After this, the implant analog was attached to the impression post (Fig. 8a) and fixed in the cast using acrylic resin (Fig. 8b). A customised abutment fitting crown #13 was fabricated (Figs. 9a and b), positioned on the implant #13 and torqued to 35 Ncm (Figs. 10a-c). Subsequently, the denture was inserted (Figs. 11a and b).

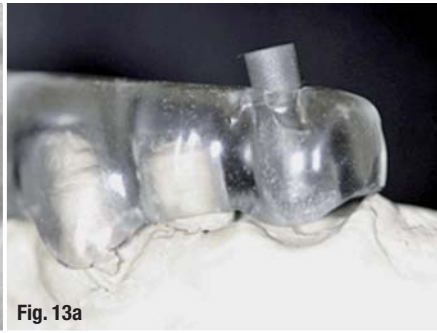
Fig. 13a

**Figs. 13a & b\_**a) Surgical guide for implant placement #15; b) X-ray after implant placement.

Thirteen years after prosthetic rehabilitation, the patient reported to the office with a root fracture in tooth #15. The tooth was extracted, the secondary telescopic crown in regio #15 was removed, and the supraconstruction was temporarily filled with a photo-cured, highly elastic temporary material (Fermit, Ivoclar Vivadent, Ellwangen, Germany). The patient again refused a sinus lift and therefore the immediate implant placement regio #15 was scheduled. The axis of the tooth #15, the fabrication of the transfer key and the implant placement, were performed as previously described in case 1. A short implant (Endopore 4.1 x 9 mm, Sybron Implant Solutions, Bremen, Germany) was inserted into area #15 (Fig. 13). Four months after implant placement, impressions were taken and a cus-

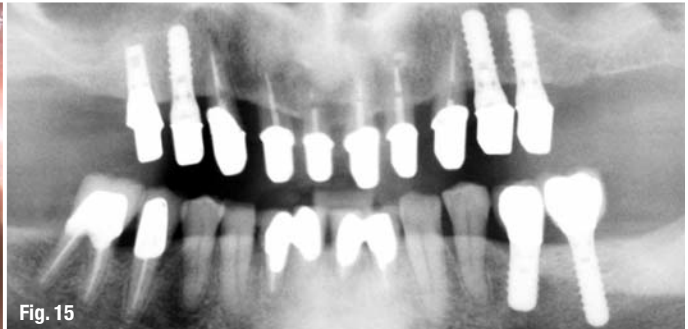
Fig. 15

**Fig. 15\_**Orthopantomograph taken at the completion of treatment.

tomised gold implant abutment and new secondary telescopic crown were fabricated and integrated into the same position as tooth #15 (Figs. 14 and 15). During a healing period as well as after the integration of the new abutment and the new secondary telescope in the bridge, the patient further used his telescopic maxillary restoration (Figs. 16a–d).

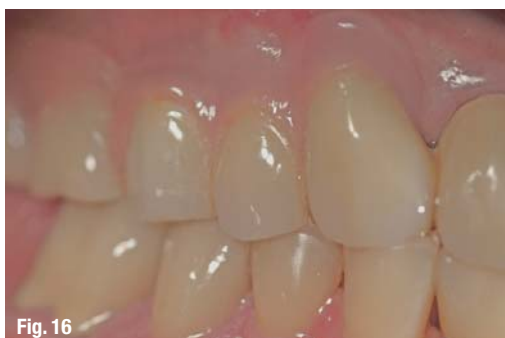
Fig. 16

**Fig. 16\_**Clinical view.
