Abutment fracture in a bridge supported by natural teeth and implants

Authors Dr Gregory-George Zafiropoulos, Dr Giorgio Deli & Dr Rainer Valentin, Germany/Italy

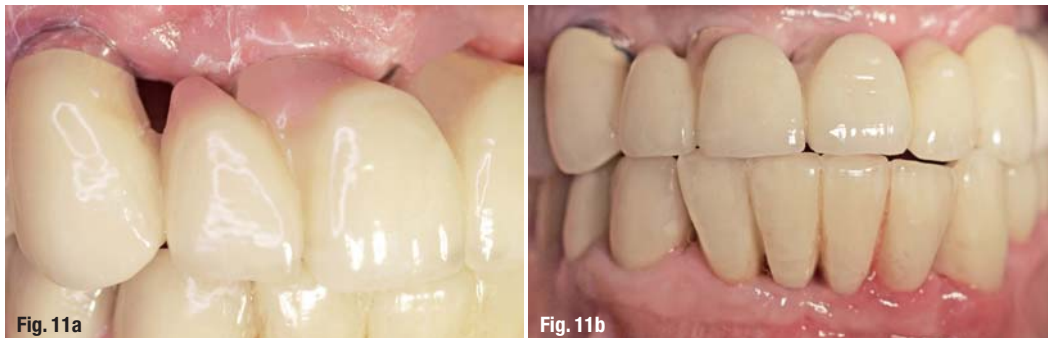
Figs. 11a & b Denture in place; a) close-up; b) anterior view.

provisional cement (TempBond, Kerr Co., Orange, USA; Fig. 4b). In addition, a surgical stent fitting onto the abutments was milled from clear PMMA (Zenotec; Wieland, Pforzheim, Germany, Fig. 5a). The planned axis of implant #13 was determined using a dental parallelometer (Fig. 5b), and a drill sleeve was placed into the surgical stent (Fig. 5c). An implant (4.5 x 10 mm, SB line; Dentegris, Duisburg, Germany) was inserted with a torque of 35 Ncm using a two-phase protocol (Fig. 6). Three months after implant placement, an impression post was positioned on the implant and the surgical stent was placed in the patient's mouth after the drill sleeve had been removed. The impression post was attached to the surgical stent using modeling resin (pattern resin, GC, Alsip, USA; Fig. 7). After this, the implant analog was attached to the impression post (Fig. 8a) and fixed in the cast using acrylic resin (Fig. 8b). A customised abutment fitting crown #13 was fabricated (Figs. 9a and b), positioned on the implant #13 and torqued to 35 Ncm (Figs. 10a-c). Subsequently, the denture was inserted (Figs. 11a and b).

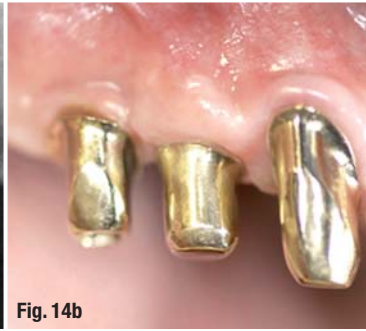
Fig. 14a

Figs. 14a & b_Customised gold implant abutment #15 in place; a) X-ray; b) clinical view.

tomised gold implant abutment and new secondary telescopic crown were fabricated and integrated into the same position as tooth #15 (Figs. 14 and 15). During a healing period as well as after the integration of the new abutment and the new secondary telescope in the bridge, the patient further used his telescopic maxillary restoration (Figs. 16a–d).

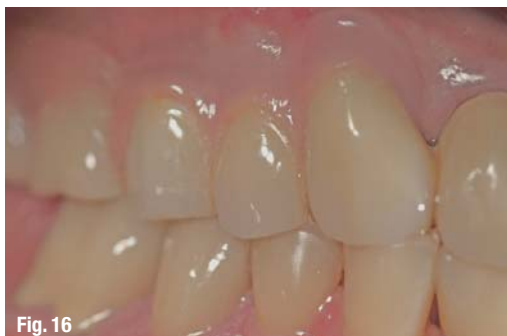
Fig. 16

Fig. 16_Clinical view.
