Abutment fracture in a bridge supported by natural teeth and implants

Authors Dr Gregory-George Zafiropoulos, Dr Giorgio Deli & Dr Rainer Valentin, Germany/Italy

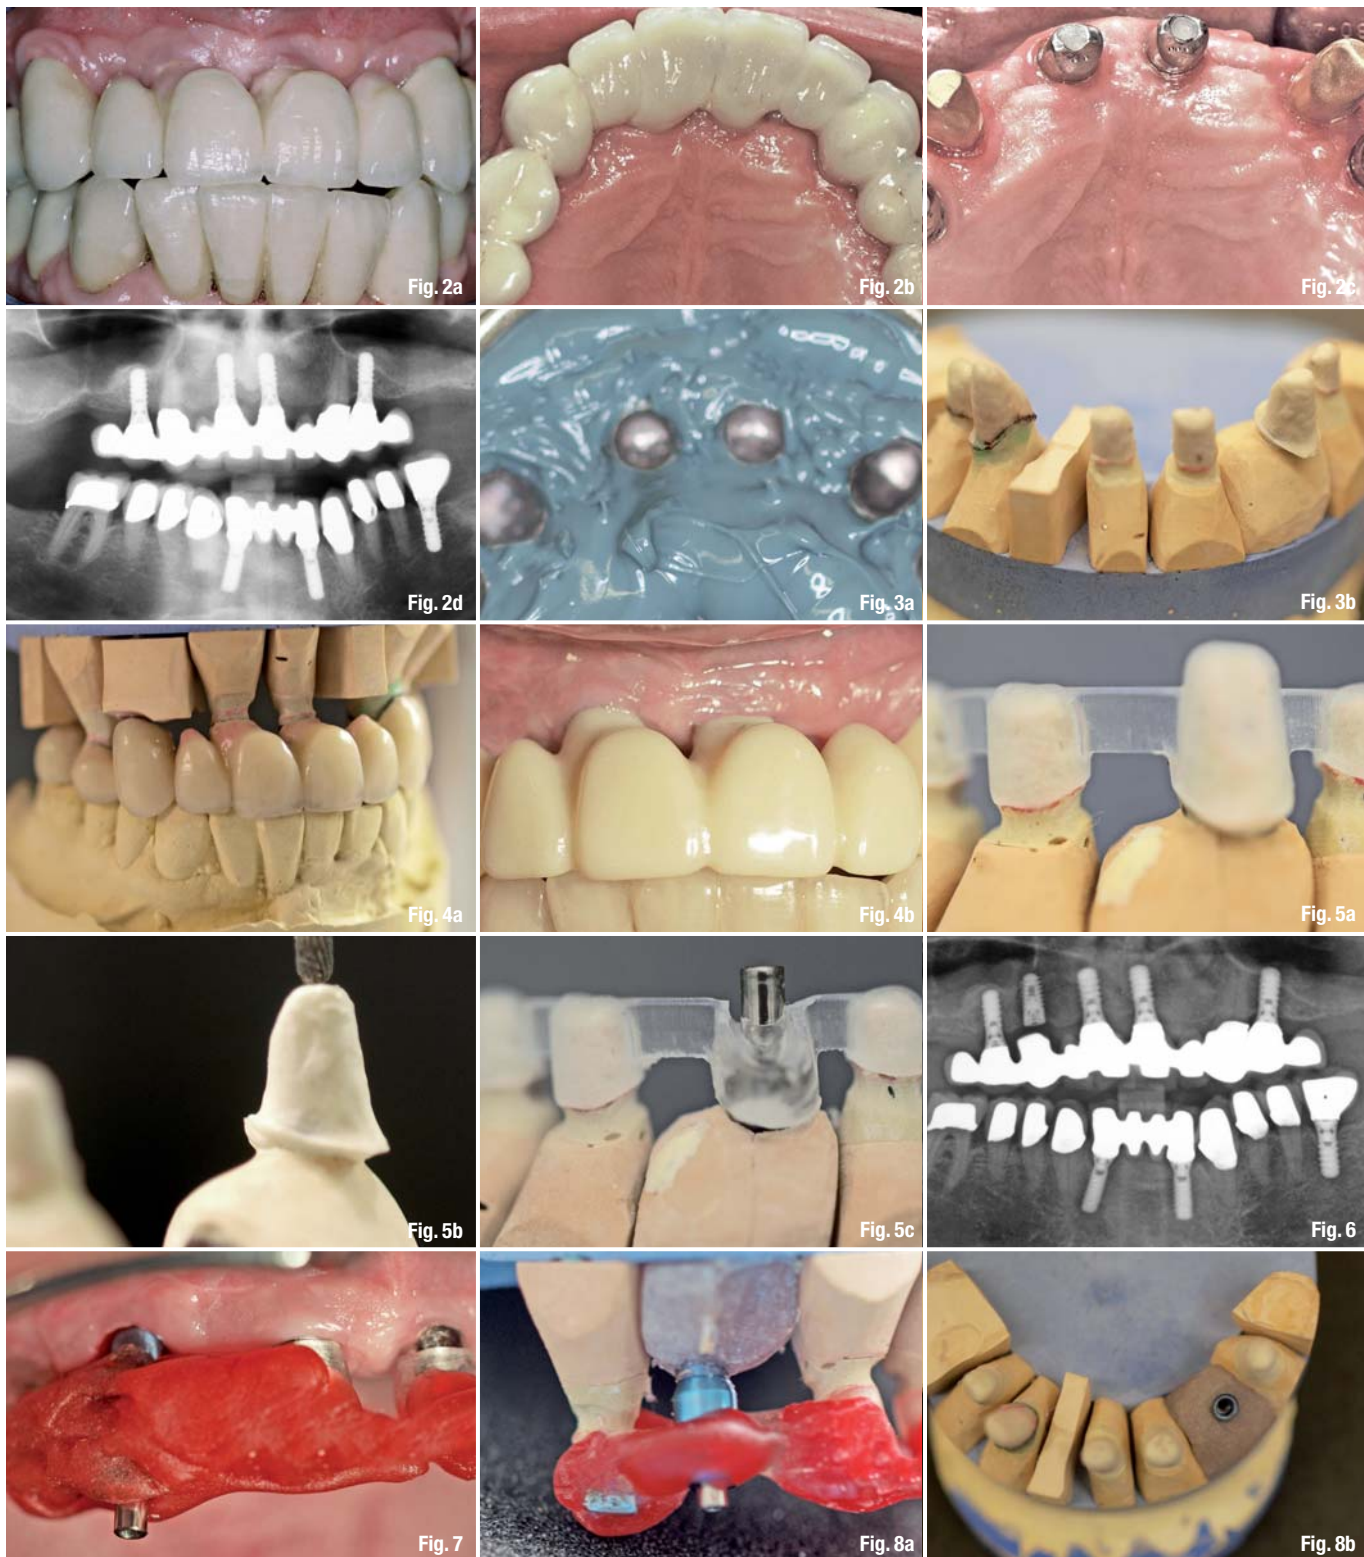
Fig. 2_ Restauration after initial treatment, before the accident; a) anterior view; b) intraoral view; c) implants with abutments and teeth #13 and #23 with gold copings in place; d) panoramic radiograph.

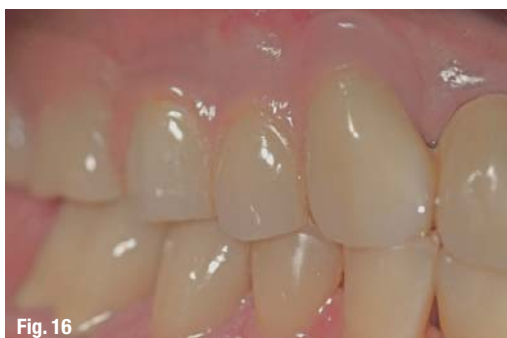
Fig. 16

Fig. 16_Clinical view.

tomised gold implant abutment and new secondary telescopic crown were fabricated and integrated into the same position as tooth #15 (Figs. 14 and 15). During a healing period as well as after the integration of the new abutment and the new secondary telescope in the bridge, the patient further used his telescopic maxillary restoration (Figs. 16a–d).
