Abutment fracture in a bridge supported by natural teeth and implants

Authors Dr Gregory-George Zafiropoulos, Dr Giorgio Deli & Dr Rainer Valentin, Germany/Italy

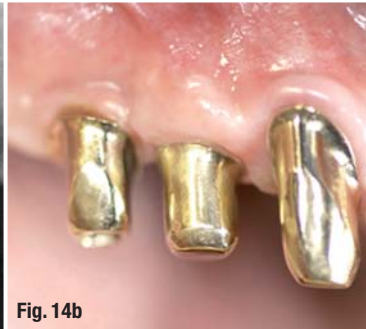
Figs. 14a & b_Customised gold implant abutment #15 in place; a) X-ray; b) clinical view.

tomised gold implant abutment and new secondary telescopic crown were fabricated and integrated into the same position as tooth #15 (Figs. 14 and 15). During a healing period as well as after the integration of the new abutment and the new secondary telescope in the bridge, the patient further used his telescopic maxillary restoration (Figs. 16a–d).
