# Abutment fracture in a bridge supported by natural teeth and implants

**Authors** Dr Gregory-George Zafiropoulos, Dr Giorgio Deli & Dr Rainer Valentin, Germany/Italy

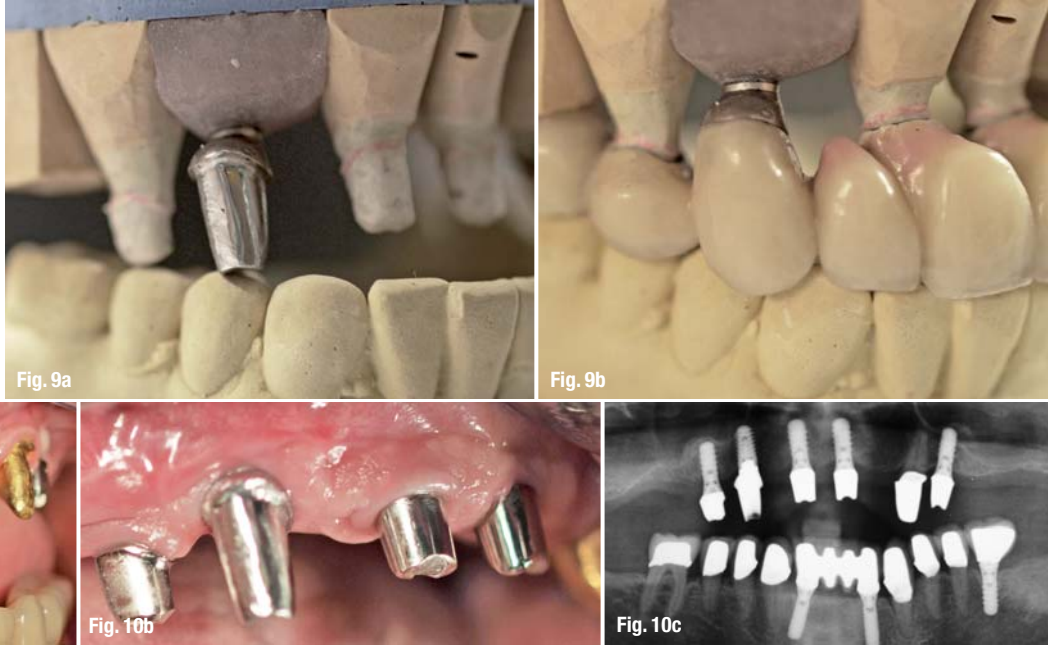
**Figs. 3a & b\_** a) Impression with the maxillary restoration; b) fabricated cast.

**Figs. 4a & b\_** a) Cast articulated using the maxilla restoration as a guide; b) provisional FPD in place.

**Figs. 5a–c\_** a) Surgical stent; b) determination of the axial direction; c) drill sleeve was placed into the surgical stent.

**Fig. 6\_** Panoramic radiograph obtained after implant insertion at position #6.

**Fig. 7\_** Impression post in the surgical guide.

**Figs. 8a & b\_** a) Transfer of the implant position to mounted cast; b) implant analog in cast.

**Figs. 9a & b** a) Fabricated customised abutment; b) try-in of the abutment in the restoration.

**Figs. 10a–c** a & b) Abutment mounted on the implant; c) panoramic radiograph of custom-made abutment #13 in place.

posite (Ceramage, SHOFU, Ratingen, Germany). The patient was put on a three-months maintenance schedule. Six years after implant and prosthetic treatment, the patient reported to the office. Tooth #13 had been fractured in a car accident. He refused any new restoration and insisted on keeping the existing one. Thus, implant placement in position #13 was planned. The fractured tooth #13 was extracted. The maxillary denture was inserted and a bite registration in central occlusion was performed using self-curing acrylic resin (pattern resin; GC, Alsip, USA). An impression (Impregum; 3M ESPE, Neuss, Germany) of the maxilla was taken with the denture in place. The denture was removed from the patient's mouth together with the impression (Fig. 3a). This allowed for the fabrication of a cast with an exact duplication of the abutments (Fig. 3b).

The casts were placed in an articulator using the denture as a guide to achieve correct occlusion (Fig. 4a). A temporary fixed partial denture (from #14 to #24 with #15 and #25 cantilevers) from coloured polymethyl methacrylate (PMMA; Zenotec; Wieland, Pforzheim, Germany) was milled based on a scan of the maxilla cast, and was adhered on the abutments using

provisional cement (TempBond, Kerr Co., Orange, USA; Fig. 4b). In addition, a surgical stent fitting onto the abutments was milled from clear PMMA (Zenotec; Wieland, Pforzheim, Germany, Fig. 5a). The planned axis of implant #13 was determined using a dental parallelometer (Fig. 5b), and a drill sleeve was placed into the surgical stent (Fig. 5c). An implant (4.5 x 10 mm, SB line; Dentegris, Duisburg, Germany) was inserted with a torque of 35 Ncm using a two-phase protocol (Fig. 6). Three months after implant placement, an impression post was positioned on the implant and the surgical stent was placed in the patient's mouth after the drill sleeve had been removed. The impression post was attached to the surgical stent using modeling resin (pattern resin, GC, Alsip, USA; Fig. 7). After this, the implant analog was attached to the impression post (Fig. 8a) and fixed in the cast using acrylic resin (Fig. 8b). A customised abutment fitting crown #13 was fabricated (Figs. 9a and b), positioned on the implant #13 and torqued to 35 Ncm (Figs. 10a-c). Subsequently, the denture was inserted (Figs. 11a and b).

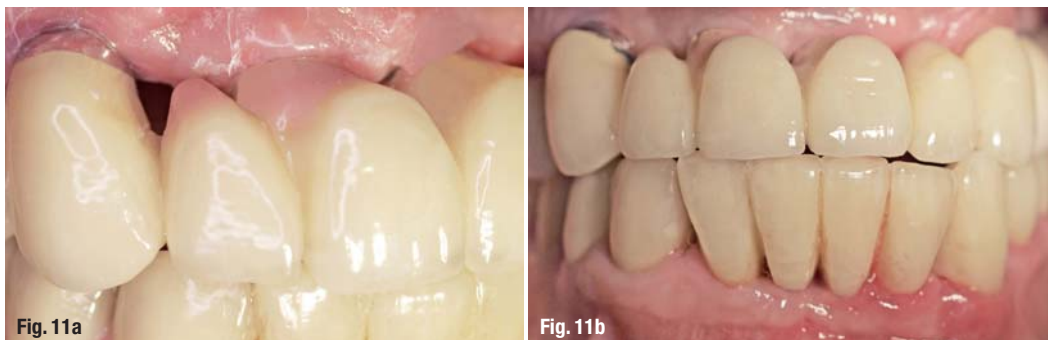
**Figs. 11a & b** Denture in place; a) close-up; b) anterior view.

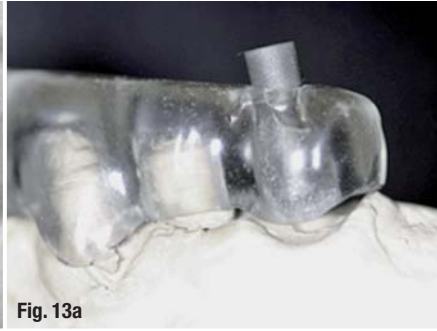
Fig. 13a

**Figs. 13a & b\_**a) Surgical guide for implant placement #15; b) X-ray after implant placement.

Thirteen years after prosthetic rehabilitation, the patient reported to the office with a root fracture in tooth #15. The tooth was extracted, the secondary telescopic crown in regio #15 was removed, and the supraconstruction was temporarily filled with a photo-cured, highly elastic temporary material (Fermit, Ivoclar Vivadent, Ellwangen, Germany). The patient again refused a sinus lift and therefore the immediate implant placement regio #15 was scheduled. The axis of the tooth #15, the fabrication of the transfer key and the implant placement, were performed as previously described in case 1. A short implant (Endopore 4.1 x 9 mm, Sybron Implant Solutions, Bremen, Germany) was inserted into area #15 (Fig. 13). Four months after implant placement, impressions were taken and a cus-

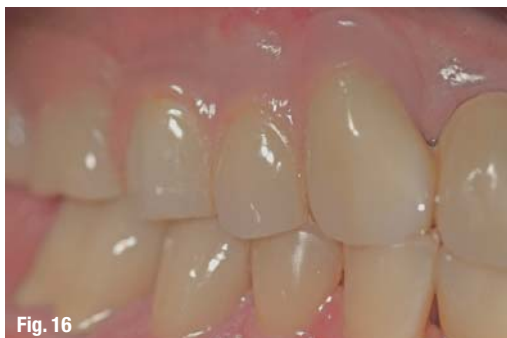
Fig. 16

**Fig. 16\_**Clinical view.

tomised gold implant abutment and new secondary telescopic crown were fabricated and integrated into the same position as tooth #15 (Figs. 14 and 15). During a healing period as well as after the integration of the new abutment and the new secondary telescope in the bridge, the patient further used his telescopic maxillary restoration (Figs. 16a–d).
