Abutment fracture in a bridge supported by natural teeth and implants

Authors Dr Gregory-George Zafiropoulos, Dr Giorgio Deli & Dr Rainer Valentin, Germany/Italy

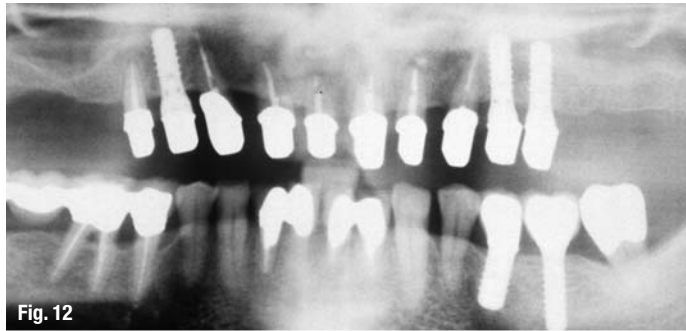
Fig. 12

Fig. 12_ Orthopantomograph taken at the completion of the perio-implant-prosthetic treatment.

was restored with single-fix crowns retained on natural teeth and implants (Fig. 12). The maxilla was restored (in the same way described above for the first case with a removable palatal free metal-ceramic bridge using double crowns, e.g. telescopic crowns, as attachments, retained on seven natural teeth (#14,13–23) and three implants (#13, 24, 25; RN, 10 × 4.1 mm, Straumann, Basel, Switzerland). Because the patient did not consent to a sinus augmentation, no implants were placed in regio #16 and #26. Tooth #14 was treated endodontically and was used as the last abutment (Fig. 12).

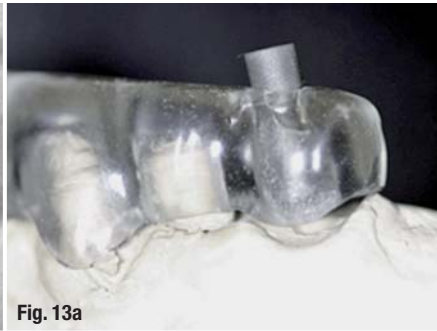
Fig. 13a

Figs. 13a & b_ a) Surgical guide for implant placement #15; b) X-ray after implant placement.

Thirteen years after prosthetic rehabilitation, the patient reported to the office with a root fracture in tooth #15. The tooth was extracted, the secondary telescopic crown in regio #15 was removed, and the supraconstruction was temporarily filled with a photo-cured, highly elastic temporary material (Fermit, Ivoclar Vivadent, Ellwangen, Germany). The patient again refused a sinus lift and therefore the immediate implant placement regio #15 was scheduled. The axis of the tooth #15, the fabrication of the transfer key and the implant placement, were performed as previously described in case 1. A short implant (Endopore 4.1 × 9 mm, Sybron Implant Solutions, Bremen, Germany) was inserted into area #15 (Fig. 13). Four months after implant placement, impressions were taken and a cus-

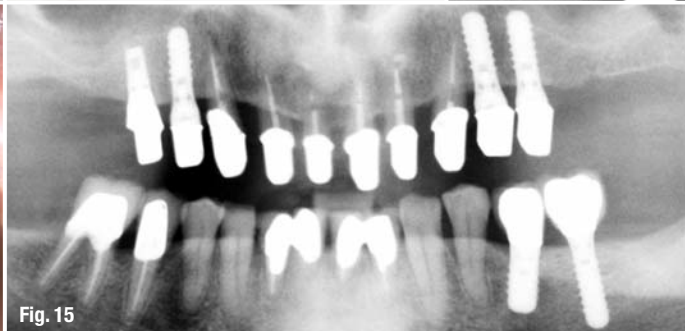
Fig. 15

Fig. 15_ Orthopantomograph taken at the completion of treatment.

tomised gold implant abutment and new secondary telescopic crown were fabricated and integrated into the same position as tooth #15 (Figs. 14 and 15). During a healing period as well as after the integration of the new abutment and the new secondary telescope in the bridge, the patient further used his telescopic maxillary restoration (Figs. 16a–d).

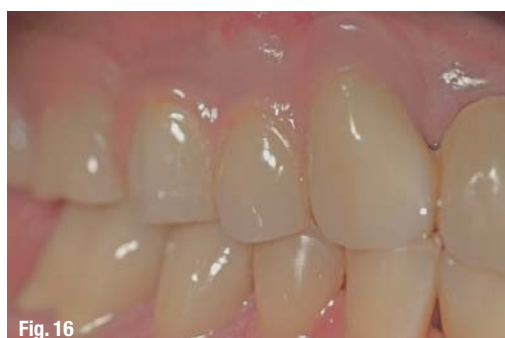
Fig. 16

Fig. 16_ Clinical view.
