# Overcoming a difficult aesthetic situation

**Author:** Prof. Dr Dr M. Kemal Unsal, Turkey

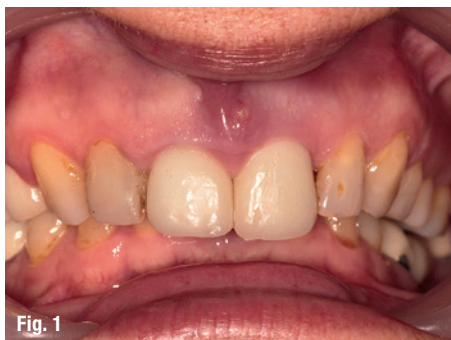
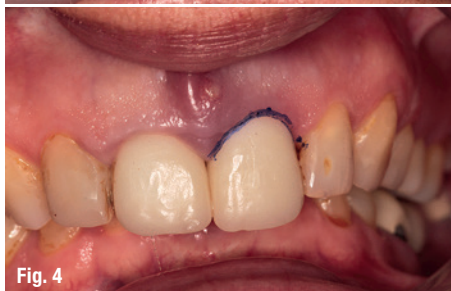
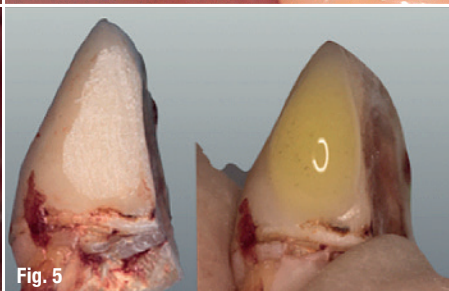
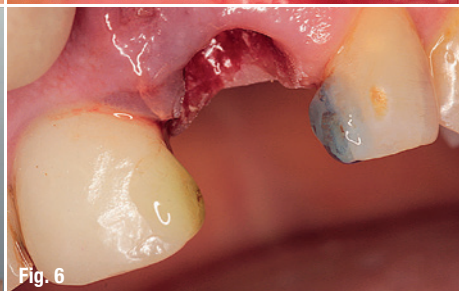
- Fig. 1:** The tooth had received a root treatment and a ceramic laminate restoration ten years ago.
- Fig. 2:** Upon intraoral and radiographic examination, the tooth was diagnosed with a horizontal crack and decided to be extracted.
- Fig. 3:** As the buccal bone wall was intact, no membrane was used.
- Fig. 4:** Marking the gum level with a permanent pen just before extraction.
- Fig. 5:** Roughening of the glazed surface of the ceramic restorations with diamond burs.
- Fig. 6:** Application of only orthophosphoric acid of 36 per cent on the natural enamel of tooth #22 for 30 seconds and composite bonding.

A 58-year-old woman without any systemic disorders attended our clinic. Her main complaint was the increased mobility of her upper left central incisor #21. The mentioned tooth had received a root treatment and a ceramic laminate restoration ten years ago (Fig. 1). Upon intraoral and radiographic examination, the tooth was diagnosed with a horizontal crack and decided to be extracted (Fig. 2). The remaining broken root piece was also extracted as a single piece. An immediate NucleOSS T6 implant with a length of 12 mm and a width of 4.1 mm was inserted. The buccal aspect of the extraction socket was filled with a xenograft. As the buccal bone wall was intact, no membrane was used (Fig. 3).

needs an immediate temporary restoration. The most time-saving and aesthetic restoration type is an immediate temporary crown attached to the implant. However, this practice needs an insertion torque of 30 Ncm or more. This case did not meet this criterion. Therefore, the idea of using the coronal part of the extracted tooth as a temporary restoration was considered. The gum level was marked with a permanent pen just before extraction (Fig. 4).

Due to an extensive deep bite, there was no room to use a fibre splint in order to achieve retention via the neighbouring teeth. The only remaining alternative was to attach the extracted coronal part using light-cured composite. One of the neighbouring teeth and the extracted coronal part was carrying a ceramic laminate, whereas the tooth #22 was yet untreated. Therefore, the glazed surface of the ceramic restorations was roughened with diamond burs and nine per cent HFl acid was applied, followed by silane and

bond application (Fig. 5). On the natural enamel of tooth #22 only orthophosphoric acid of 36 per cent was used for 30 seconds followed by a composite bonding material application (Fig. 6). The patient was advised to follow a soft diet and discharged (Fig. 7). During the three-month healing period, the crown was de-attached twice. However, these appointments were also considered as an advantage as it allowed the clinician to add light curing composite material beneath the extracted crown. This way, a better crown profile was attained.

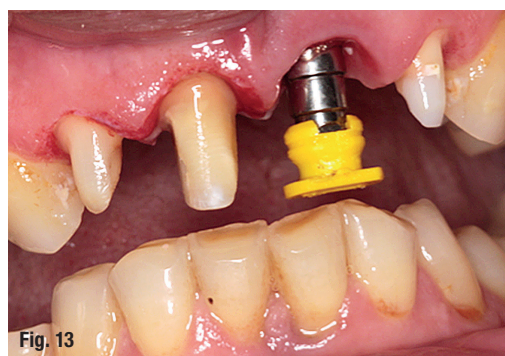
**Fig. 13:** Closed tray impression was made and preparation of tooth #12, 11 and 22 for metal-free ceramic restorations.

**Fig. 14:** At the try-in appointment the clinician was unable to attach the custom-made abutment.

**Fig. 15:** Design of a standard NucleOSS Ti-Base abutment.

**Fig. 16:** The red-dotted lines demonstrating why the standard Ti-Base abutment was not able to meet the angle for the required fitting accuracy.

**Fig. 17:** Comparison of the new and old design of both Ti-Base abutments.

Following the final gum-tissue conditioning, a closed tray impression was made. However, due to the aesthetic demands of the patient, teeth #12, 11 and 22 were also prepared for metal-free ceramic restorations (Fig. 13) and the impression was taken. A custom-milled Zr abutment on a Ti-Base was ordered for the implant-retained restoration. Other teeth would receive a metal-free ceramic restoration.

At the try-in appointment, however, the clinician was unable to attach the custom-made abutment. The periapical radiography revealed the reason (Fig. 14). The implant was intentionally positioned deep in the coronal direction to avoid any aesthetic problems. However, Ti-Base custom abutments of nearly all companies have a shoulder design, on

which the custom-made Zr should stand. Ti-Base design is mainly used in aesthetic regions so it is very understandable that all designs intend to position the shoulder at the deepest level of the Ti-Base abutment. The design of a standard NucleOSS Ti-Base abutment is very similar to other companies' products. Its design can be seen in Figure 15.

situation could not be observed at the impression stage as the impression coping design were conical and did not pose any problems. The red-dotted lines in Figure 16 clearly demonstrates why the standard Ti-Base abutment was not able to meet the angle for the required fitting accuracy. At that stage, the only way to manufacture an acceptable restoration was an additional surgery which would re-contour the bone around the coronal portion of the implant. Such an intervention would not only lengthen the treatment time but carry a very high risk of aesthetic failure. In order to avoid such an outcome, the manufacturer designed a new custom Ti-Base abutment to be applied in these situations. The new and old design of both Ti-Base abutments can be seen in Figure 17 side by side.
