# Implant **retreatment**

Dr Philippe Leclercq, France; Jean-François Martinez, France & Michael Brüh, Germany

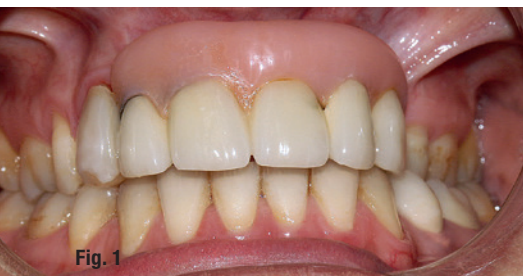
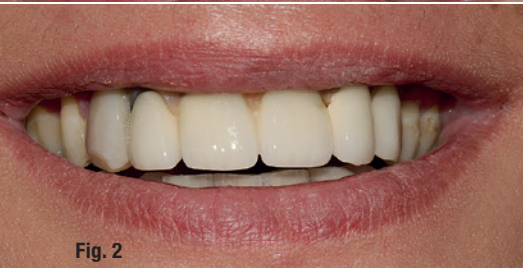
Fig. 1

**Figs. 1 & 2:** Initial prostheses: Lip support was ensured by a large false gingiva, and fractured cosmetic material at the right maxillary canine was evident. The patient's smile showed the prosthetic teeth placed off-centre and an infiltration at the right lateral incisal level. **Fig. 3:** Examination after three years revealed a negative short-term prognosis for the implants owing to significant recession at the right implant and hyperplastic tissue. **Fig. 4:** The framework was unscrewed, abutments removed and implants easily removed. **Fig. 5:** Implant removal site showing even greater deterioration in bone volume. **Figs. 6 & 7:** The grafts were harvested from the chin symphysis and firmly attached by surgical screws in the recipient site.

Dissatisfied with the treatment, the patient was re-examined three years after the initial treatment. The patient's smile showed an infiltration at the right lateral incisal level and that the prosthetic teeth were placed off-centre. The lip support, ensured by a large false gingiva, was correct. The cosmetic material of the right maxillary canine was fractured (Figs. 1 & 2).

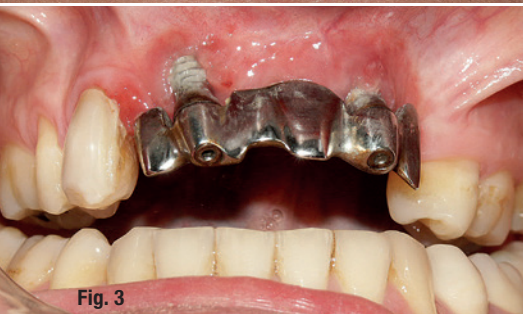
Fig. 3

Once the patient's prosthesis had been removed and an examination of the site conducted, an extremely negative prognosis was determined for the implants (Fig. 3), which is often the case with maxillary overdentures. The right implant showed a loss of the majority of its vestibular bone, causing significant recession. The tissue was hyperplastic, making hygiene difficult. The framework was off-centre presumably because of the implants, which explained the off-centre axis of the prosthetic teeth.

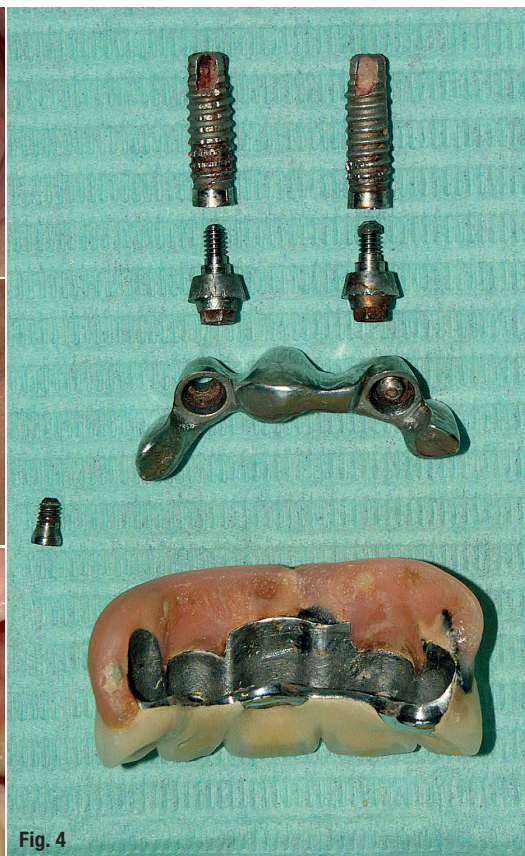
Fig. 4

Owing to insufficient osseointegration, the removal of the implants was fairly easy (Fig. 4). Removal was accomplished with the aid of an implant removal tool.

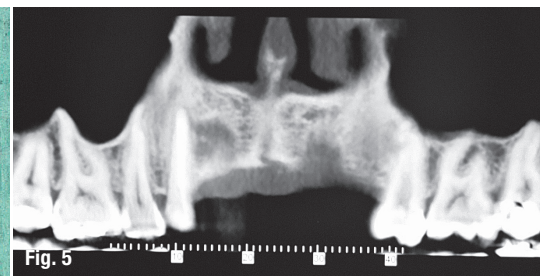
Fig. 5

Three months after implant removal, a clinical and radiographic assessment was conducted. The assessment showed further significant vertical bone loss and loss in bone volume (Fig. 5). Significant vertical bone loss is difficult to correct owing to random gingival recovery. It was thus decided to augment the bone volume by performing a chin bone graft.

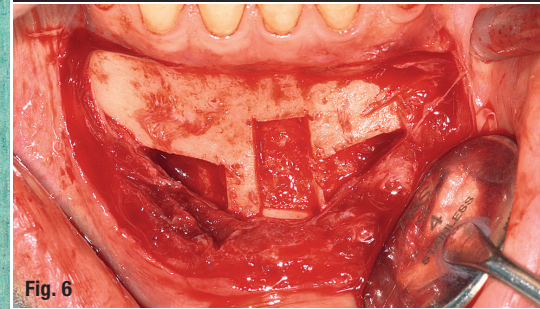
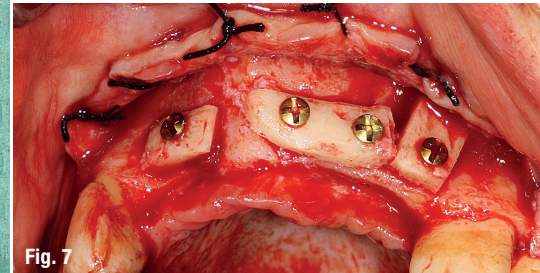
Fig. 6

grafts were then positioned and secured in place with mini-screws (Figs. 6 & 7).

Anaesthetic was administered in the maxillary and mandibular anterior region. For the mandible, the sample was taken from the cortical bone and a section of the cancellous bone by piezoelectric surgery. The grafts were harvested from the chin symphysis, as close as possible to the mandibular inferior ridge to avoid disturbing the incisor's sensitive innervation, which can be a frequent complication of the procedure. The vestibular cortical bone scar was perforated with a small round bur, allowing for rapid revascularisation of the grafts. The

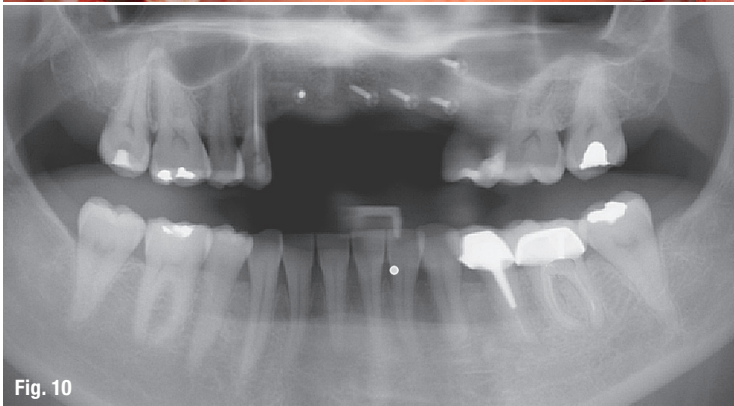
Fig. 10

**Figs. 8 & 9:** The properly compressed PRF membranes permitted complete coverage of the surgical site, in this instance on the maxilla. **Fig. 10:** Panoramic radiograph showing the grafts to be correctly healed and satisfactorily adhered to the recipient bone sites. **Fig. 11:** Increased vestibular bone volume allowed positioning of the teeth at the crestal bone level and reduction of the false gingiva. **Fig. 12:** A key of the added wax was taken and fabricated in clear casting resin.

After four months, according to radiographic examination, the tissue had healed and the bone mass appeared stable (Fig. 10). New impressions were taken to prepare for the next step in treatment: the implant drilling guide. After four months of healing, the increased vestibular bone volume allowed positioning the teeth at the crestal bone and reduction of the false gingiva using additional wax (Fig. 11). A key of the added wax was taken and fabricated in clear

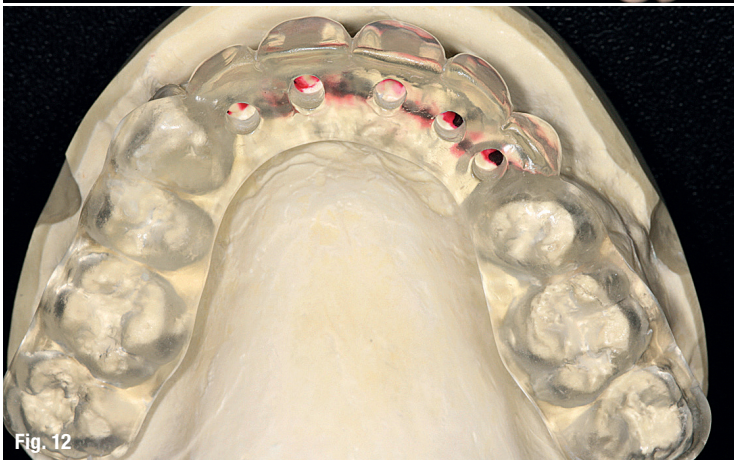
Fig. 12

casting resin. The implant positions were decided on and finalised by drilling placement holes, determining the exact position of the implants (Fig. 12). The correct positioning of implants in relation to the future prosthesis is an important prerequisite for aesthetic and functional success.

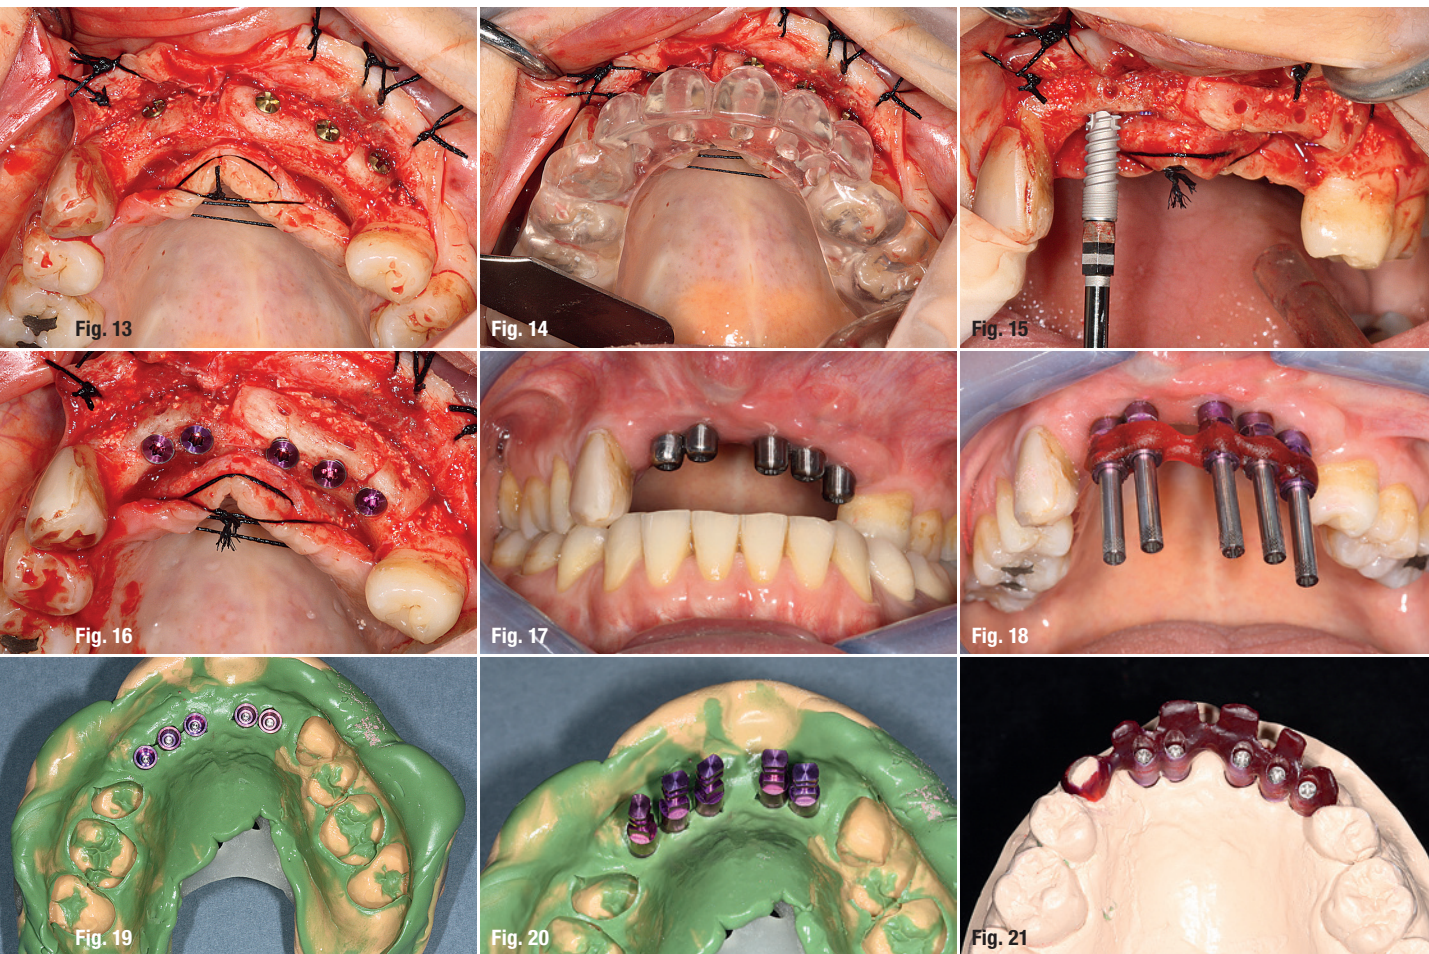
**Fig. 13:** The reopened site showing correct graft integration, a notable increase in cortical bone and excellent vascularity. **Fig. 14:** Testing of the sterilised surgical drilling guide proved drilling would be at the centre of the reconstructed bone ridge. **Fig. 15:** Aadv self-tapping implants were placed. **Fig. 16:** All five implants equipped with threaded cover screws and the surrounding tissue sutured. **Fig. 17:** Loaded implants, healing abutments *in situ*. **Fig. 18:** The healing abutments were removed and replaced with pick-up impression copings secured with self-curing resin. **Figs. 19 & 20:** Removal of the impression and fitting of the impression copings with their laboratory equivalent. **Fig. 21:** Model of the framework, temporarily including the canine, cast in pattern resin.

Local anaesthesia was administered and the bone site reopened. The site showed correct integration of the grafts, a notable increase in cortical bone and excellent vascularity throughout the site (Fig. 13). The sterilised surgical drilling guide was tested and showed that drilling would in fact be at the centre of the reconstructed bone ridge (Fig. 14).

After removal of the screws stabilising the grafts, the guide was placed and drilling (using physiological saline solution) completed. Five Aadva (GC Tech.Europe) self-tapping Grade 5 titanium microstructure implants were inserted by slow drilling (Fig. 15). Aspiration with physiological saline solution was not used at this time so that the first contact with the titanium oxide would be the patient's blood, thus promoting the implants'

osseointegration. This specific implantation technique was validated by Brun et al.<sup>6</sup> All of the implants were equipped with threaded cover screws and the surrounding tissue was sutured (Fig. 16).

After four months, the implants were loaded using an apically positioned flap. The healing abutments were placed and the flap sutured around them (Fig. 17). Radiographic analysis and especially a percussion test showed the implants' perfect osseointegration. After 15 days of gingival healing around the abutments, they were removed and the impression copings were placed and secured with a self-curing resin (Fig. 18). Impressions were taken and the healing screws were reinserted (Figs. 19 & 20).

This prosthesis serves as a model for the final prosthesis. It is made with easily modifiable material like resin, but with a metal framework to guarantee a certain level of rigidity. In the first step, a model of the framework, which temporarily included the canine to increase stability, was cast in pattern resin (Fig. 21). The model was then scanned (Aadva, GC Tech.Europe; two cameras, 2 MP, precision: 10 µm) before being transferred to a machining centre (GM 1000, GC Tech.Europe; Figs. 22–24). Once back from the machining, the titanium framework was tested on the working model and its stability was verified (Figs. 25 & 26).

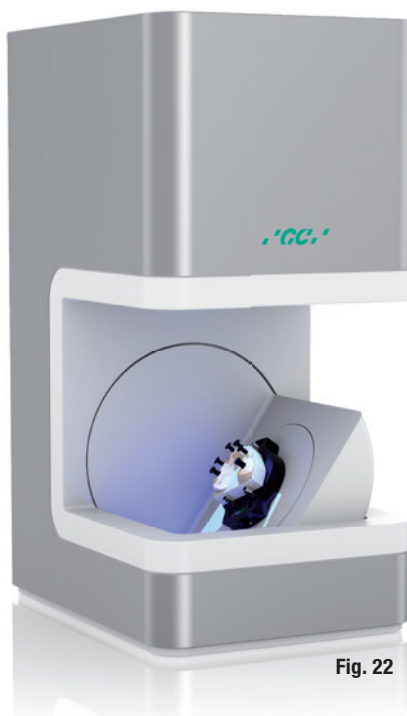
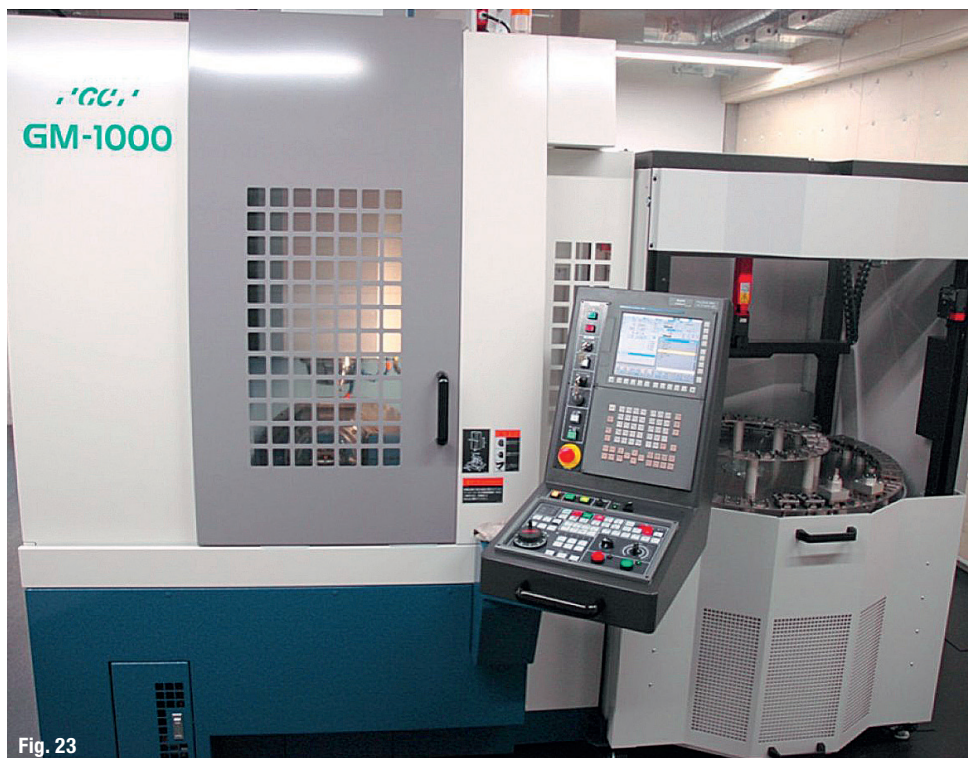
Fig. 22

**Figs. 22 & 23:** The model was scanned before being transferred to a machining centre. **Fig. 24:** After scanning, the computer prefiguration of the framework was validated. **Figs. 25 & 26:** Testing of the titanium framework on the working model and verification of stability.

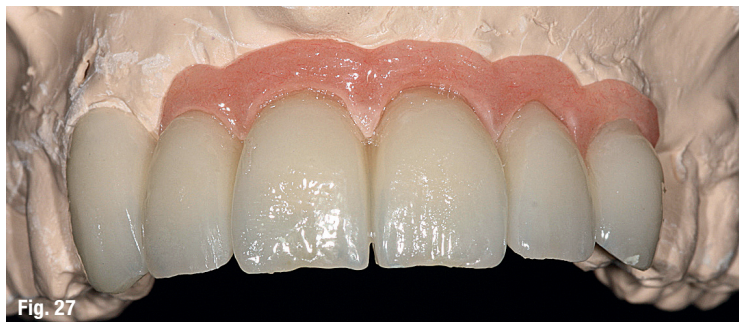
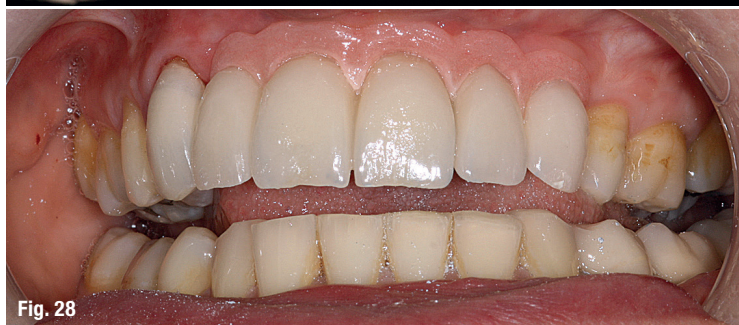
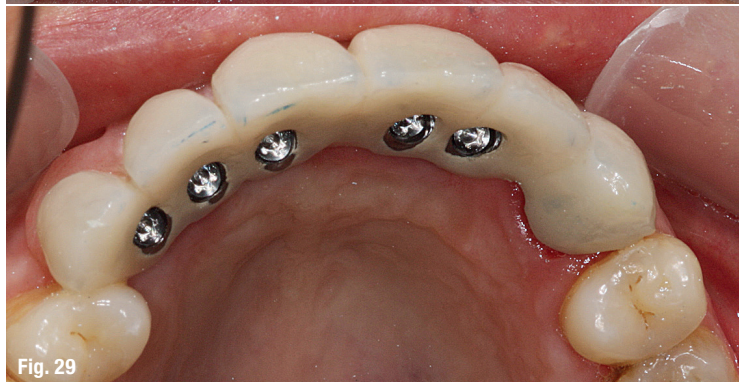
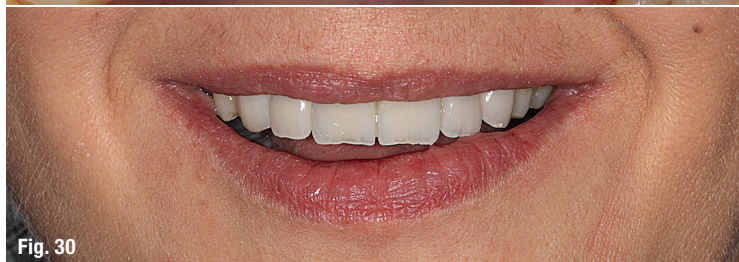
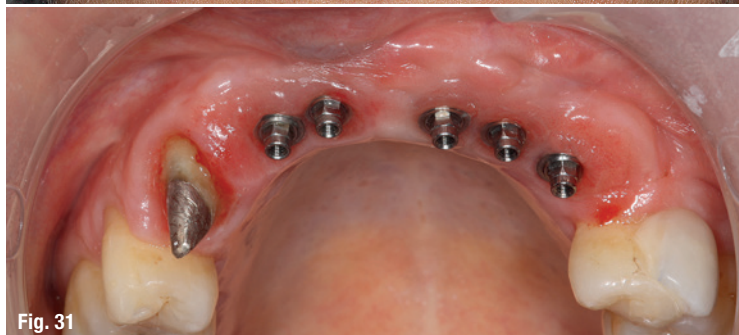
**Fig. 27:** The cosmetic material placed onto the framework. **Figs. 28 & 29:** The prosthesis was attached with screws and the necessary occlusal verification was conducted. **Fig. 30:** The patient's smile showing now well-balanced incisors in line with the face's sagittal plane, lip support appearing to be correct. **Fig. 31:** Removal of the validation prosthesis and examination of the areas of compressed mucosa and difficult for dental hygiene. Reinstallation of validation prosthesis after correction.

The cosmetic material (UNIFAST III resin; surface rendering: OPTIGLAZE color, GC Tech.Europe) was then placed on the framework (Fig. 27). The bone graft permitted a maximum reduction of the vestibular false gingiva.

In the following step, the prosthesis was attached in the mouth with screws and the necessary occlusal verification was conducted, including maximum intercuspation, protrusion and lateral excursion. The natural canine on the right was also equipped with a verification tooth. It should be noted, that in lateral excursion on the left, with the antagonist being the original tooth equipped with its periodontal ligament receptors, the canine function was retained; however the group function, which is usually preferred, was neurophysiologically inept (Figs. 28 & 29).

The patient's smile showed that the incisors were now well balanced and in line with the face's sagittal plane. Lip support appeared to be correct and, as often is the case, this would all be validated by the patient's surrounding friends and family (Fig. 30).

After three months, the validation prosthesis was removed in order to examine the areas where mucosa had been compressed and dental hygiene difficult. These areas were corrected and the validation prosthesis reinstalled (Fig. 31).
