# Implant **retreatment**

Dr Philippe Leclercq, France; Jean-François Martinez, France & Michael Brüh, Germany

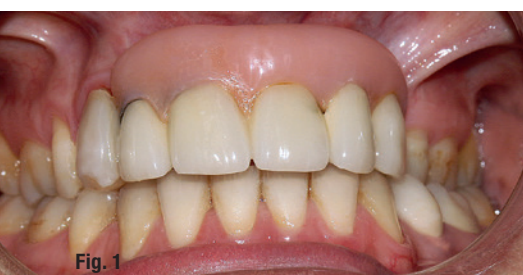
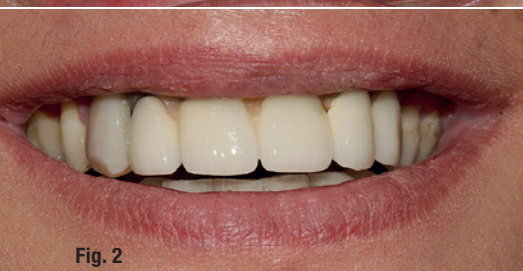
Fig. 1

**Figs. 1 & 2:** Initial prostheses: Lip support was ensured by a large false gingiva, and fractured cosmetic material at the right maxillary canine was evident. The patient's smile showed the prosthetic teeth placed off-centre and an infiltration at the right lateral incisal level. **Fig. 3:** Examination after three years revealed a negative short-term prognosis for the implants owing to significant recession at the right implant and hyperplastic tissue. **Fig. 4:** The framework was unscrewed, abutments removed and implants easily removed. **Fig. 5:** Implant removal site showing even greater deterioration in bone volume. **Figs. 6 & 7:** The grafts were harvested from the chin symphysis and firmly attached by surgical screws in the recipient site.

Dissatisfied with the treatment, the patient was re-examined three years after the initial treatment. The patient's smile showed an infiltration at the right lateral incisal level and that the prosthetic teeth were placed off-centre. The lip support, ensured by a large false gingiva, was correct. The cosmetic material of the right maxillary canine was fractured (Figs. 1 & 2).

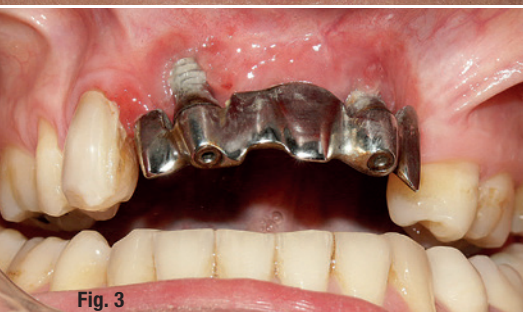
Fig. 3

Once the patient's prosthesis had been removed and an examination of the site conducted, an extremely negative prognosis was determined for the implants (Fig. 3), which is often the case with maxillary overdentures. The right implant showed a loss of the majority of its vestibular bone, causing significant recession. The tissue was hyperplastic, making hygiene difficult. The framework was off-centre presumably because of the implants, which explained the off-centre axis of the prosthetic teeth.

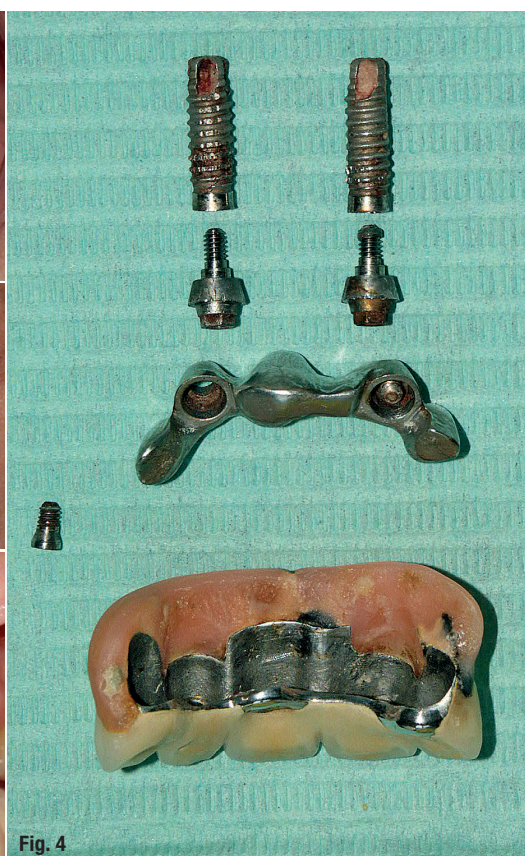
Fig. 4

Owing to insufficient osseointegration, the removal of the implants was fairly easy (Fig. 4). Removal was accomplished with the aid of an implant removal tool.

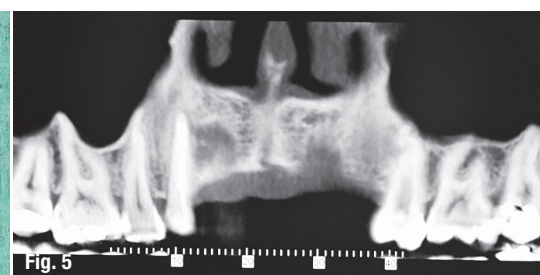
Fig. 5

Three months after implant removal, a clinical and radiographic assessment was conducted. The assessment showed further significant vertical bone loss and loss in bone volume (Fig. 5). Significant vertical bone loss is difficult to correct owing to random gingival recovery. It was thus decided to augment the bone volume by performing a chin bone graft.

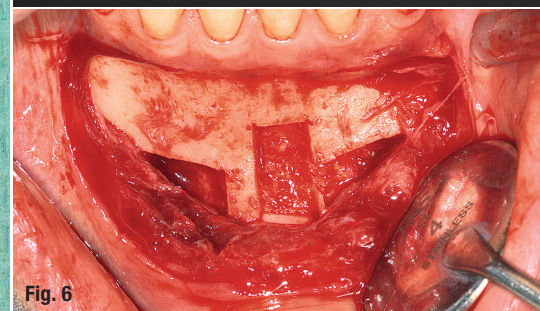
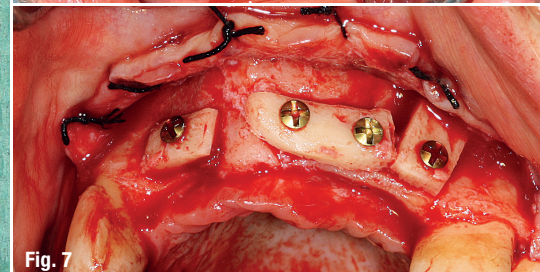
Fig. 6

Anaesthetic was administered in the maxillary and mandibular anterior region. For the mandible, the sample was taken from the cortical bone and a section of the cancellous bone by piezoelectric surgery. The grafts were harvested from the chin symphysis, as close as possible to the mandibular inferior ridge to avoid disturbing the incisor's sensitive innervation, which can be a frequent complication of the procedure. The vestibular cortical bone scar was perforated with a small round bur, allowing for rapid revascularisation of the grafts. The

grafts were then positioned and secured in place with mini-screws (Figs. 6 & 7).

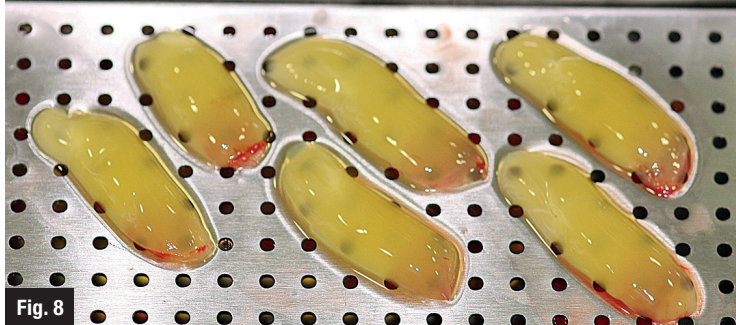
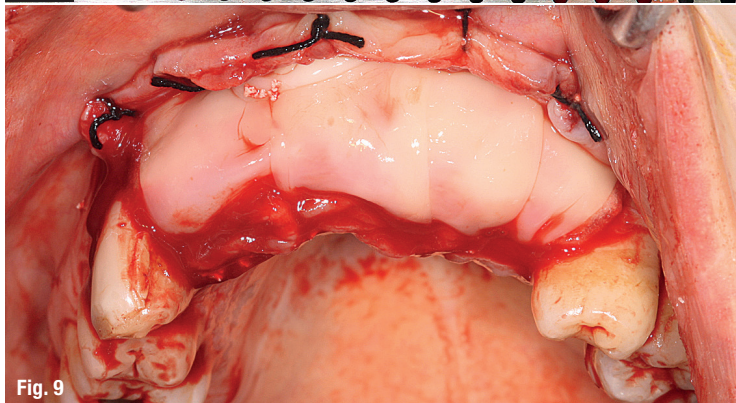
Fig. 8

**Figs. 8 & 9:** The properly compressed PRF membranes permitted complete coverage of the surgical site, in this instance on the maxilla. **Fig. 10:** Panoramic radiograph showing the grafts to be correctly healed and satisfactorily adhered to the recipient bone sites. **Fig. 11:** Increased vestibular bone volume allowed positioning of the teeth at the crestal bone level and reduction of the false gingiva. **Fig. 12:** A key of the added wax was taken and fabricated in clear casting resin.

To increase success, a blood sample was taken and centrifuged according to the Choukroun platelet-rich fibrin (PRF) technique<sup>5</sup> in order to recuperate the fibrin clots. The clots were compressed between two compresses to evacuate the serum and to form the membranes which were then applied to the surgical site and in the mandibular harvesting sites (Figs. 8 & 9).

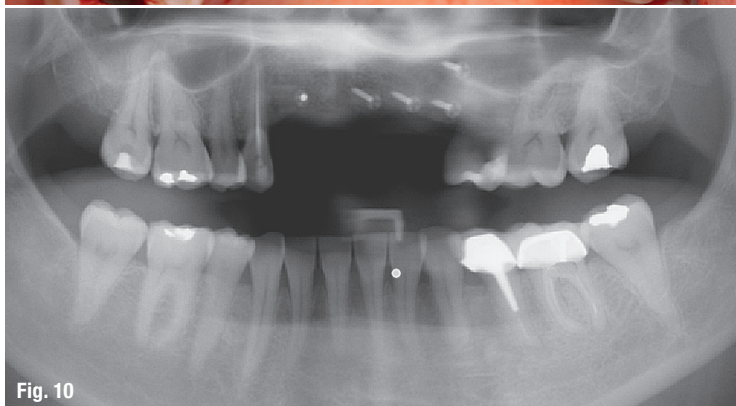
Fig. 10

After four months, according to radiographic examination, the tissue had healed and the bone mass appeared stable (Fig. 10). New impressions were taken to prepare for the next step in treatment: the implant drilling guide. After four months of healing, the increased vestibular bone volume allowed positioning the teeth at the crestal bone and reduction of the false gingiva using additional wax (Fig. 11). A key of the added wax was taken and fabricated in clear

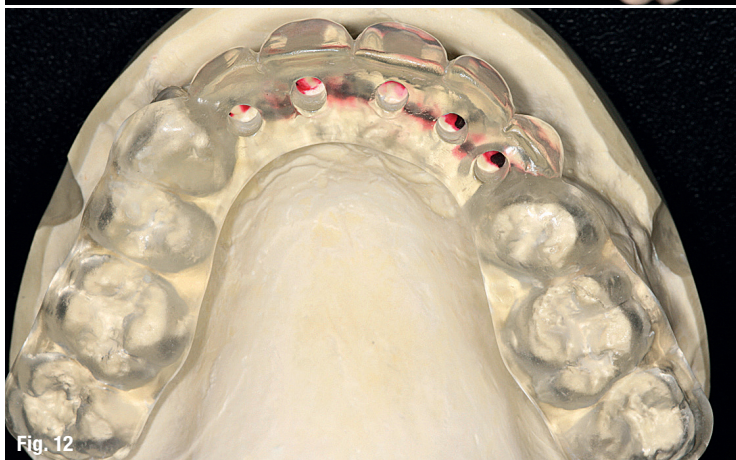
Fig. 12

casting resin. The implant positions were decided on and finalised by drilling placement holes, determining the exact position of the implants (Fig. 12). The correct positioning of implants in relation to the future prosthesis is an important prerequisite for aesthetic and functional success.

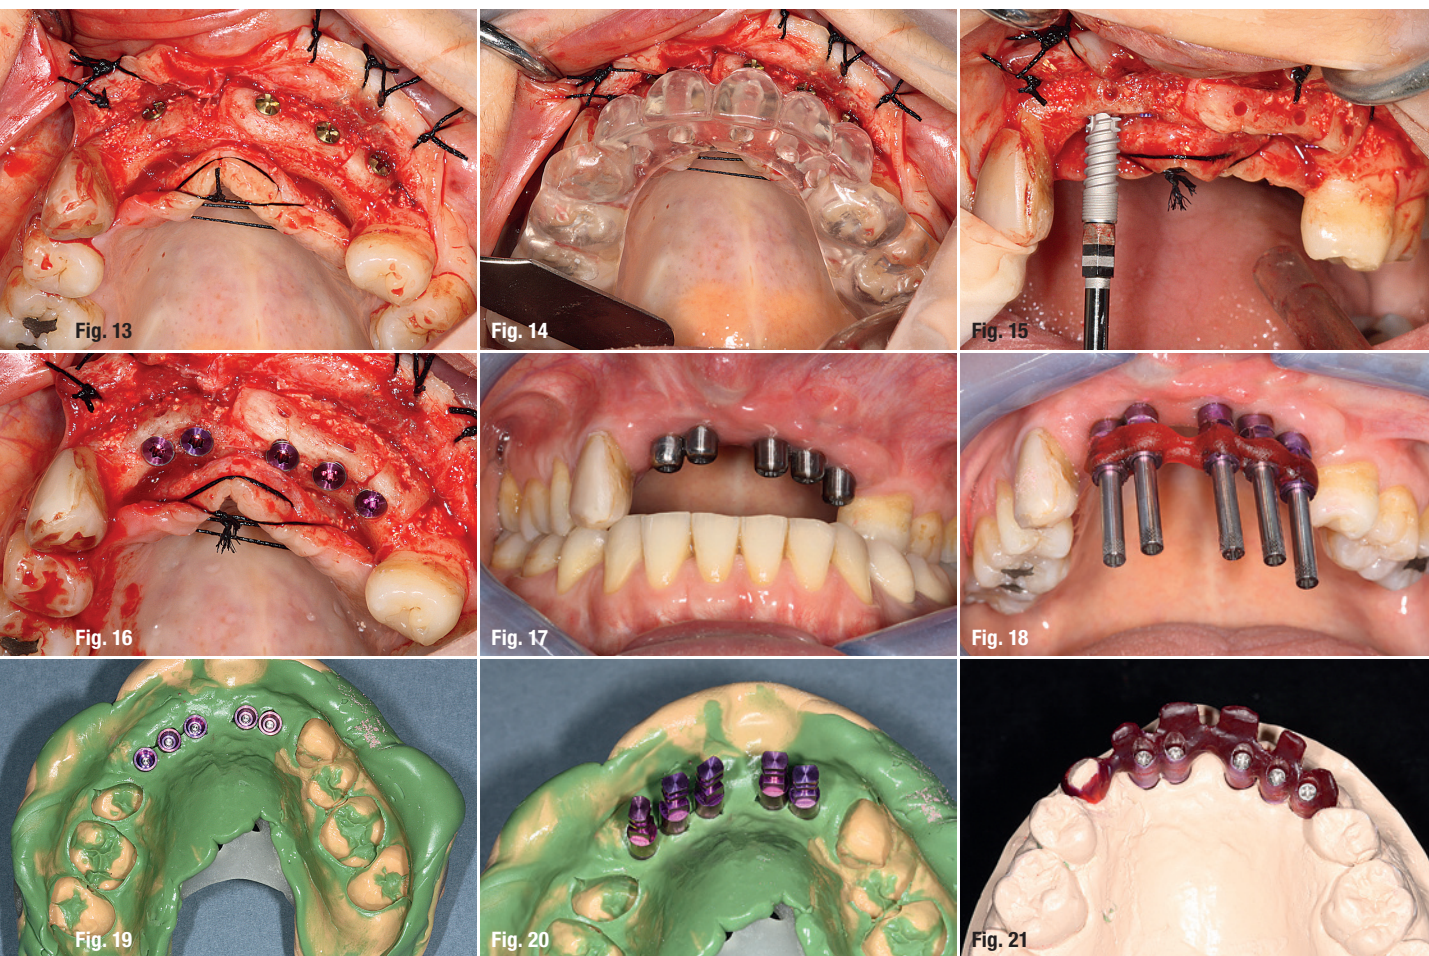
**Fig. 13:** The reopened site showing correct graft integration, a notable increase in cortical bone and excellent vascularity. **Fig. 14:** Testing of the sterilised surgical drilling guide proved drilling would be at the centre of the reconstructed bone ridge. **Fig. 15:** Aadvia self-tapping implants were placed. **Fig. 16:** All five implants equipped with threaded cover screws and the surrounding tissue sutured. **Fig. 17:** Loaded implants, healing abutments *in situ*. **Fig. 18:** The healing abutments were removed and replaced with pick-up impression copings secured with self-curing resin. **Figs. 19 & 20:** Removal of the impression and fitting of the impression copings with their laboratory equivalent. **Fig. 21:** Model of the framework, temporarily including the canine, cast in pattern resin.

Local anaesthesia was administered and the bone site reopened. The site showed correct integration of the grafts, a notable increase in cortical bone and excellent vascularity throughout the site (Fig. 13). The sterilised surgical drilling guide was tested and showed that drilling would in fact be at the centre of the reconstructed bone ridge (Fig. 14).

After removal of the screws stabilising the grafts, the guide was placed and drilling (using physiological saline solution) completed. Five Aadva (GC Tech.Europe) self-tapping Grade 5 titanium microstructure implants were inserted by slow drilling (Fig. 15). Aspiration with physiological saline solution was not used at this time so that the first contact with the titanium oxide would be the patient's blood, thus promoting the implants'

osseointegration. This specific implantation technique was validated by Brun et al.<sup>6</sup> All of the implants were equipped with threaded cover screws and the surrounding tissue was sutured (Fig. 16).

After four months, the implants were loaded using an apically positioned flap. The healing abutments were placed and the flap sutured around them (Fig. 17). Radiographic analysis and especially a percussion test showed the implants' perfect osseointegration. After 15 days of gingival healing around the abutments, they were removed and the impression copings were placed and secured with a self-curing resin (Fig. 18). Impressions were taken and the healing screws were reinserted (Figs. 19 & 20).

This prosthesis serves as a model for the final prosthesis. It is made with easily modifiable material like resin, but with a metal framework to guarantee a certain level of rigidity. In the first step, a model of the framework, which temporarily included the canine to increase stability, was cast in pattern resin (Fig. 21). The model was then scanned (Aadva, GC Tech.Europe; two cameras, 2 MP, precision: 10 µm) before being transferred to a machining centre (GM 1000, GC Tech.Europe; Figs. 22–24). Once back from the machining, the titanium framework was tested on the working model and its stability was verified (Figs. 25 & 26).

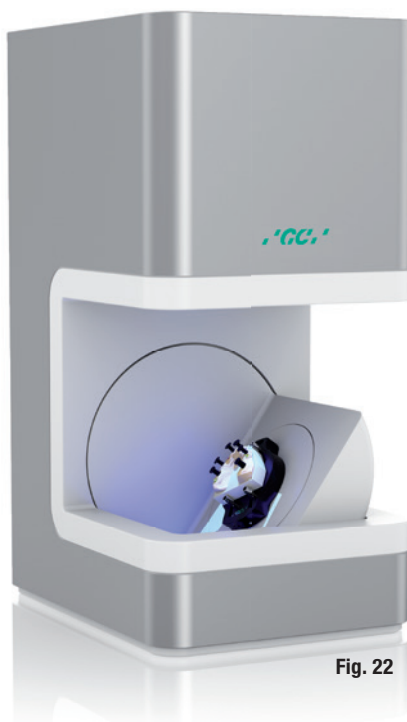
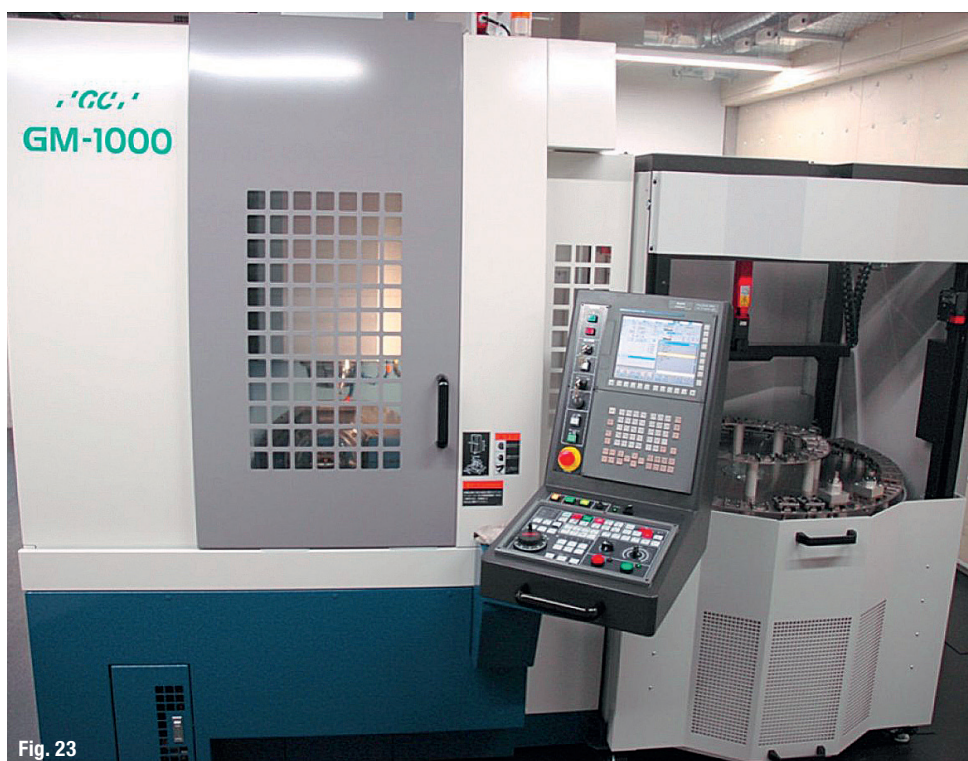
Fig. 22

**Figs. 22 & 23:** The model was scanned before being transferred to a machining centre. **Fig. 24:** After scanning, the computer prefiguration of the framework was validated. **Figs. 25 & 26:** Testing of the titanium framework on the working model and verification of stability.

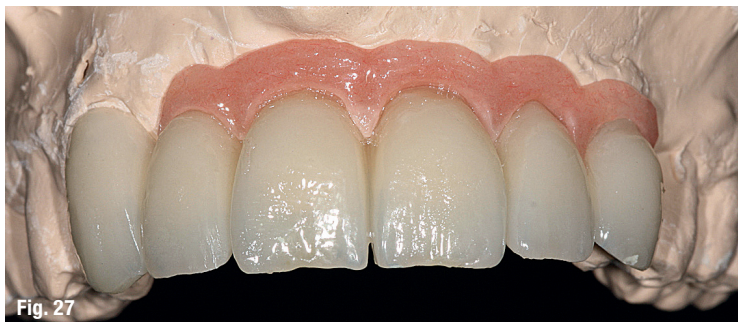
Fig. 27

**Fig. 27:** The cosmetic material placed onto the framework. **Figs. 28 & 29:** The prosthesis was attached with screws and the necessary occlusal verification was conducted. **Fig. 30:** The patient's smile showing now well-balanced incisors in line with the face's sagittal plane, lip support appearing to be correct. **Fig. 31:** Removal of the validation prosthesis and examination of the areas of compressed mucosa and difficult for dental hygiene. Reinstallation of validation prosthesis after correction.

The cosmetic material (UNIFAST III resin; surface rendering: OPTIGLAZE color, GC Tech.Europe) was then placed on the framework (Fig. 27). The bone graft permitted a maximum reduction of the vestibular false gingiva.

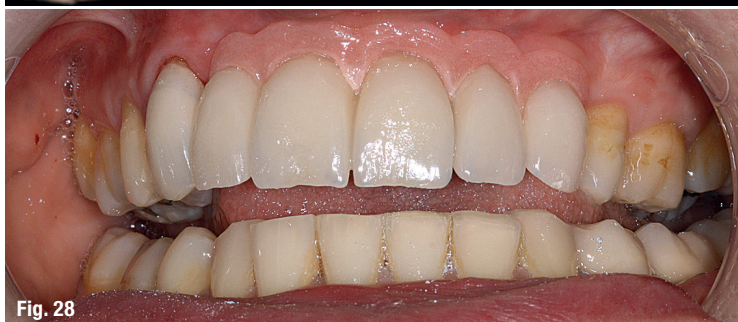
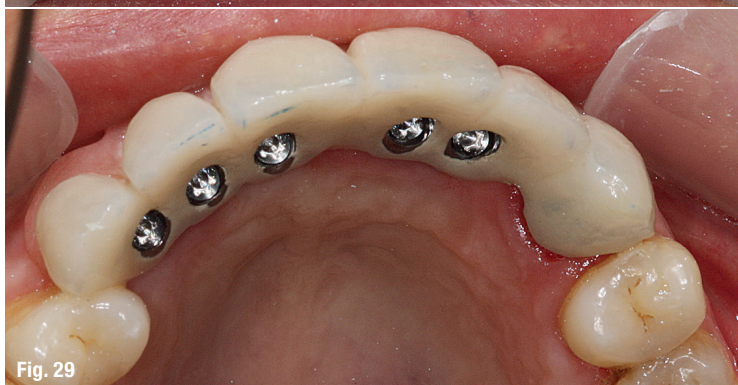
Fig. 28

In the following step, the prosthesis was attached in the mouth with screws and the necessary occlusal verification was conducted, including maximum intercuspation, protrusion and lateral excursion. The natural canine on the right was also equipped with a verification tooth. It should be noted, that in lateral excursion on the left, with the antagonist being the original tooth equipped with its periodontal ligament receptors, the canine function was retained; however the group function, which is usually preferred, was neurophysiologically inept (Figs. 28 & 29).

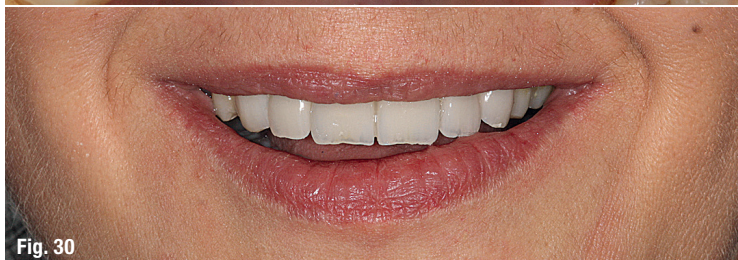
Fig. 30

The patient's smile showed that the incisors were now well balanced and in line with the face's sagittal plane. Lip support appeared to be correct and, as often is the case, this would all be validated by the patient's surrounding friends and family (Fig. 30).

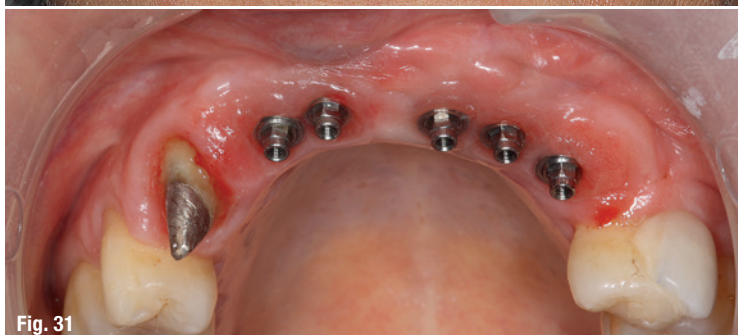
Fig. 31

After three months, the validation prosthesis was removed in order to examine the areas where mucosa had been compressed and dental hygiene difficult. These areas were corrected and the validation prosthesis reinstalled (Fig. 31).

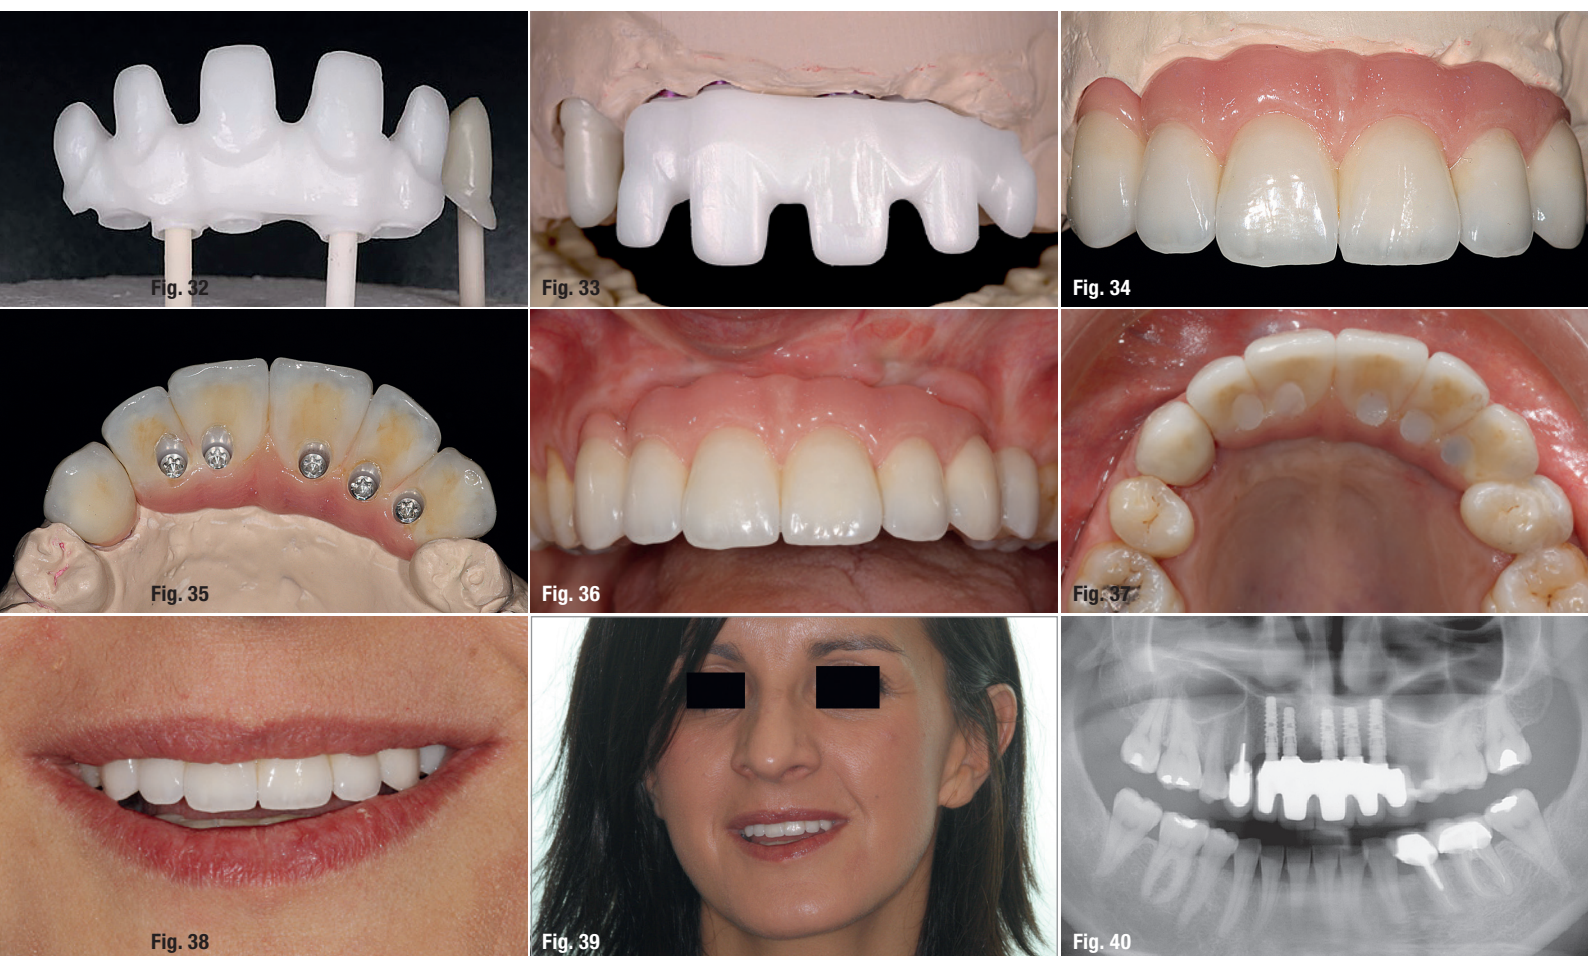
**Figs. 32 & 33:** Final prosthesis framework and the coping for the right canine tested on the working model. **Figs. 34 & 35:** After fitting of the zirconia framework, the ceramic was cast using the exact parameters validated by the resin prosthesis. **Figs. 36 & 37:** Installation of the final prosthesis and verification of correct occlusion. Screw channels filled with composite. **Figs. 38 & 39:** Final cosmetic check-up showing correct lip support with the new extremely reduced false gingiva. **Fig. 40:** Radiographic check-up after seven years.

As with the titanium validation prosthesis, the framework and the coping for the right canine were scanned and transmitted to the machining centre. They were then tested on the working model (Figs. 32 & 33). After fitting of the zirconia framework, the ceramic was cast using the exact parameters validated by the resin prosthesis (MB Dentaltechnik, Figs. 34 & 35).

In the following step, the final prosthesis was installed and the correct occlusion verified: maximum intercuspation, protrusion and lateral excursion. The screw channels were filled with composite (Figs. 36 & 37).

The final cosmetic check-up, validated by the resin prosthesis, showed the lip support with the new extremely reduced false gingiva to be correct (Figs. 38 & 39). This was achieved owing to the bone graft.

Retreatment was regularly monitored with patient check-ups (Fig. 40). All implant treatments, no matter of what type, must be rigorously monitored in all treatment phases, but a retreatment requires even more diligence. A patient affected by the failure of a previous treatment will not accept even the smallest problem. To this end, the role of healing periods is thus essential to retreatment success.
