# Implant **retreatment**

Dr Philippe Leclercq, France; Jean-François Martinez, France & Michael Brüh, Germany

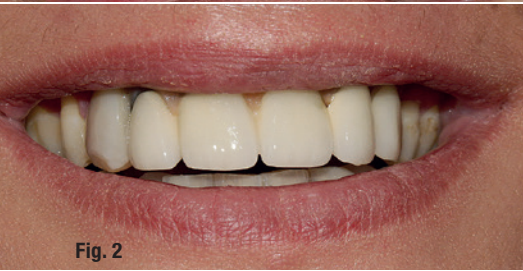
Fig. 1

**Figs. 1 & 2:** Initial prostheses: Lip support was ensured by a large false gingiva, and fractured cosmetic material at the right maxillary canine was evident. The patient's smile showed the prosthetic teeth placed off-centre and an infiltration at the right lateral incisal level. **Fig. 3:** Examination after three years revealed a negative short-term prognosis for the implants owing to significant recession at the right implant and hyperplastic tissue. **Fig. 4:** The framework was unscrewed, abutments removed and implants easily removed. **Fig. 5:** Implant removal site showing even greater deterioration in bone volume. **Figs. 6 & 7:** The grafts were harvested from the chin symphysis and firmly attached by surgical screws in the recipient site.

Dissatisfied with the treatment, the patient was re-examined three years after the initial treatment. The patient's smile showed an infiltration at the right lateral incisal level and that the prosthetic teeth were placed off-centre. The lip support, ensured by a large false gingiva, was correct. The cosmetic material of the right maxillary canine was fractured (Figs. 1 & 2).

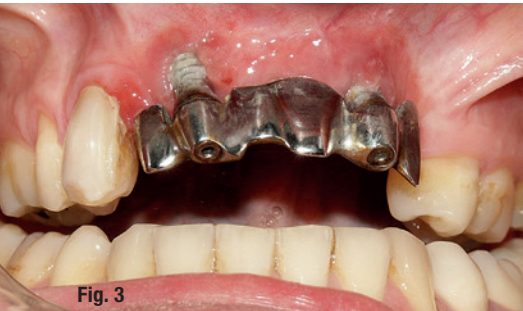
Fig. 3

Once the patient's prosthesis had been removed and an examination of the site conducted, an extremely negative prognosis was determined for the implants (Fig. 3), which is often the case with maxillary overdentures. The right implant showed a loss of the majority of its vestibular bone, causing significant recession. The tissue was hyperplastic, making hygiene difficult. The framework was off-centre presumably because of the implants, which explained the off-centre axis of the prosthetic teeth.

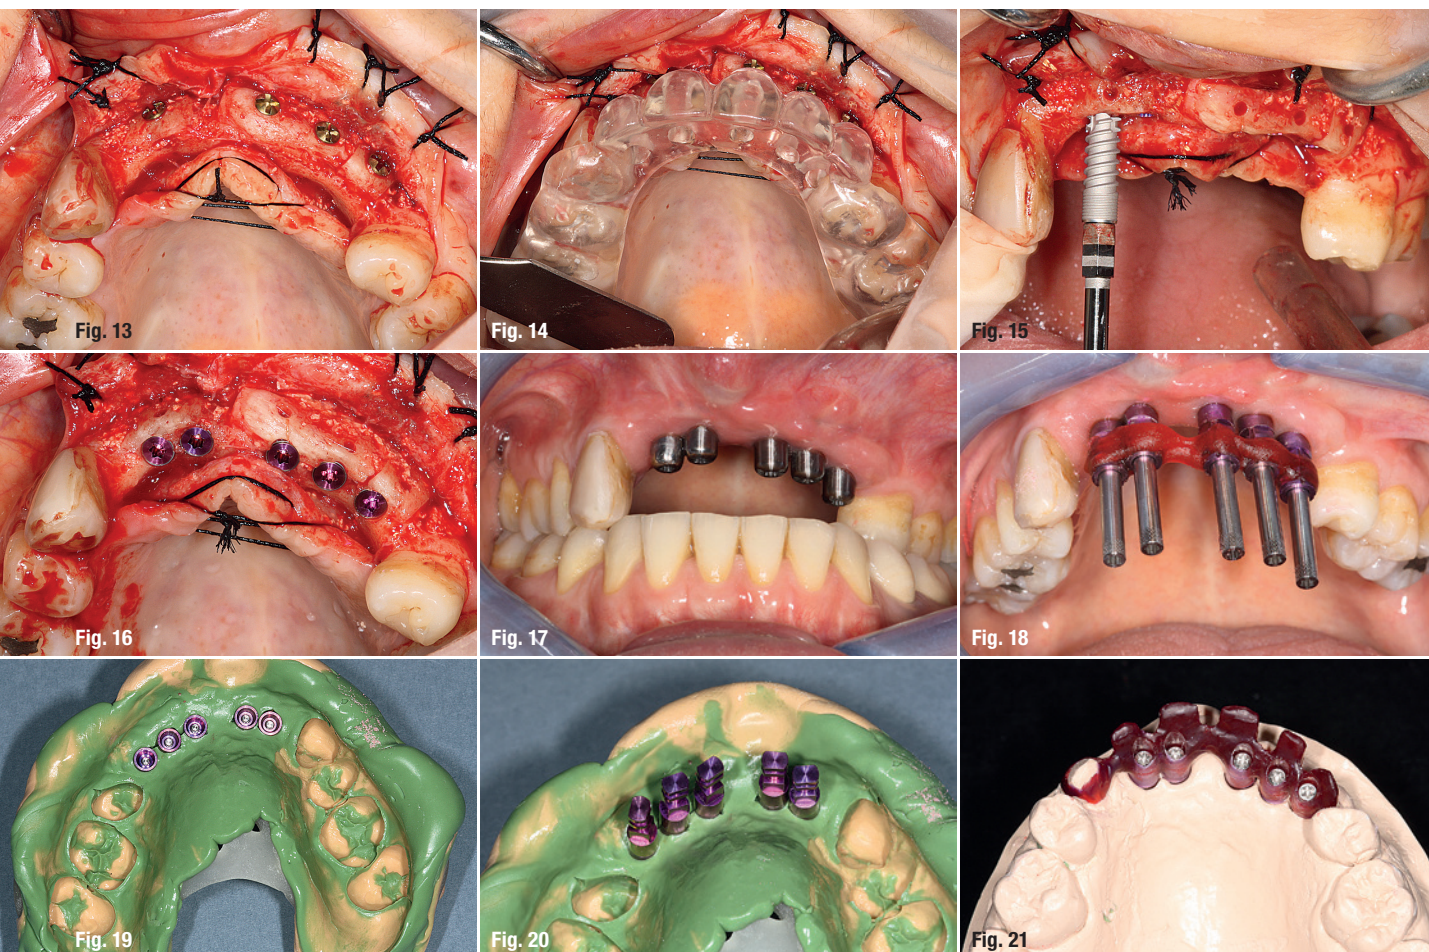
**Fig. 13:** The reopened site showing correct graft integration, a notable increase in cortical bone and excellent vascularity. **Fig. 14:** Testing of the sterilised surgical drilling guide proved drilling would be at the centre of the reconstructed bone ridge. **Fig. 15:** Aadv self-tapping implants were placed. **Fig. 16:** All five implants equipped with threaded cover screws and the surrounding tissue sutured. **Fig. 17:** Loaded implants, healing abutments *in situ*. **Fig. 18:** The healing abutments were removed and replaced with pick-up impression copings secured with self-curing resin. **Figs. 19 & 20:** Removal of the impression and fitting of the impression copings with their laboratory equivalent. **Fig. 21:** Model of the framework, temporarily including the canine, cast in pattern resin.

Local anaesthesia was administered and the bone site reopened. The site showed correct integration of the grafts, a notable increase in cortical bone and excellent vascularity throughout the site (Fig. 13). The sterilised surgical drilling guide was tested and showed that drilling would in fact be at the centre of the reconstructed bone ridge (Fig. 14).

After removal of the screws stabilising the grafts, the guide was placed and drilling (using physiological saline solution) completed. Five Aadva (GC Tech.Europe) self-tapping Grade 5 titanium microstructure implants were inserted by slow drilling (Fig. 15). Aspiration with physiological saline solution was not used at this time so that the first contact with the titanium oxide would be the patient's blood, thus promoting the implants'

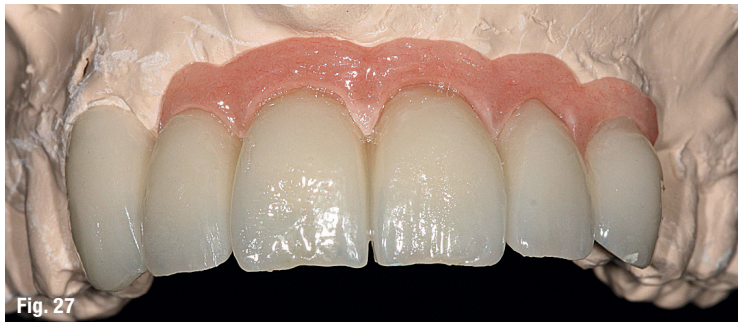
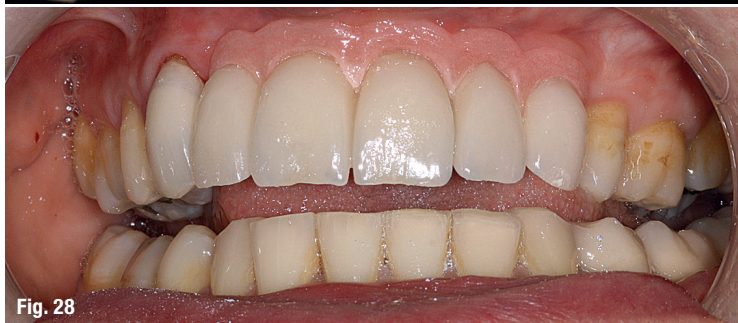
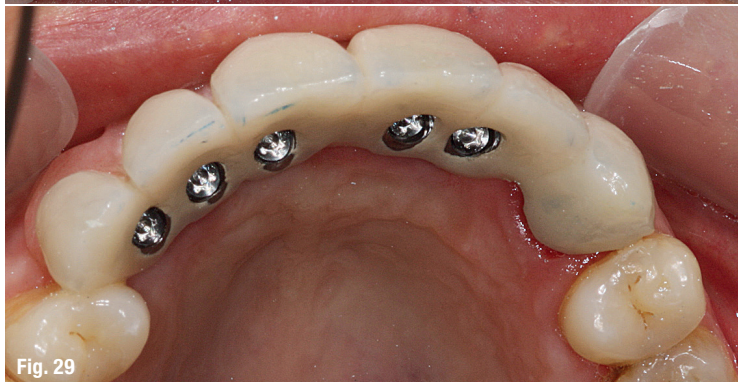
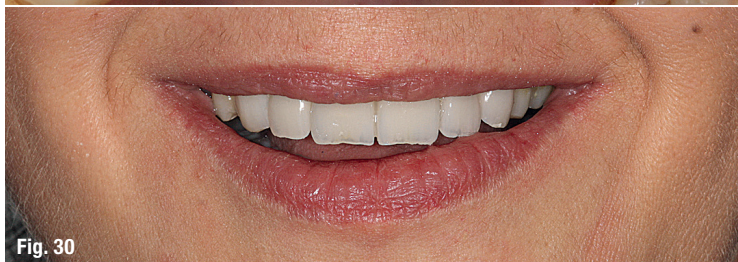
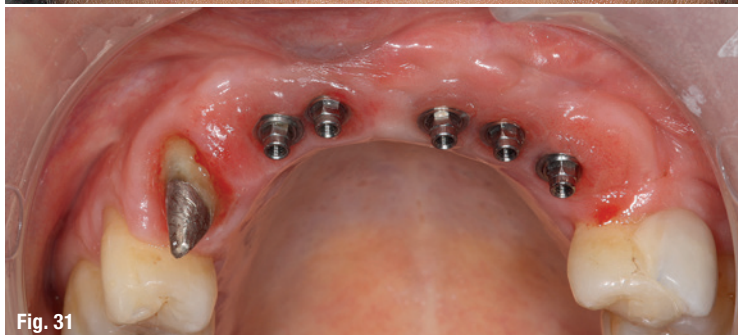
**Fig. 27:** The cosmetic material placed onto the framework. **Figs. 28 & 29:** The prosthesis was attached with screws and the necessary occlusal verification was conducted. **Fig. 30:** The patient's smile showing now well-balanced incisors in line with the face's sagittal plane, lip support appearing to be correct. **Fig. 31:** Removal of the validation prosthesis and examination of the areas of compressed mucosa and difficult for dental hygiene. Reinstallation of validation prosthesis after correction.

The cosmetic material (UNIFAST III resin; surface rendering: OPTIGLAZE color, GC Tech.Europe) was then placed on the framework (Fig. 27). The bone graft permitted a maximum reduction of the vestibular false gingiva.

In the following step, the prosthesis was attached in the mouth with screws and the necessary occlusal verification was conducted, including maximum intercuspation, protrusion and lateral excursion. The natural canine on the right was also equipped with a verification tooth. It should be noted, that in lateral excursion on the left, with the antagonist being the original tooth equipped with its periodontal ligament receptors, the canine function was retained; however the group function, which is usually preferred, was neurophysiologically inept (Figs. 28 & 29).

The patient's smile showed that the incisors were now well balanced and in line with the face's sagittal plane. Lip support appeared to be correct and, as often is the case, this would all be validated by the patient's surrounding friends and family (Fig. 30).

After three months, the validation prosthesis was removed in order to examine the areas where mucosa had been compressed and dental hygiene difficult. These areas were corrected and the validation prosthesis reinstalled (Fig. 31).
