# Implant retreatment

Dr Philippe Leclercq, France; Jean-François Martinez, France & Michael Brüh, Germany

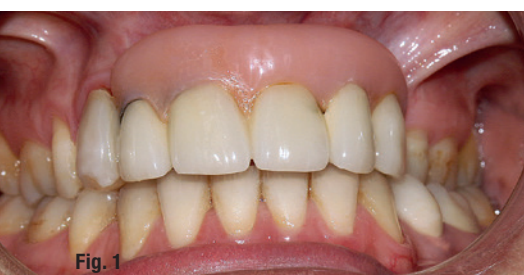
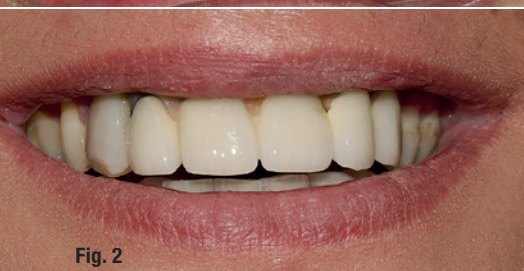
Fig. 1

**Figs. 1 & 2:** Initial prostheses: Lip support was ensured by a large false gingiva, and fractured cosmetic material at the right maxillary canine was evident. The patient's smile showed the prosthetic teeth placed off-centre and an infiltration at the right lateral incisal level. **Fig. 3:** Examination after three years revealed a negative short-term prognosis for the implants owing to significant recession at the right implant and hyperplastic tissue. **Fig. 4:** The framework was unscrewed, abutments removed and implants easily removed. **Fig. 5:** Implant removal site showing even greater deterioration in bone volume. **Figs. 6 & 7:** The grafts were harvested from the chin symphysis and firmly attached by surgical screws in the recipient site.

Dissatisfied with the treatment, the patient was re-examined three years after the initial treatment. The patient's smile showed an infiltration at the right lateral incisal level and that the prosthetic teeth were placed off-centre. The lip support, ensured by a large false gingiva, was correct. The cosmetic material of the right maxillary canine was fractured (Figs. 1 & 2).

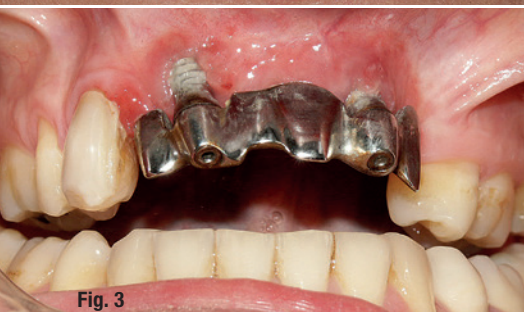
Fig. 3

Once the patient's prosthesis had been removed and an examination of the site conducted, an extremely negative prognosis was determined for the implants (Fig. 3), which is often the case with maxillary overdentures. The right implant showed a loss of the majority of its vestibular bone, causing significant recession. The tissue was hyperplastic, making hygiene difficult. The framework was off-centre presumably because of the implants, which explained the off-centre axis of the prosthetic teeth.

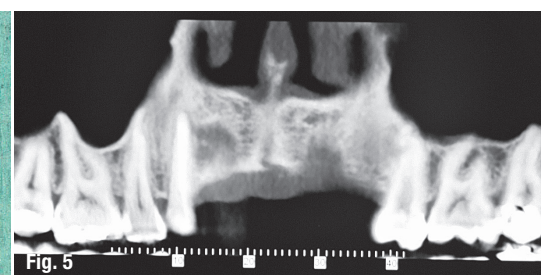
Fig. 5

Three months after implant removal, a clinical and radiographic assessment was conducted. The assessment showed further significant vertical bone loss and loss in bone volume (Fig. 5). Significant vertical bone loss is difficult to correct owing to random gingival recovery. It was thus decided to augment the bone volume by performing a chin bone graft.

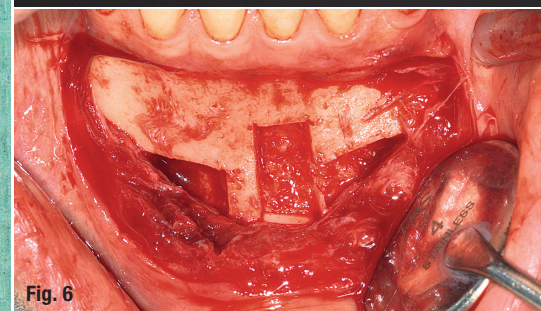
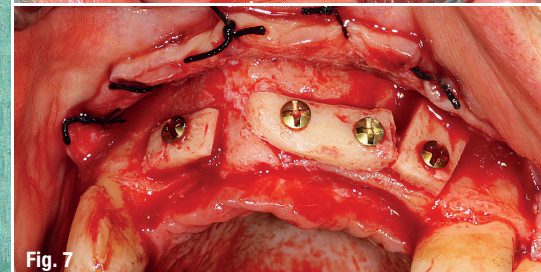
Fig. 6

Anaesthetic was administered in the maxillary and mandibular anterior region. For the mandible, the sample was taken from the cortical bone and a section of the cancellous bone by piezoelectric surgery. The grafts were harvested from the chin symphysis, as close as possible to the mandibular inferior ridge to avoid disturbing the incisor's sensitive innervation, which can be a frequent complication of the procedure. The vestibular cortical bone scar was perforated with a small round bur, allowing for rapid revascularisation of the grafts. The

grafts were then positioned and secured in place with mini-screws (Figs. 6 & 7).

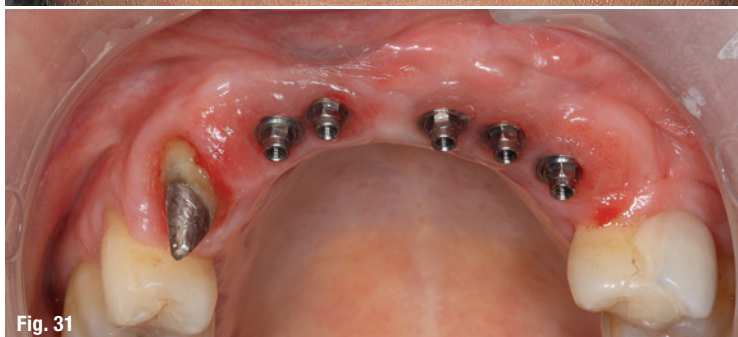
Fig. 31

**Fig. 27:** The cosmetic material placed onto the framework. **Figs. 28 & 29:** The prosthesis was attached with screws and the necessary occlusal verification was conducted. **Fig. 30:** The patient's smile showing now well-balanced incisors in line with the face's sagittal plane, lip support appearing to be correct. **Fig. 31:** Removal of the validation prosthesis and examination of the areas of compressed mucosa and difficult for dental hygiene. Reinstallation of validation prosthesis after correction.

After three months, the validation prosthesis was removed in order to examine the areas where mucosa had been compressed and dental hygiene difficult. These areas were corrected and the validation prosthesis reinstalled (Fig. 31).
