Implant **retreatment**

Dr Philippe Leclercq, France; Jean-François Martinez, France & Michael Brüh, Germany

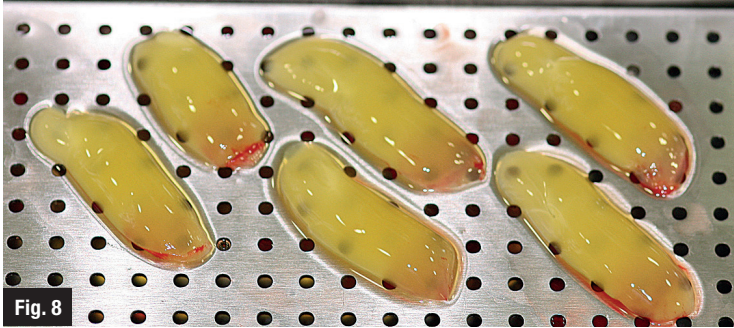
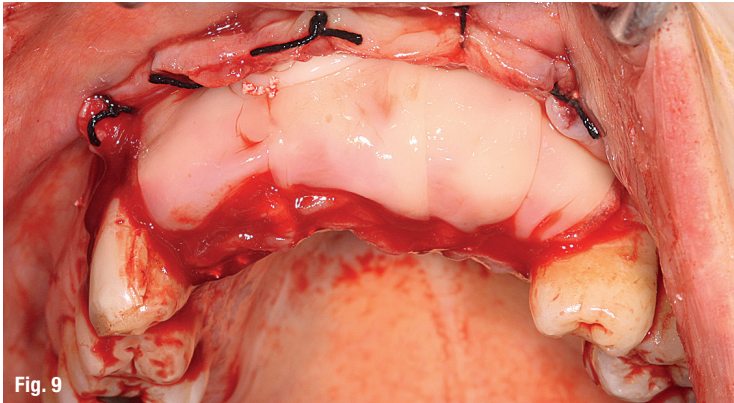
Figs. 8 & 9: The properly compressed PRF membranes permitted complete coverage of the surgical site, in this instance on the maxilla. **Fig. 10:** Panoramic radiograph showing the grafts to be correctly healed and satisfactorily adhered to the recipient bone sites. **Fig. 11:** Increased vestibular bone volume allowed positioning of the teeth at the crestal bone level and reduction of the false gingiva. **Fig. 12:** A key of the added wax was taken and fabricated in clear casting resin.

To increase success, a blood sample was taken and centrifuged according to the Choukroun platelet-rich fibrin (PRF) technique⁵ in order to recuperate the fibrin clots. The clots were compressed between two compresses to evacuate the serum and to form the membranes which were then applied to the surgical site and in the mandibular harvesting sites (Figs. 8 & 9).

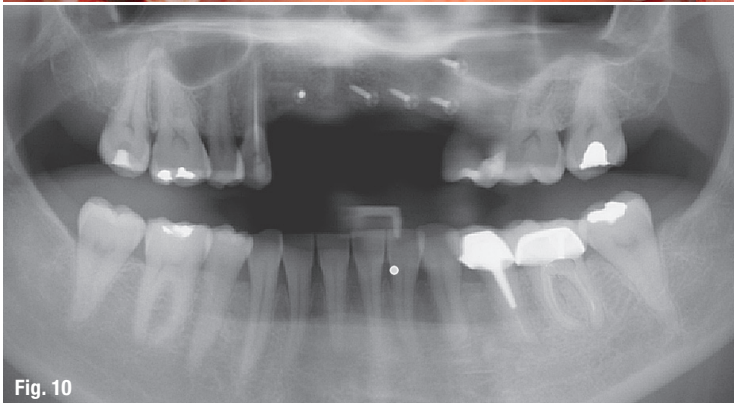
Fig. 10

After four months, according to radiographic examination, the tissue had healed and the bone mass appeared stable (Fig. 10). New impressions were taken to prepare for the next step in treatment: the implant drilling guide. After four months of healing, the increased vestibular bone volume allowed positioning the teeth at the crestal bone and reduction of the false gingiva using additional wax (Fig. 11). A key of the added wax was taken and fabricated in clear

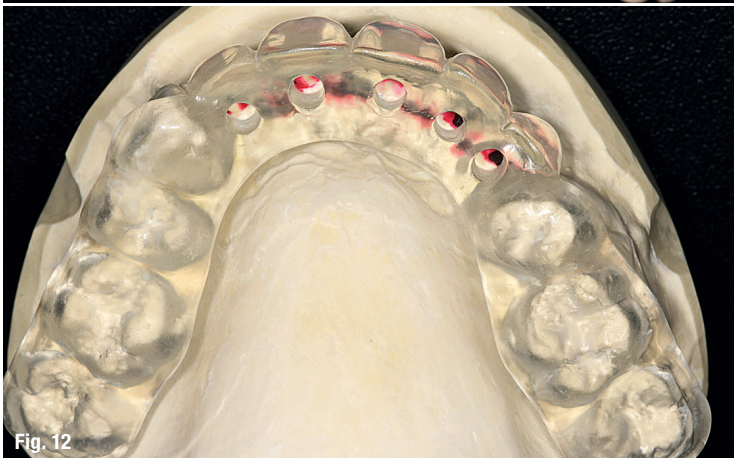
Fig. 12

casting resin. The implant positions were decided on and finalised by drilling placement holes, determining the exact position of the implants (Fig. 12). The correct positioning of implants in relation to the future prosthesis is an important prerequisite for aesthetic and functional success.

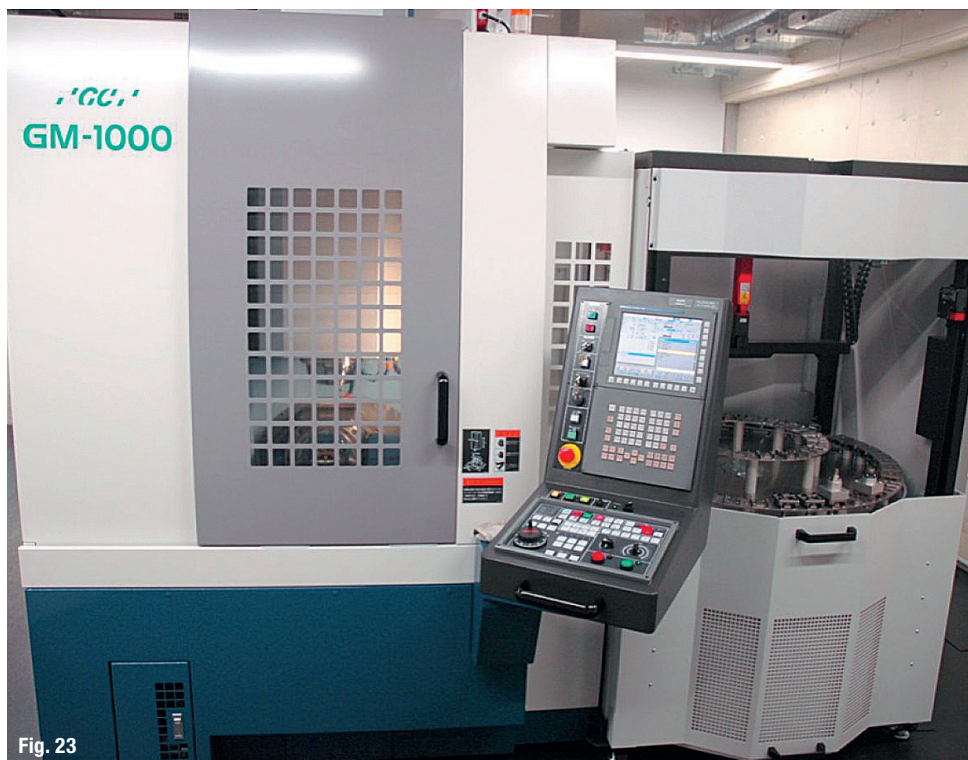
Figs. 22 & 23: The model was scanned before being transferred to a machining centre. **Fig. 24:** After scanning, the computer prefiguration of the framework was validated. **Figs. 25 & 26:** Testing of the titanium framework on the working model and verification of stability.

This prosthesis serves as a model for the final prosthesis. It is made with easily modifiable material like resin, but with a metal framework to guarantee a certain level of rigidity. In the first step, a model of the framework, which temporarily included the canine to increase stability, was cast in pattern resin (Fig. 21). The model was then scanned (Aadva, GC Tech.Europe; two cameras, 2 MP, precision: 10 µm) before being transferred to a machining centre (GM 1000, GC Tech.Europe; Figs. 22–24). Once back from the machining, the titanium framework was tested on the working model and its stability was verified (Figs. 25 & 26).
