# Peri-apical microsurgery for removal of a fractured endodontic instrument

Author\_ Dr Leandro A. P. Pereira, Brazil

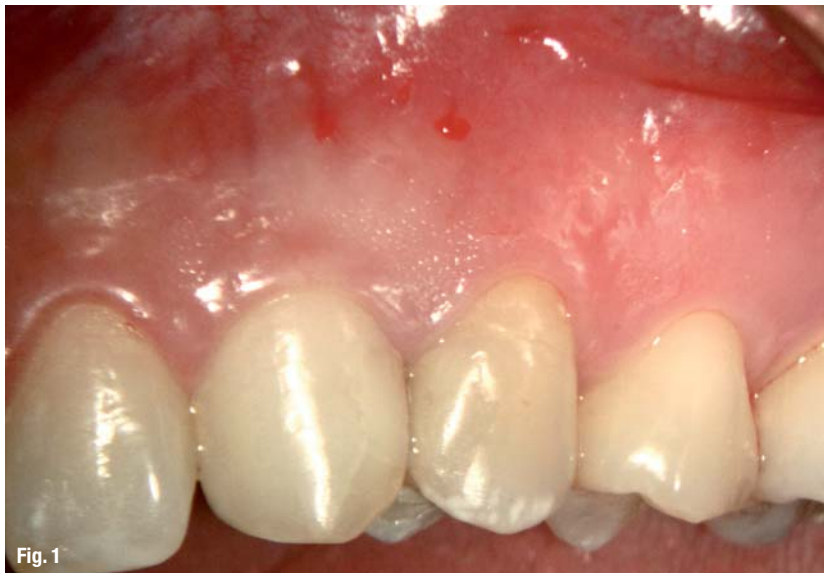
Fig. 1

Fig. 1\_Initial clinical aspect.

She reported having undergone endodontic treatment in tooth #24 more than six years ago. In the peri-apical radiographic examination, it was possible to visualise deficient endodontic treatment and the presence of apical bone rarefaction (Figs. 1 & 2). An acute peri-apical abscess was diagnosed.

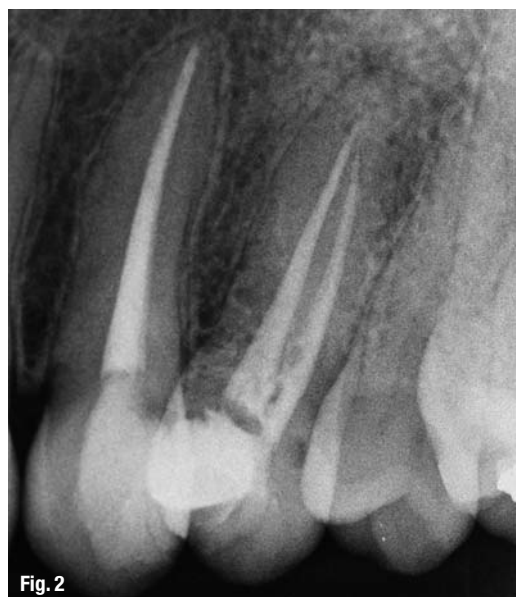
Fig. 2

Fig. 2\_Initial X-ray.

A full thickness flap was made with a semilunar incision. Selection of this type of incision was determined by the absence of a large, radiographically visible bone defect (Fig. 2) and for aesthetic reasons. This type of incision does not carry the risk of post-operative gingival recession.

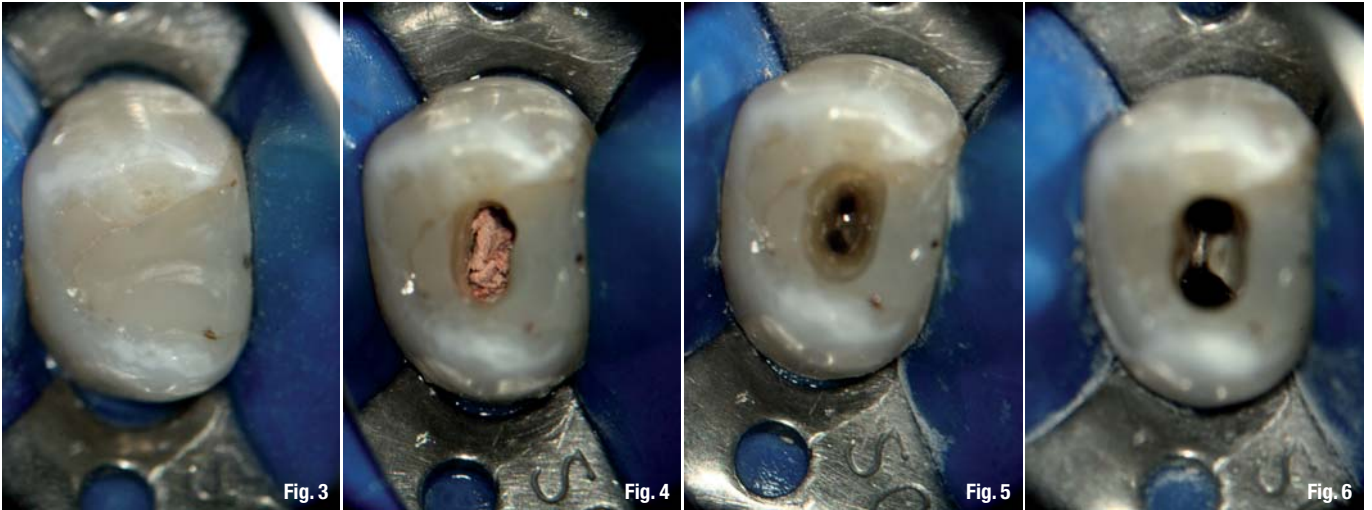
**Fig. 3** \_Initial occlusal clinical aspect.  
**Fig. 4** \_Gutta-percha removal without solvents.  
**Fig. 5** \_2.5% NaOCl.  
**Fig. 6** \_After shaping.

restoration, using ultrasonic diamond inserts (CR1, CVDentus; Fig. 3).<sup>11</sup> Filling was removed from the root canals with the use of ultrasound and type K hand files, without the use of solvents (Fig. 4). As auxiliary chemical substances, 2.5% NaOCl (Figs. 5 & 6), ENDO-PTC and 17% EDTA-T were used.

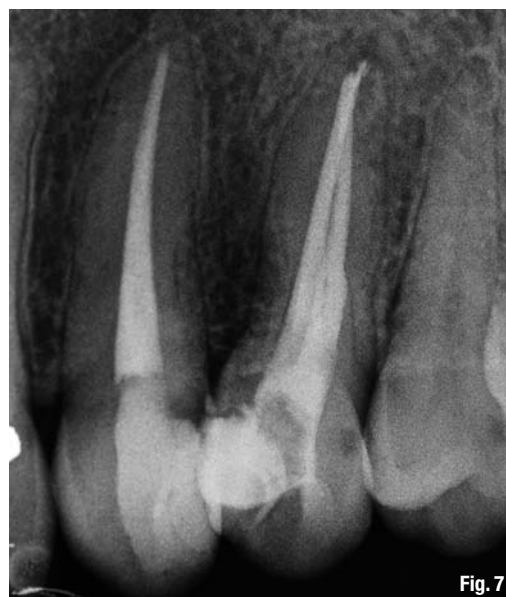
**Fig. 7** \_After filling, with broken file still in place, and before micro-surgery.

For the complete resolution of infection, the root canals were filled (Fig. 7) and after this, piezoelectric peri-apical microsurgery was performed to resect the apical third of the root.

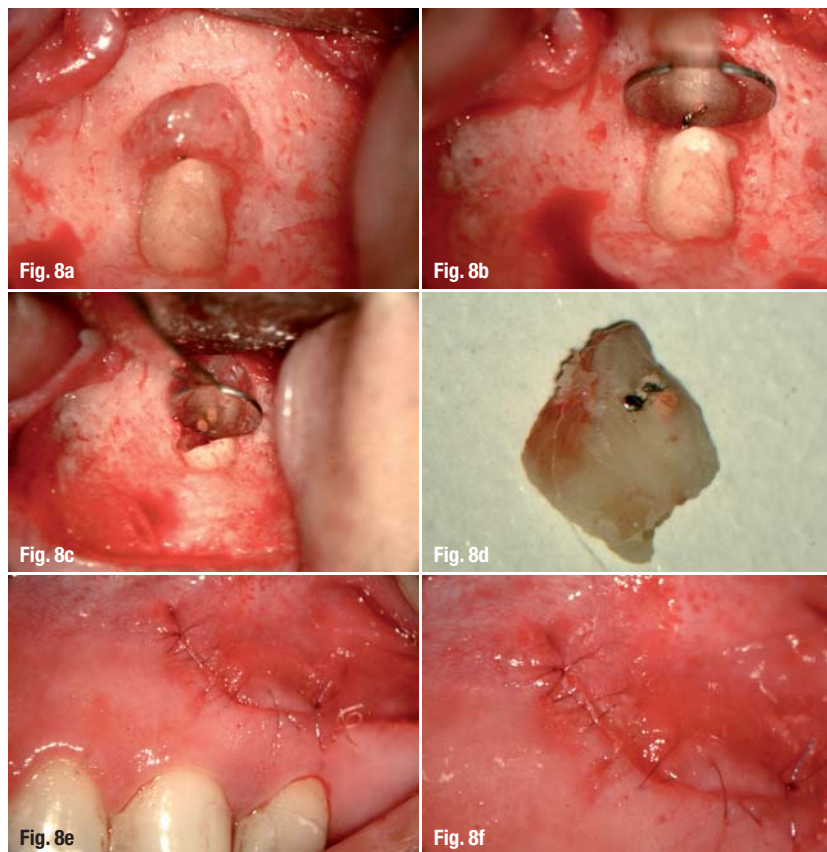
**Fig. 8a** \_Broken file, surgical view.

**Fig. 8b** \_Broken file, micro-mirror view.

**Fig. 8c** \_Retro view of obturation.

**Figs. 8d** \_Apical fragment.

**Figs. 8e** \_Vicryl 8-0 sutures (operating microscope at 12.5x magnification).

**Fig. 8f** \_Sutures (20x).

There are technical and biological advantages to osteotomy performed using ultrasound when compared to the use of high or low speed burs. Ultrasound has a highly selective tissue cutting ability. Its action occurs only on mineralised tissues such as bone and tooth, preserving soft tissues such as nerves, vessels and mucosae. During osteotomy, the amplitude of the micro-movements generated by the ultrasonic insert ranged between 60 and 210 µm, making the hard-tissue cut extremely precise. This is associated with the formation of acoustic micro-stream and cavitation in the operative field, which promote a clean field, as observed in Figures 8a to c.<sup>13-20</sup>

The fractured instrument was removed together with the apical root third in the apicectomy (Fig. 8d). The apical root cut was performed at an angle of 90° to the long axis of the root, in order to expose the smallest quantity of dentinal tubules and preserve the most root extension, favouring microbiological control and function of the dental remainder.<sup>21</sup>

The quality of the remainder of the root filling was evaluated by introducing a micro-mirror into the apical bone recess and reviewing the remainder of the root filling, which was considered satisfactory because it filled the root canals uniformly (Fig. 8c).

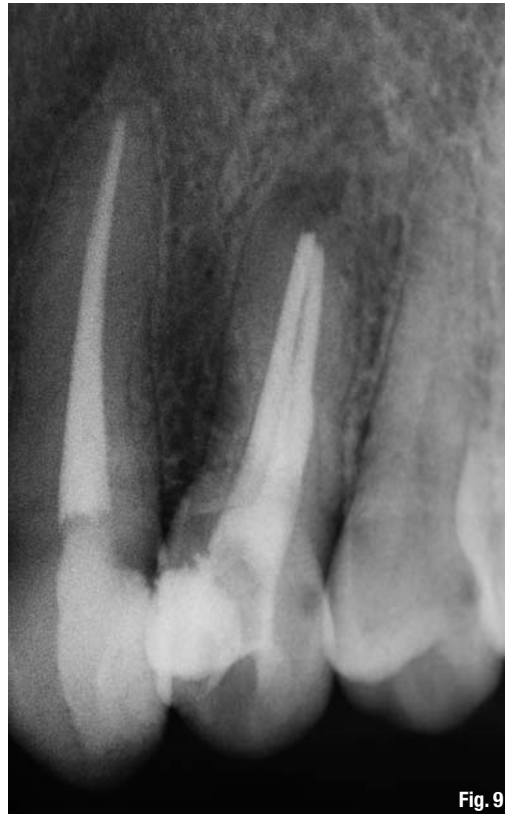
Fig. 9 Post-op X-ray.

The sutures were made with the aid of the operating microscope. Two simple stitches with Vicryl 6-0 thread were made to stabilise the flap, and another continuous stitch was made with Vicryl 9-0 thread to coapt the edges (Fig. 9).
