Peri-apical microsurgery for removal of a fractured endodontic instrument

Author_ Dr Leandro A. P. Pereira, Brazil

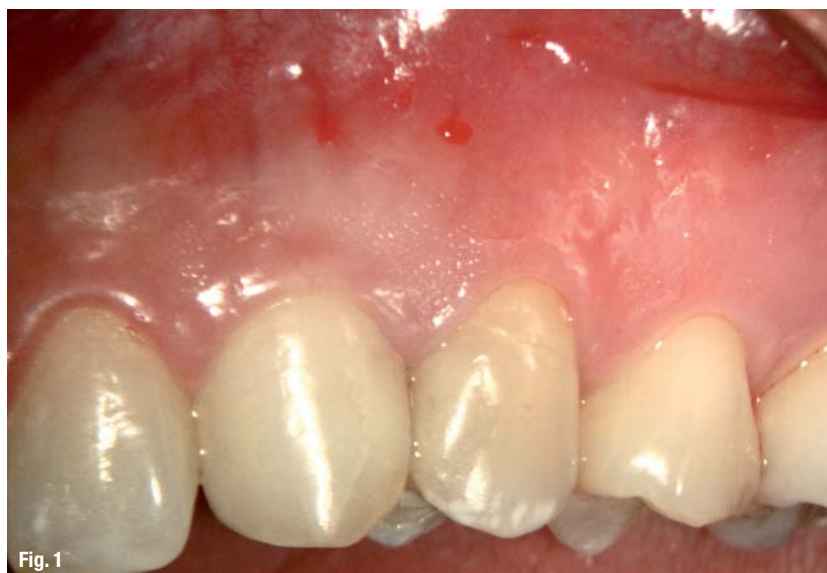
Fig. 1

Fig. 1_Initial clinical aspect.

She reported having undergone endodontic treatment in tooth #24 more than six years ago. In the peri-apical radiographic examination, it was possible to visualise deficient endodontic treatment and the presence of apical bone rarefaction (Figs. 1 & 2). An acute peri-apical abscess was diagnosed.

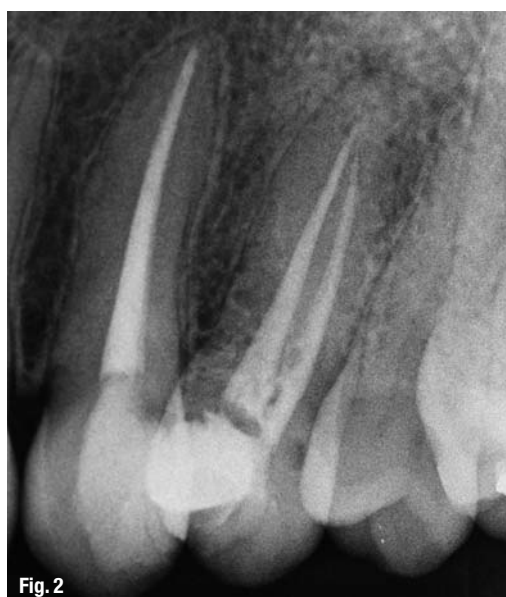
Fig. 2

Fig. 2_Initial X-ray.

A full thickness flap was made with a semilunar incision. Selection of this type of incision was determined by the absence of a large, radiographically visible bone defect (Fig. 2) and for aesthetic reasons. This type of incision does not carry the risk of post-operative gingival recession.
