Peri-apical microsurgery for removal of a fractured endodontic instrument

Author_ Dr Leandro A. P. Pereira, Brazil

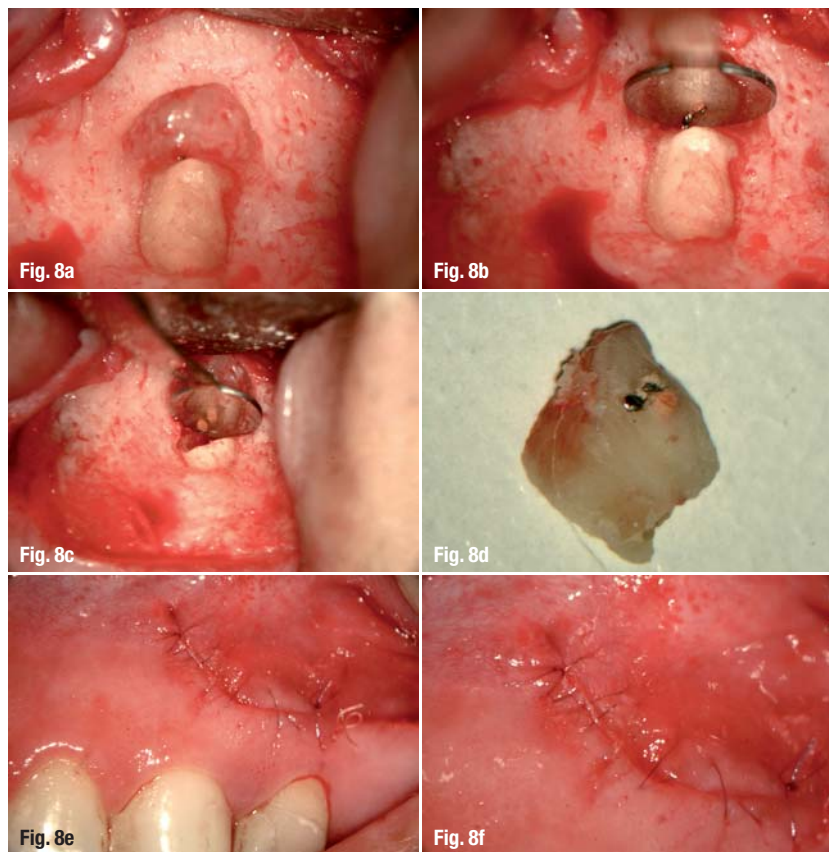
Fig. 8a _Broken file, surgical view.
Fig. 8b _Broken file, micro-mirror view.
Fig. 8c _Retro view of obturation.
Figs. 8d _Apical fragment.
Figs. 8e _Vicryl 8-0 sutures (operating microscope at 12.5x magnification).
Fig. 8f _Sutures (20x).

The fractured instrument was removed together with the apical root third in the apicectomy (Fig. 8d). The apical root cut was performed at an angle of 90° to the long axis of the root, in order to expose the smallest quantity of dentinal tubules and preserve the most root extension, favouring microbiological control and function of the dental remainder.²¹

The quality of the remainder of the root filling was evaluated by introducing a micro-mirror into the apical bone recess and reviewing the remainder of the root filling, which was considered satisfactory because it filled the root canals uniformly (Fig. 8c).

There are technical and biological advantages to osteotomy performed using ultrasound when compared to the use of high or low speed burs. Ultrasound has a highly selective tissue cutting ability. Its action occurs only on mineralised tissues such as bone and tooth, preserving soft tissues such as nerves, vessels and mucosae. During osteotomy, the amplitude of the micro-movements generated by the ultrasonic insert ranged between 60 and 210 µm, making the hard-tissue cut extremely precise. This is associated with the formation of acoustic micro-stream and cavitation in the operative field, which promote a clean field, as observed in Figures 8a to c.¹³⁻²⁰
