# Immediate implant placement and temporisation in the aesthetic zone

Author\_ Dr Phillip J. Friel, Great Britain

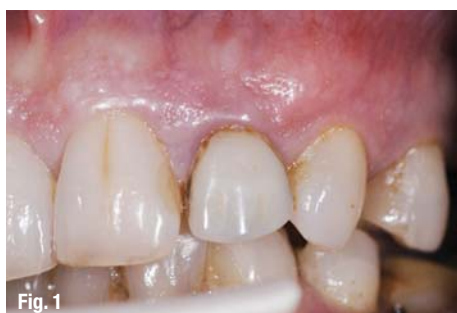
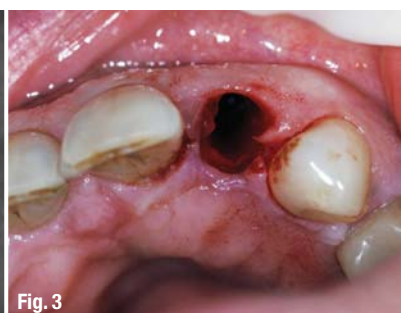
Following atraumatic tooth removal, the socket was thoroughly irrigated, debrided and fully assessed (Fig. 3). The socket was found to be intact, stable and formed from solid bone. The
