Removal of a fractured instrument: Two case reports

Author_ Dr Rafaël Michiels, Belgium

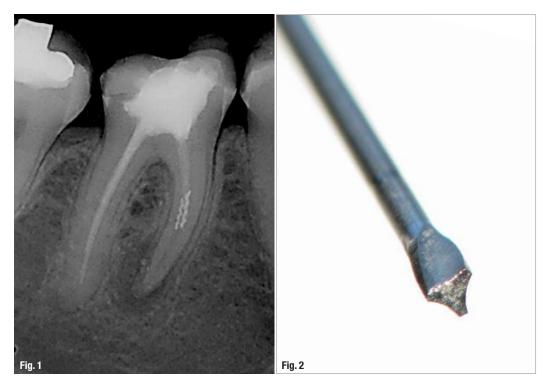
Fig. 1_Diagnostic radiograph, showing two separated instruments in the mesial root. Fig. 2_A modified Gates-Glidden bur used for creating a plateau above the instrument.

nostic radiograph (Fig. 1) showed not one but two broken instruments in the mesial root, one in each mesial canal. Thereafter, the tooth was isolated with the rubber dam and the coronal filling was removed. Straight-line access was established, as this is imperative in order to be able to reach and see the fractured instruments. Gates-Glidden burs (DENTSPLY Maillefer) were used to enlarge the mesial orifices coronally.

After reaching the instrument in the mesio-buccal canal, I modified a size 3 Gates-Glidden bur by removing the tip of the bur (Fig. 2). In this manner, one gains an aggressive bur that allows one to create a platform above the instrument. At this moment, the instrument could be clearly visualised (Fig. 3). Ultrasonics were then used to loosen the fragment. ProUltra tips (DENTSPLY Maillefer), both zirconium nitride and titanium, were used for this purpose.

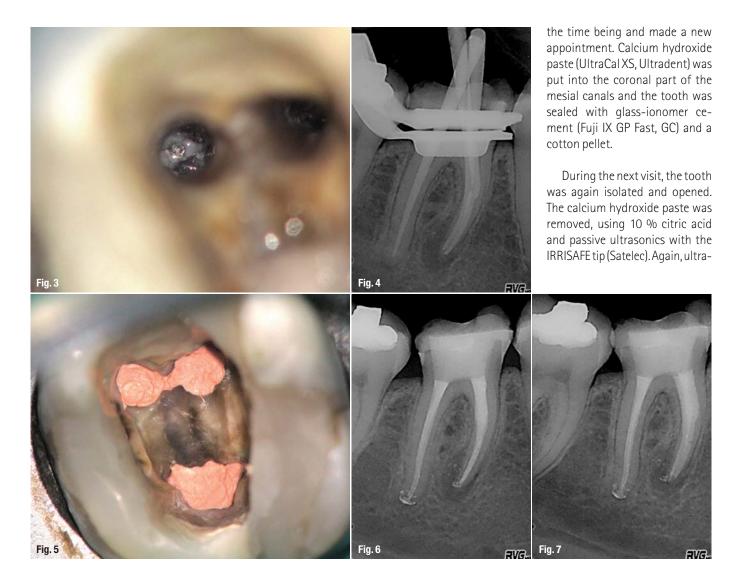
Fig. 3_One of the separated instruments.
Fig. 4_Gutta-percha cone fitting.
Fig. 5_The pulp chamber after obturation with gutta-percha.
Fig. 6_Final radiograph (parallel).
Fig. 7_Final radiograph (angled).

scraped with Micro-Debriders (DENTSPLY Maillefer) in order to remove the last remnants of gutta-percha. All canals were shaped to a size 40.06 ProFile. Final apical shaping was performed with K-Flexofiles (DENTSPLY Maillefer). Smear-layer removal was carried out by irrigating the canal with 10% citric acid. A final wash of the canal was performed with sterile saline. Tapered gutta-percha cones were then fitted (Fig. 4) and tug-back was confirmed. Topseal (DENTSPLY Maillefer) was used as a rootcanal sealer.

obturation (Fig. 5), a temporary restoration of glassionomer cement was placed (Fuji IX GP Fast). Final radiographs (Figs. 6 & 7) were taken, both parallel and angled. The radiographs show two completely separated mesial canals; hence, instrument removal in both canals was favourable. The prognosis of this case was good and the patient was referred to her general dentist for a definitive coronal restoration.

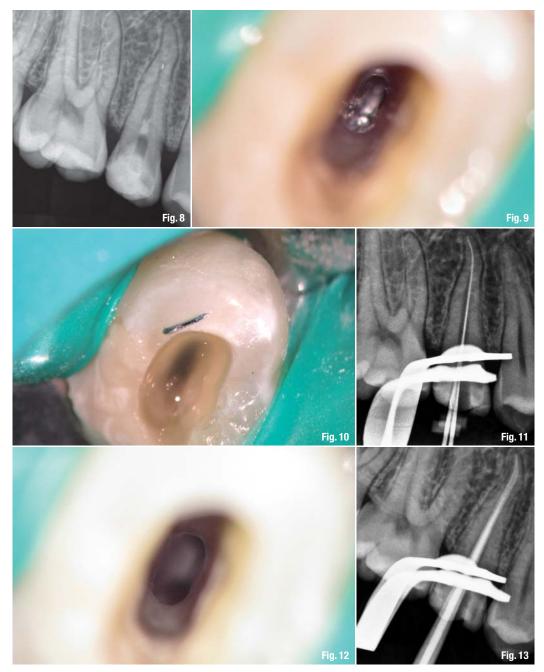
Fig. 8_Diagnostic radiograph, showing the separated instrument at approx. 5 mm from the apex. Fig. 9_The separated instrument. Fig. 10_The separated file after retrieval.

Fig. 11_Working length determination. Fig. 12_Deep apical split.

Fig. 13_Gutta-percha cone fitting.

A new diagnostic radiograph (Fig. 8) was taken, which showed the fragment approx. 5 mm from the apex. The tooth was isolated with a rubber dam and access was gained through the temporary restoration, which was placed by the referring dentist.

After opening, the remnants of calcium hydroxide paste were removed with 10% citric acid and passive ultrasonics. The fractured instrument could be visualised immediately (Fig. 9), because the canal was very large in the middle and coronal part. This allowed a very conservative and tissue-saving approach. Given the position in the canal and the shape of the canal, a deep apical split of the canal was suspected. After probing with small K-files, a patent palatal was confirmed.

The fractured instrument was retrieved (Fig. 10) and after determining working length (Fig. 11), shaping with rotary nickel-titanium instruments (Twisted Files, SybronEndo) was started. Both canals were shaped to a size 25.08 Twisted File. The master apical file was kept small due to the deep split (Fig. 12) and the tension felt while shaping, thus minimising new instrument fracture. Apical finishing was carried out with size 25 K-flexofiles. Smear-layer removal was performed with a rinse of 10 % citric acid. A final wash of the canal was carried out with sterile saline. Tapered gutta-percha cones were then fitted and tug-back was confirmed (Fig. 13). Topseal was used as a root-canal sealer. Both canals were obturated according to the continuous wave of condensation technique with the Elements Obturation Unit. After obturation (Figs. 14 & 15), a temporary restoration in glass-ionomer cement was placed together with a cotton pellet, which was soaked in an alcohol and chlorhexidine mixture first and then air-dried after it had been placed in the access cavity. Final radiographs (Figs. 16 & 17) were taken, both parallel and angled. The prognosis of this case was good and the patient was referred to his general dentist for a definitive coronal restoration.

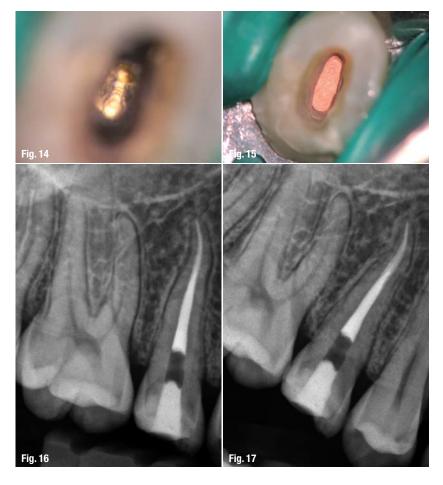
Fig. 14_Apical obturation with gutta-percha.
Fig. 15_The pulp chamber after complete obturation with gutta-percha.
Fig. 16_Final radiograph (parallel).
Fig. 17_Final radiograph (angled).
