# Rehabilitation of an edentulous mandible

## Restoration with one-piece zirconia implants

Prof. Ziv Mazor, Israel

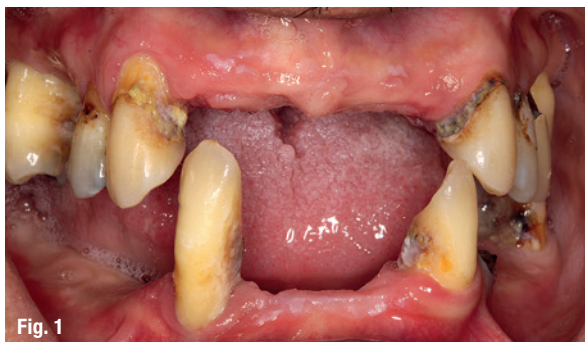
A 37-year-old patient presented suffering from aggressive periodontitis which resulted in almost total edentulism in the lower jaw (Fig. 1). For that reason, the patient asked for fixed restorations. The treatment plan involved

Fig. 1: Frontal view of the patient's mandible. Figs. 2 & 3: Implant positioning using the planning software Simplant.

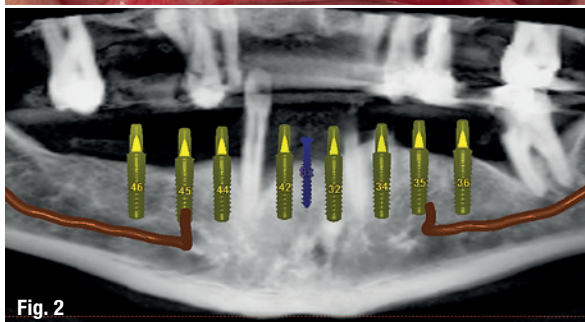
the extraction and grinding of the remaining teeth, the use of an autogenous dentine graft to fill up the alveolar defects and the subsequent insertion of one-piece zirconia implants (TAV Dental) utilising immediate loading. A bone-supported guide had been fabricated by means of the Simplant software to ensure optimal implant positioning (Figs. 2 & 3).
