Zirconia implants and digital workflow: A case report

Drs Saurabh Gupta, India & Sammy Noubissi, USA

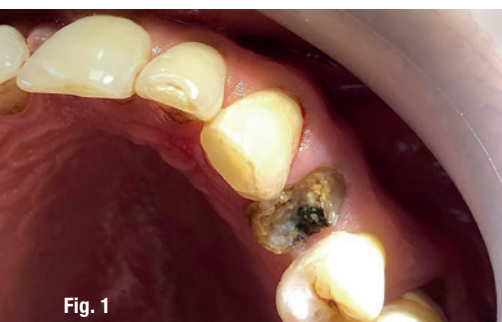
A 44-year-old patient attended the scheduled dental maintenance appointment complaining of a fractured tooth (Fig. 1), which had been treated endodontically and restored with a crown five years prior. The patient was a non-smoker and had an otherwise unremarkable medical history. Clinical assessments revealed little pain during percussion. A periapical radiograph confirmed the clinical findings and revealed the fracture line to be at the
