# Zirconia implants and digital workflow: A case report

Drs Saurabh Gupta, India & Sammy Noubissi, USA

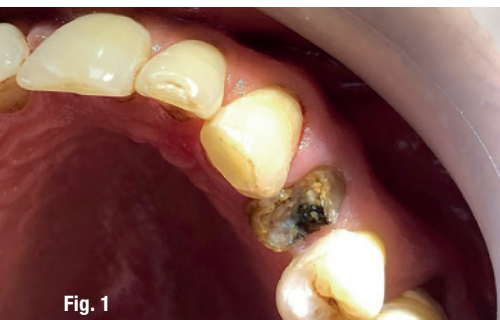
A 44-year-old patient attended the scheduled dental maintenance appointment complaining of a fractured tooth (Fig. 1), which had been treated endodontically and restored with a crown five years prior. The patient was a non-smoker and had an otherwise unremarkable medical history. Clinical assessments revealed little pain during percussion. A periapical radiograph confirmed the clinical findings and revealed the fracture line to be at the

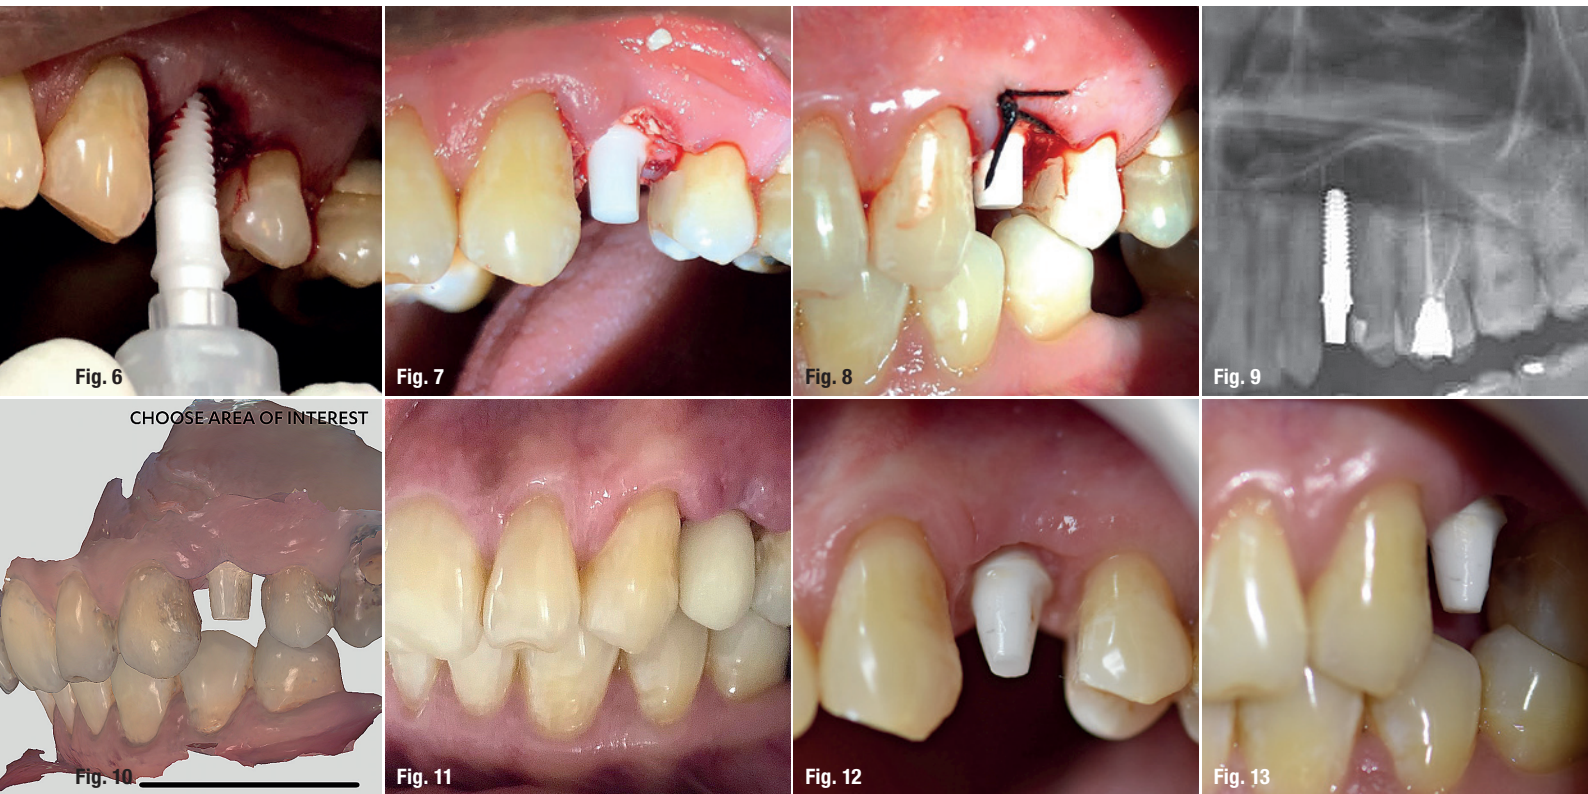
**Fig. 6:** Placement of the implant. **Fig. 7:** Bone grafting material placed around the implant body. **Fig. 8:** The horizontal mattress suture. **Fig. 9:** Radiograph taken immediately after surgery. **Fig. 10:** The optical scan after surgery. **Fig. 11:** The provisional restoration. **Figs. 12 & 13:** Tooth preparation.
