Extraction, tissue management and implant surgery over the long term

Dr Philippe Jourdan, France

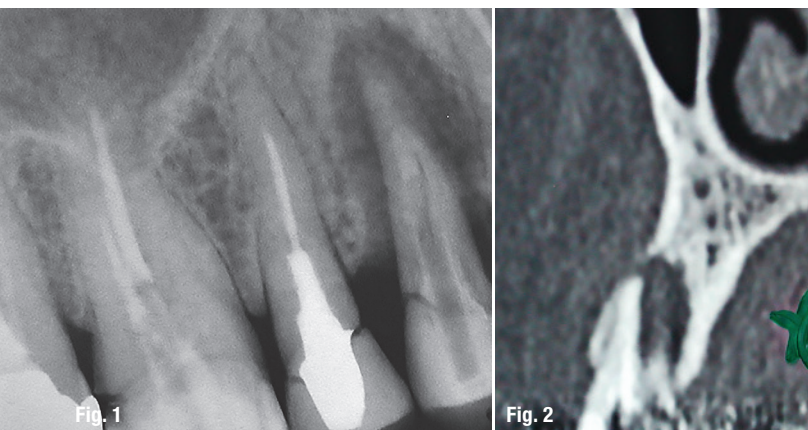
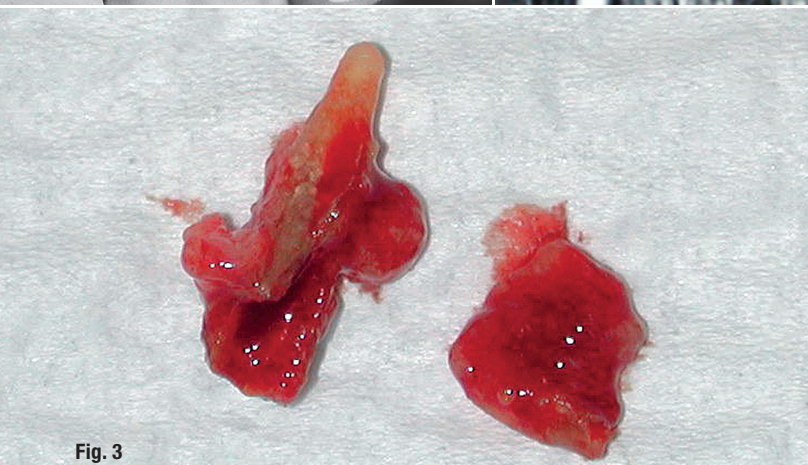
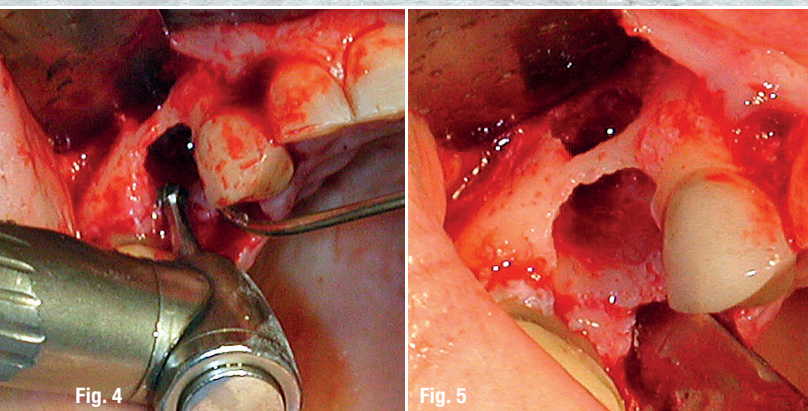
Fig. 1: Pre-op radiograph showing a fractured root. **Fig. 2:** A cyst had developed around the fractured tooth. **Fig. 3:** The extracted tooth in two pieces. **Fig. 4:** Preparation of the surgical site. **Fig. 5:** The cavity after extraction of the tooth.
