Comparing various implant designs and surfaces

A clinical study

Authors_Dr Roy Leshem¹, David Leshem², Israel

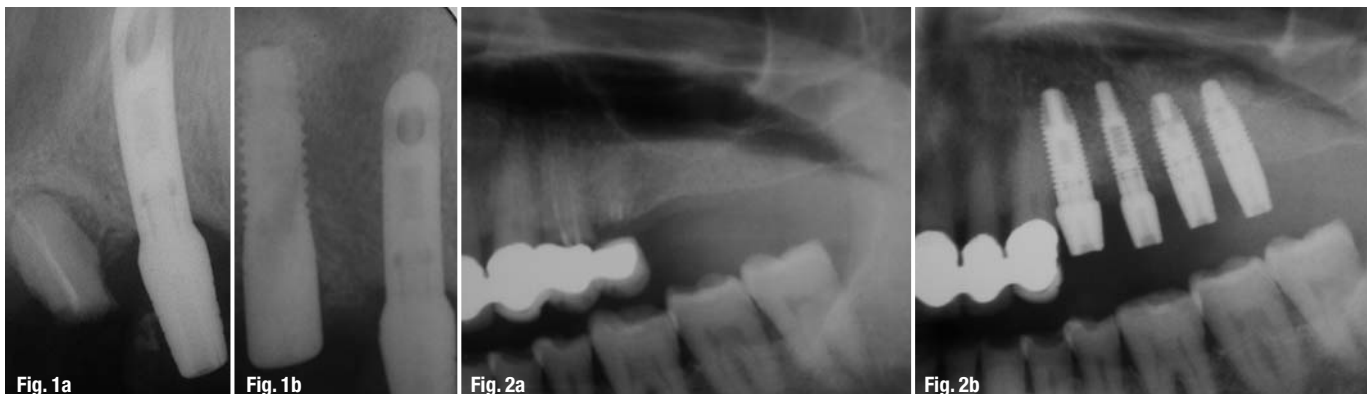
Fig. 1a_Alveolar bone height 1 mm to sinus, before extracting second premolar.

Fig. 1b_13 mm 4.2 thread implant placed with closed technique sinus augmentation.

Fig. 2a_Alveolar bone height 3 mm to sinus.

Fig. 2b_11.5 mm 5.0 thread implants placed with closed technique sinus augmentation.

The objective of the study was to present the success rate of fixtures of different designs and surfaces used in complex implant procedures, implants placed in internal sinus lift procedures (Figs. 1a–b), implants placed in lateral sinus lift procedures (Figs. 2a–b) bone augmentations, implants placed including grafting of buccal defect (Figs. 3a–d), and implants placed simultaneously with teeth extractions (Figs. 4a–d), all performed by one team.
