Explantation of an implant in a heavy smoker

Dr Branislav Fatori, Dr Inge Schmitz & Prof. Werner Götz, Germany

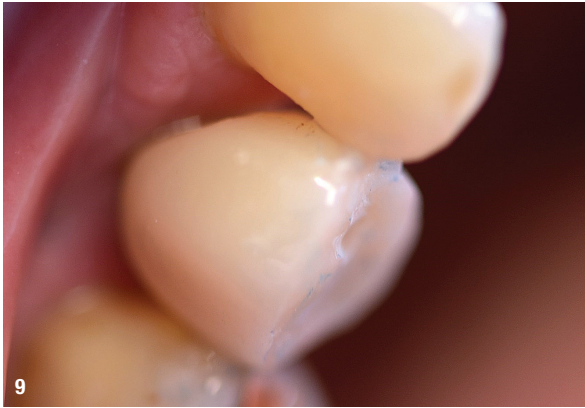
Fig. 9: Clinical situation showing the newly replaced implant.

tological examination, for which the material was processed conventionally by means of thin-section microscopy according to Donath and dyed with toluidine blue. The histological examination based on particulate blocks of the explant showed good contact between the bone and explant (Figs. 5–8). Crestally, there was good osseointegration with good bone-to-implant contact. Near the implant, regular osteogenesis and peripheral contact osteogenesis could be observed. In addition, there was very good vascularisation in the peri-implant area. No necrosis or inflammatory tissue was detected. Bone augmentation by means of NanoBone (Artoss) was necessary for the replacement of the implant (Fig. 9).
