# Immediate placement of a new fully tapered tissue-level implant

Dr Mario Rocuzzo, Italy

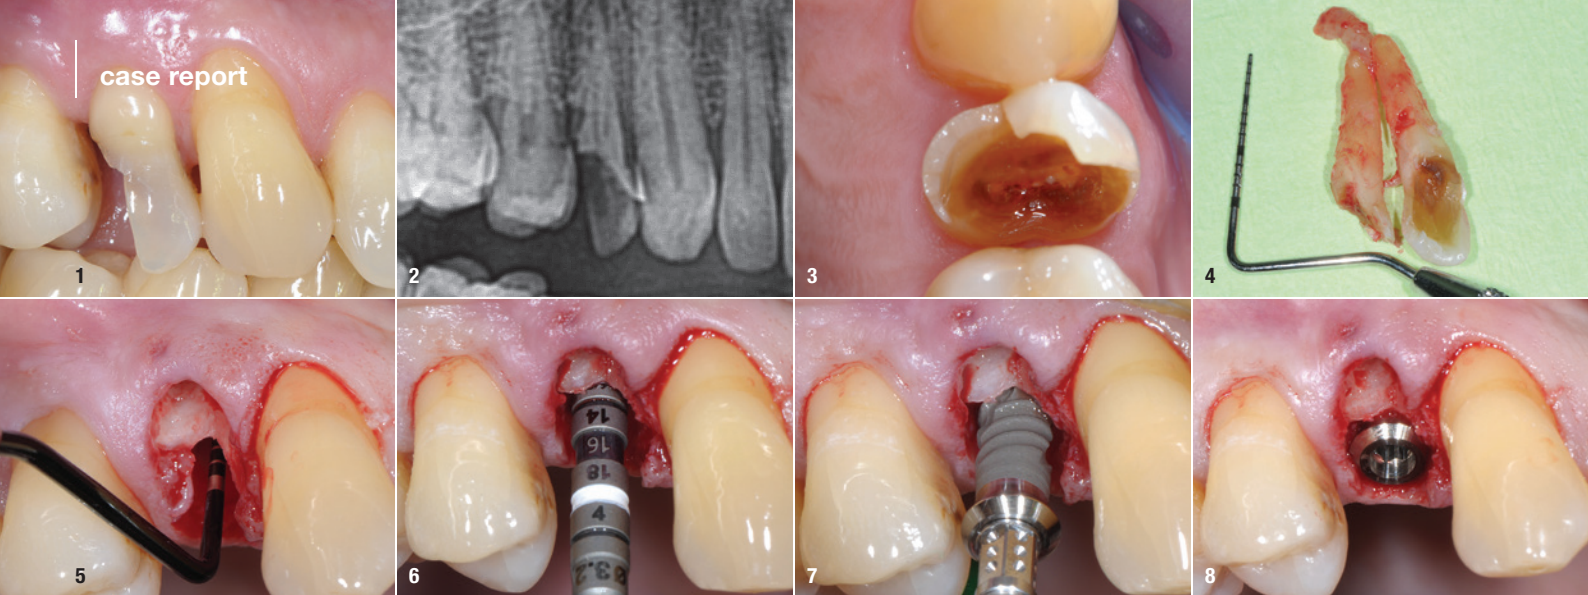
**Fig. 1:** Frontal view, showing the fracture of the maxillary right first premolar. **Fig. 2:** Pre-op radiograph. **Fig. 3:** Occlusal view, showing caries into the root and involvement of the distal furcation. **Fig. 4:** The extracted tooth. **Fig. 5:** The socket was measured with a periodontal probe. **Figs. 6 & 7:** Insertion of the implant. **Fig. 8:** View of the implant immediately after insertion.

In September 2019, a 53-year-old non-smoking male patient came for a consultation after the fracture of his maxillary right first premolar (Fig. 1). The patient presented with minimal periodontal problems, including multiple gingival recessions. The radiographic image confirmed the presence of a large periapical radiolucent area and some distal interproximal bone loss (Fig. 2). A thorough examination was carried out and revealed caries into the root and involvement of the distal furcation (Fig. 3). Upon clinical examination, the amount of healthy dentine was considered insufficient for a stump preparation for a conventional crown. Moreover, the patient was unwilling to undergo orthodontic

In order to minimise the trauma during treatment, a careful separation of the tooth into two parts was carried out before extracting both roots (Fig. 4). No incisions were made, in order to reduce the risk of soft-tissue dehiscence. Before implant insertion, meticulous cleaning and careful curettage/debridement was carried out. The dimen-

sions of the socket were measured by means of a periodontal probe (Fig. 5). A TLX SP, RT, SLActive®, Roxolid® 3.75x 12.00mm implant (Straumann Institut) was placed according to the manufacturer's instructions. The implant was inserted using the handpiece in a self-tapping fashion, and a high primary stability was achieved (Figs. 6 & 7). The implant was positioned according to the International Team for Implantology philosophy of "as shallow as possible, as deep as necessary", the SLActive® surface margin placed at bone level. The use of a reduced-diameter implant allowed the presence of more bone around the implant for greater long-term success. The implant was placed slightly on the palatal side of the alveolar bone crest, leaving sufficient space buccally (Fig. 8).
