Restoring the function and aesthetics of central incisors

Dr Philippe Jourdan, France

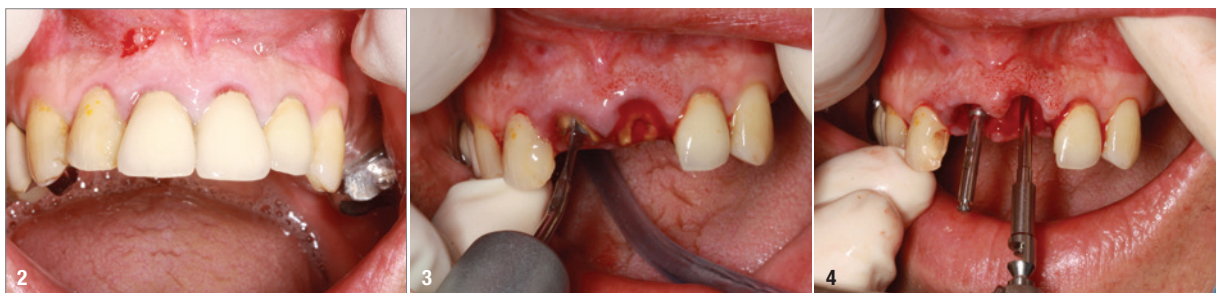
Fig. 2: Central incisors before implant surgery. Fig. 3: Preparation and extraction of central incisors. Fig. 4: Osteotomy preparation for implant placement.

Surgery began with using the piezo-surgical unit to atraumatically extract the roots of the central incisors (Fig. 3). The sockets were cleaned manually and an Er:YAG laser was used to remove the periodontal ligaments. The implant sites were prepared by creating osteotomies in each socket, the implant sites parallel to each other and positioned palatally (Fig. 4). The implants were placed into the sockets at 15 rpm (Figs. 5 & 6). Using a contra-angle handpiece makes this process much quicker and easier than carrying it out manually. Impression copings designed for taking closed-tray impressions were fitted once the implants had been placed (Fig. 7). Acrylic was applied around the impression copings and the excess material was removed distal to the lateral incisors. The acrylic was then used to take a closed-tray impression, which was treated by the dental technicians at the integrated dental laboratory at the author's practice. This impression taking technique is easier, faster and more accurate than other methods and one that the author often uses in cases where there are multiple implants and joined crowns.
