Correction of a vertical fracture and a subsequent infection

Dr Matthew J. Fien, USA

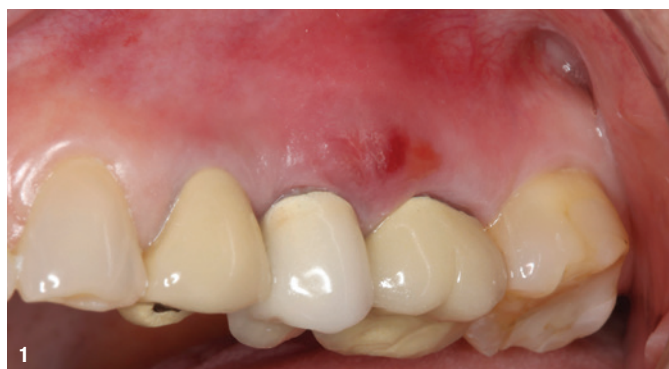
Fig. 1: Pre-op buccal view. **Fig. 2:** Pre-op radiograph. **Fig. 3:** Full-thickness flap reflection. **Fig. 4:** Extraction and degranulation. **Fig. 5:** Membrane stabilised with resorbable sutures over the allograft particulate bone graft.

A 46-year-old female patient with a non-contributory medical history presented for evaluation and treatment of swelling in her maxillary left quadrant. The intra-oral examination revealed moderate swelling and a buccal fistula 3mm from the gingival margin of tooth #25 (Fig. 1). The radiograph revealed severe bone loss as a result of fracture and subsequent infection of tooth #25 (Fig. 2). Treatment planning included tooth extraction and subsequent tissue debridement. Tooth replacement with a dental implant was planned to be carried out once the site had regenerated.
