# The use of the Er:YAG in laser-assisted **broken** abutment screw treatment

**Authors** \_Avi Reyhanian, Israel, Steven Parker, United Kingdom, Joshua Moshonov, Israel, Natan Fuhrman, Israel

## \_Case study

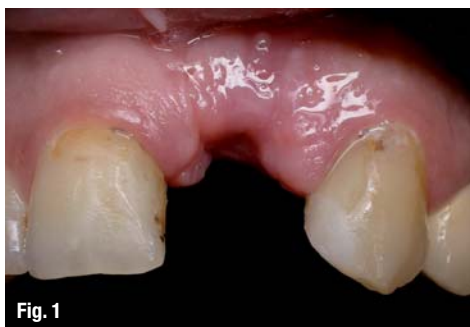
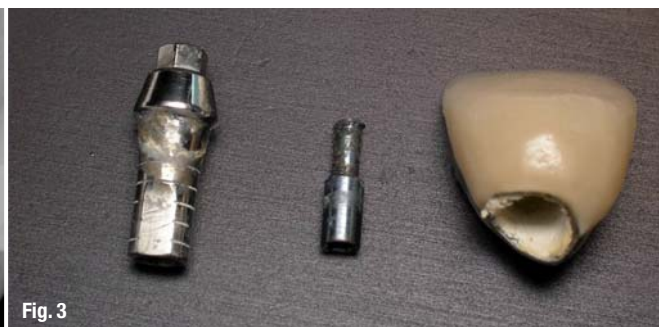
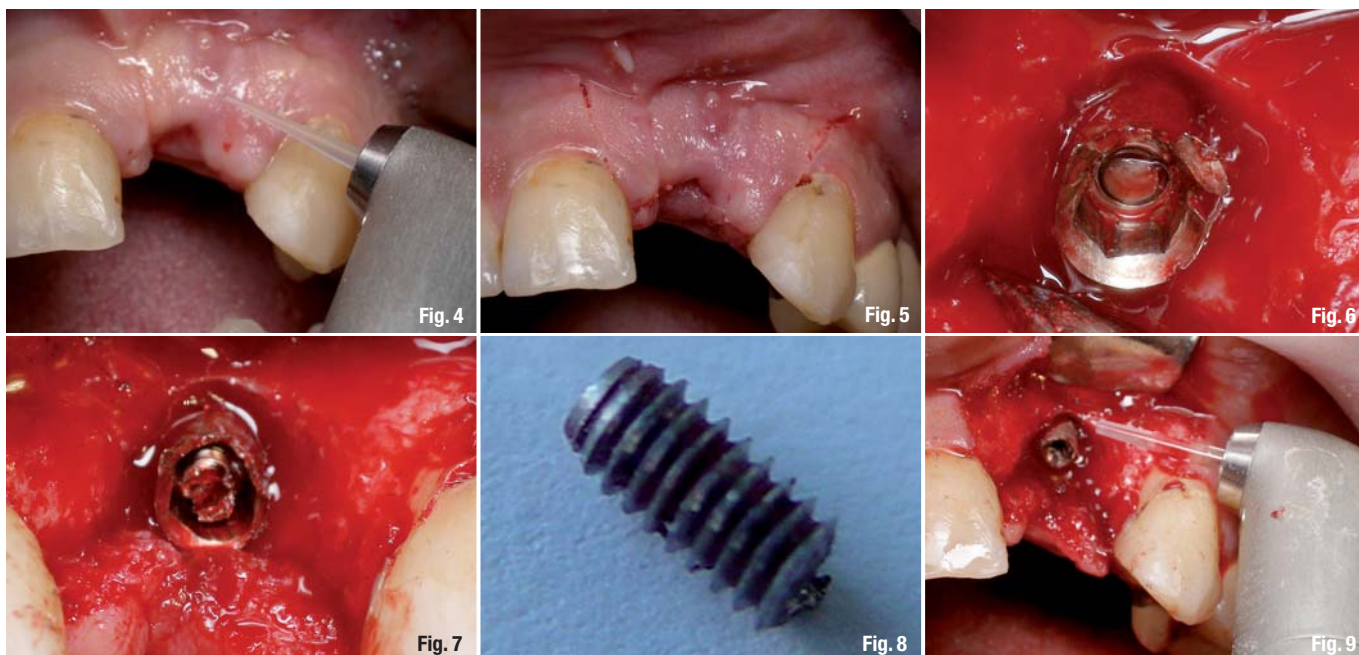
Clinical examination of the patient revealed a missing tooth at the location of #9 with no sign of an implant (Fig. 1). The patient brought the abutment, crown and broken screw with him (Fig. 3). Radiographic examination of the area showed the presence of a root-form cylindrical implant, consistent in appearance with a 13 mm long, 3.75 mm diameter abutment with an internal hex. The apical part of the screw remained threaded into the implant, but had fractured at the level of the hexagonal lock. Although

the implant was osseointegrated, there were radiographic signs of peri-implantitis with some crestal bone loss having occurred (Fig. 2).

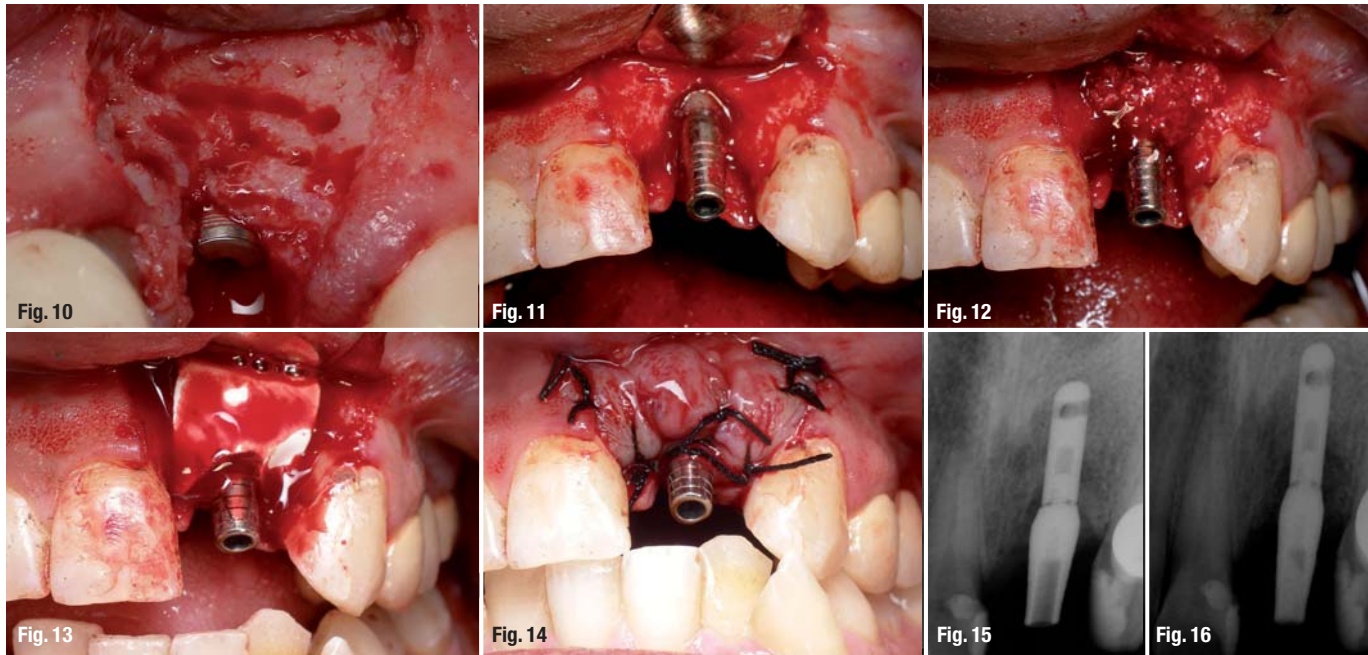
A "V" shape incision was made with the Er:YAG laser. An intrasulcular incision was made (after anaesthesia) at the buccal and palatal side of the implant, together with two vertical relieving incisions: one at the mesial side of tooth # 8 and the second at the mesial side of tooth # 11 (Figs. 4 and 5).

The buccal and palatal flaps were lifted and the area explored (Fig. 6); there was granulation tissue around the neck of the implant. The granulation tissue was ablated using the laser (Fig. 9). Vaporization of granulation tissue (if any exists) after raising a flap is efficient with the Er:YAG laser, offering a lower risk of overheating the bone than that posed by the current diode or CO<sub>2</sub> lasers.<sup>43</sup> And often obviates the need for hand instruments. Results from both controlled clinical and basic studies have pointed to the high potential of the Er:YAG laser and its excellent ability to effectively ablate soft tissue without producing major thermal side-effects to adjacent tissue has been demonstrated in numerous studies.<sup>35,36,37</sup>

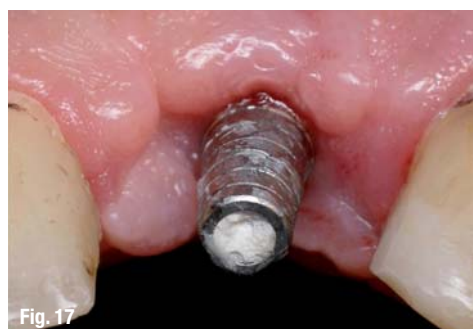
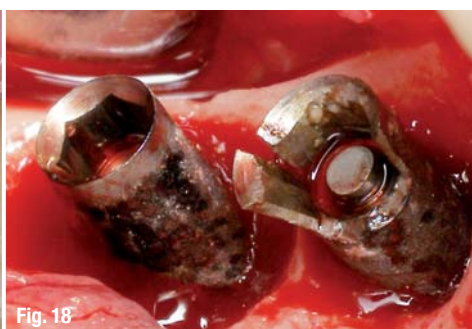
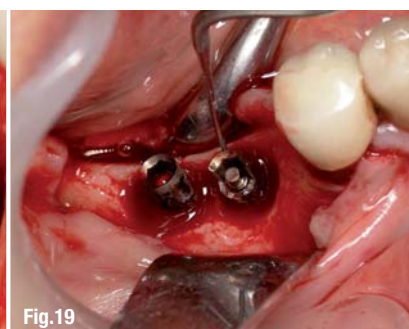
The broken hexagon slot was straightened, using a round diamond bur and the head of the implant was rendered smooth. A slot was created with a surgical drill on the head of the fractured screw, and a screwdriver was successfully used to unscrew the broken abutment screw (Figs. 7 and 8). The Er:YAG laser was aimed at the surface of the exposed implant for the purpose of decontaminating the infected exposed surfaces, without damaging them.<sup>36,40,41,42,43</sup> Studies have shown that Er:YAG laser energy effects on bone include bacterial reduction.<sup>43,44</sup> Following this, all accessible bone surfaces were exposed to laser energy to ablate necrotic bone and to shape and remodel the surface, in accordance with established clinical proto-

cols.<sup>32,34,38,39</sup> Decortication of the buccal bone was then performed (Fig. 10). The purpose of decortication is to encourage bleeding, providing progenitor cells to the site. A new abutment was then inserted into the implant (Fig. 11). All spaces between implant and existing osteotomy site were filled with a xenograft bone substitute (Bio-Oss®, Geistlich Biomaterials) and covered with an absorbent bilayer membrane (Bio-Gide®, Geistlich Biomaterials), (Figs. 12 and 13). The mucoperiosteal flap was re-positioned and sutured with silk 3-0, paying particular attention to primary closure of the flap (Fig. 14).
