The use of the Er:YAG in laser-assisted **broken** abutment screw treatment

Authors _Avi Reyhanian, Israel, Steven Parker, United Kingdom, Joshua Moshonov, Israel, Natan Fuhrman, Israel

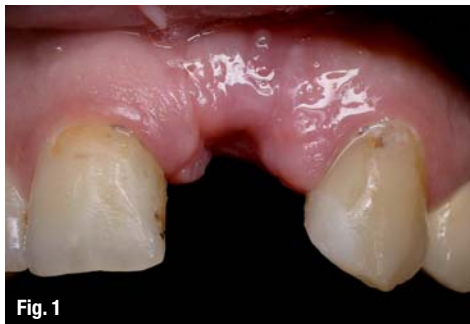
Clinical examination of the patient revealed a missing tooth at the location of #9 with no sign of an implant (Fig. 1). The patient brought the abutment, crown and broken screw with him (Fig. 3). Radiographic examination of the area showed the presence of a root-form cylindrical implant, consistent in appearance with a 13 mm long, 3.75 mm diameter abutment with an internal hex. The apical part of the screw remained threaded into the implant, but had fractured at the level of the hexagonal lock. Although
