Placement of one- and two-piece ceramic implants

Two treatment models in one patient

Prof. Belir Atalay, Dr Alper Çıldır, Dr Burcu Balkan & Dr Alanur Büyükvardar, Turkey

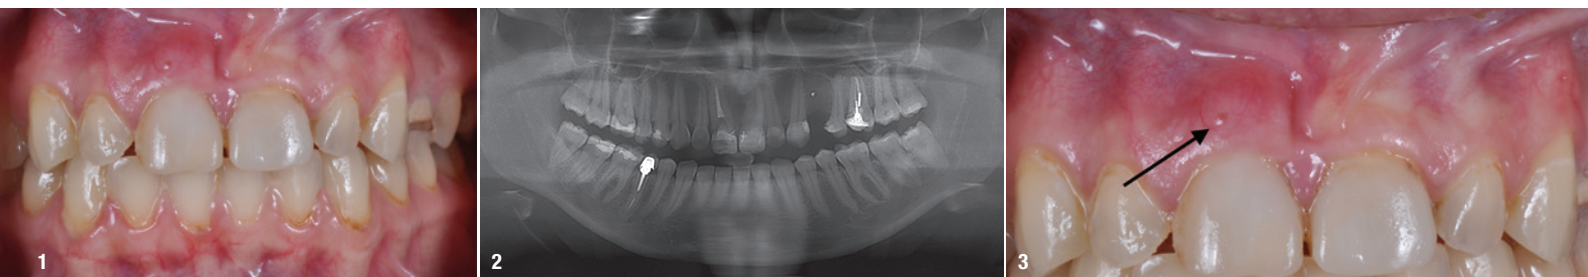
Fig. 1: Pre-op intra-oral view. **Fig. 2:** Pre-op panoramic radiograph. **Fig. 3:** Fistula formation at tooth #11.

A 35-year-old female patient presented with a request for general restoration of her teeth (Fig. 1). The patient was healthy and had an unremarkable medical history. The patient had problems in two different areas for which implant surgery could be considered. The first was a dental gap where tooth #24 had been missing for many years. The second was tooth #11 that had undergone root canal therapy previously (Fig. 2). The tooth, which was reported as mobile by the patient, was observed to have a fistula formation buccally (Fig. 3). It was also noticed that this tooth had a horizontal crown fracture under the gingiva. The treatment of these two areas is the subject of this case report.
