Room for improvement

Remarkable impurities found on randomly chosen ceramic implants

Dr Dirk U. Duddeck, Germany

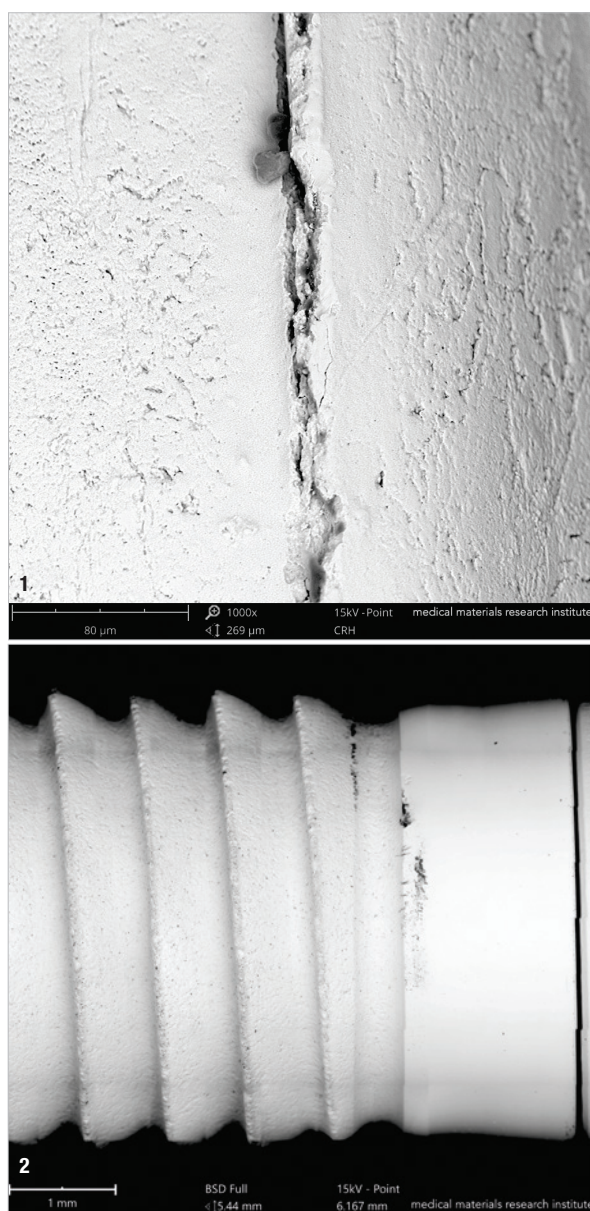
Fig. 1: Organic contaminants in a crack at the implant shoulder. **Fig. 2:** Plastic (polyoxymethylene) particles from the implant packaging on the first implant thread.

The Swedish-German research team from Charité Universitätsmedizin—Berlin (Duddeck and Florian Beuer), Sahlgrenska Academy at the University of Gothenburg (Tomas Albrektsson and Ann Wennerberg) and Malmö University (Christel Larsson), supported by the International University of Agadir (Jaafar Mouhyi), revealed some unexpected results. While the surfaces of two of the investigated implant systems were found to be largely free of particles, the other systems examined revealed significant carbon-containing organic impurities on their surfaces (Fig. 1). Subsequent time-of-flight secondary ion mass spectrometry analysis identified these contaminants as polysiloxanes, erucamide, aliphatic hydrocarbon compounds, fatty acid esters, talc and even polyacetal (polyoxymethylene; Fig. 2).

Remarkably, the study showed that in one system the sterile packaging itself was the cause of substantial plastic contamination on the sterile implant's surface—some of the contaminants were millimetres in size. Dodecylbenzenesulphonic acid (DBSA) was also detected on samples of two implant systems, which suggests that the manufacturers' cleaning process of the ceramic implants examined was insufficient. DBSA is an aggressive surface-active cleaning agent classi-
