# Room for improvement

## Remarkable impurities found on randomly chosen ceramic implants

Dr Dirk U. Duddeck, Germany

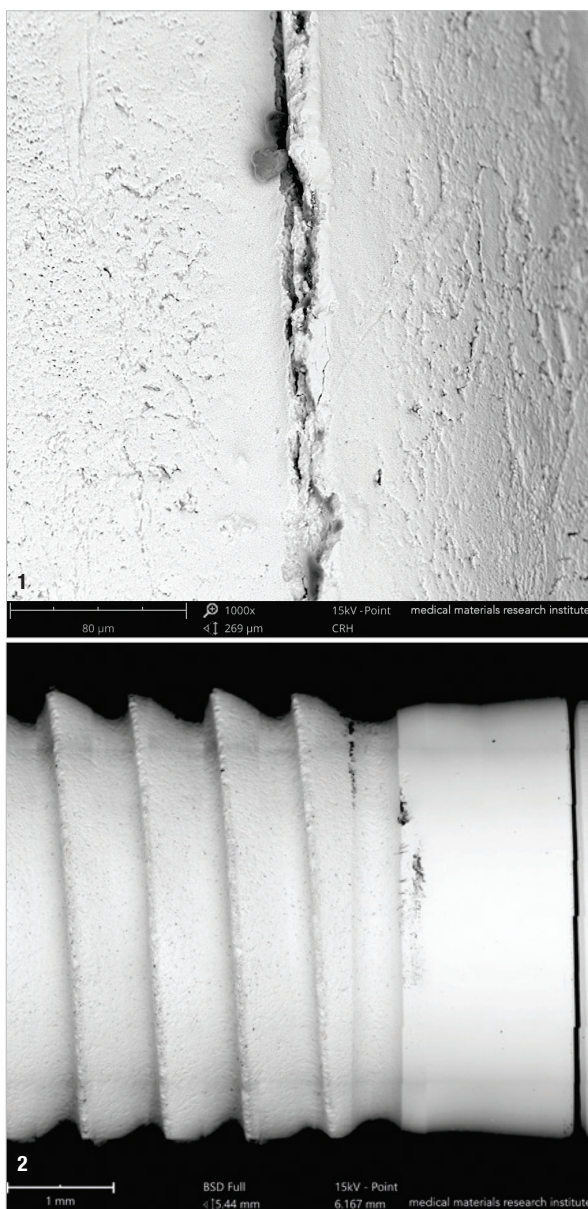
**Fig. 1:** Organic contaminants in a crack at the implant shoulder. **Fig. 2:** Plastic (polyoxymethylene) particles from the implant packaging on the first implant thread.

The Swedish-German research team from Charité Universitätsmedizin—Berlin (Duddeck and Florian Beuer), Sahlgrenska Academy at the University of Gothenburg (Tomas Albrektsson and Ann Wennerberg) and Malmö University (Christel Larsson), supported by the International University of Agadir (Jaafar Mouhyi), revealed some unexpected results. While the surfaces of two of the investigated implant systems were found to be largely free of particles, the other systems examined revealed significant carbon-containing organic impurities on their surfaces (Fig. 1). Subsequent time-of-flight secondary ion mass spectrometry analysis identified these contaminants as polysiloxanes, erucamide, aliphatic hydrocarbon compounds, fatty acid esters, talc and even polyacetal (polyoxymethylene; Fig. 2).

Remarkably, the study showed that in one system the sterile packaging itself was the cause of substantial plastic contamination on the sterile implant's surface—some of the contaminants were millimetres in size. Dodecylbenzenesulphonic acid (DBSA) was also detected on samples of two implant systems, which suggests that the manufacturers' cleaning process of the ceramic implants examined was insufficient. DBSA is an aggressive surface-active cleaning agent classi-
