How clean do **sterile** implants have to be?

Analysis and clinical relevance of **factory-related** contaminations

Dr Dirk U. Duddeck, Germany

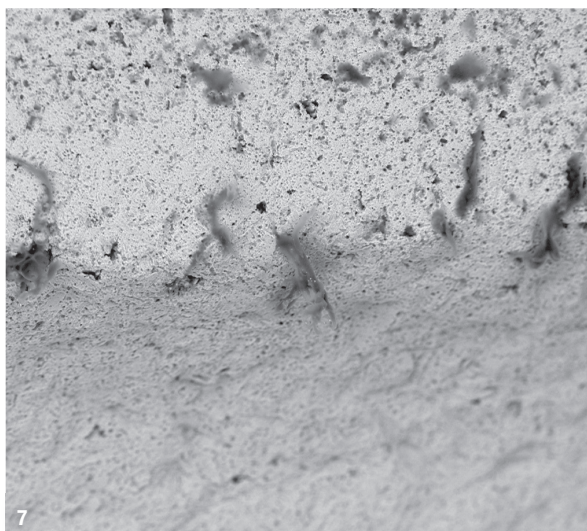
Fig. 7: Significant plastic material (polyacetal) on the shoulder of a ceramic implant (vitaclinical, VITA Zahnfabrik) from abrasion from the packaging.

Unfortunately, implant systems do not have consistent, comparable quality, as summarised in 2020 by Dr Norton, a past president of the Academy of Osseointegration, in an opinion piece in the *British Dental Journal* that is well worth reading.¹¹ The use of factory-contaminated implants not only may lead to inferior clinical outcomes but also carries the risk of legal implications. The problem of possible factory-related contamination concerns not only implants made of titanium or titanium alloys but also ceramic implants, as scientists from the universities of Gothenburg, Malmö and Berlin impressively described in a study published in 2021.¹² The bottom line of the study is that just because the material of ceramic implants is white does not necessarily mean that they are clean (Fig. 7).
